## **Instrumentation and Analysis of a Perpetual Pavement on an Interstate Freeway in Oregon**

In 2005 the Oregon Department of Transportation (ODOT) reconstructed a section of Interstate 5 south of Salem using 12 inches of hot-mix asphalt (HMA). The HMA was placed over two different base courses—rubblized portland cement concrete (PCC) and aggregate base. A mechanistic-empirical (M-E) analysis of the structure for fatigue cracking resistance indicated that the pavement structure meets the criteria for a perpetual pavement, given a number of assumptions used in the analysis. During construction, ODOT installed twelve strain gages over the rubblized PCC and twelve strain gages over the aggregate base prior to placement of the HMA layer. Additionally, temperature sensors were installed at various depths in the HMA layer and a weigh-in-motion site was installed immediately upstream of the strain gage sites. Data collected from these instruments includes strains at the bottom of the HMA layer, truck axle weights and configurations at highway speeds, and temperatures at various depths within the HMA layer.

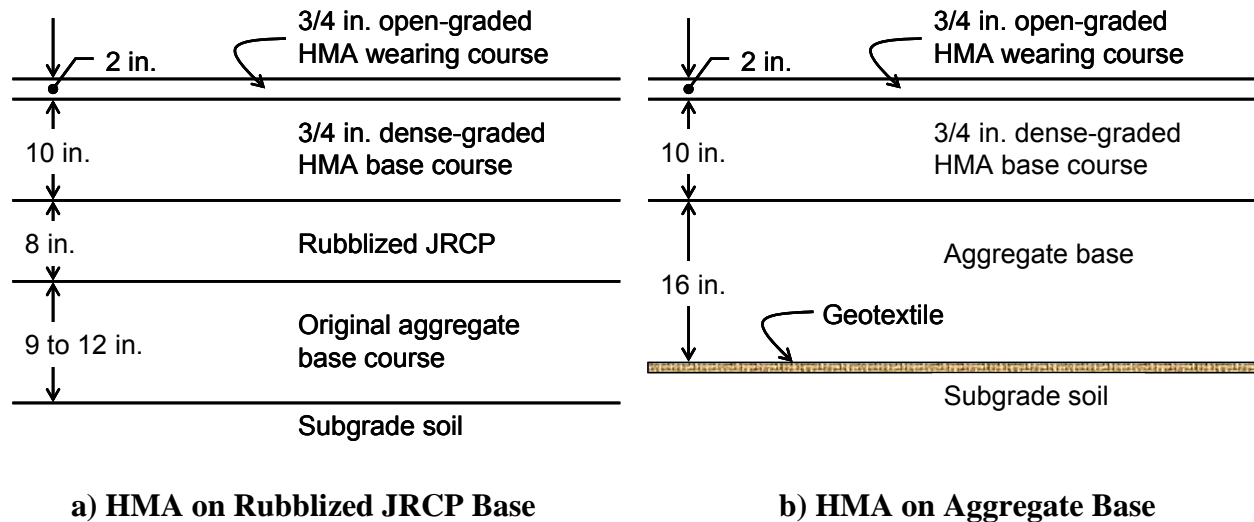
**FIGURE 2 Final Structural Sections.**

ODOT selected 12 inches (300 mm) as the design thickness (see Figure 2a) and conducted a sensitivity analysis by varying the layer coefficient of the aggregate base and the rubblized PCC at reliability levels from 90 to 100%. It was found through this analysis that the 12 inch (300 mm) thickness would result in a minimum reliability of approximately 97%.

ODOT used the AASHTO Design Guide (3) for the sections to be reconstructed under the structures. For a 20-year design life (72,896,000 ESALs) and using a reliability of 90%, an overall standard deviation of 0.45, a subgrade modulus of 5.8 ksi, and initial and terminal serviceability values of 4.2 and 2.5, respectively, the resultant structure was determined to be 13 inches (325 mm) of HMA on 16 inches (400 mm) of aggregate base. However, for consistency in thickness with the adjacent sections over rubblized JRCP base, the HMA thickness was reduced to 12 inches as indicated in Figure 2b. Note also that a geotextile was placed over the subgrade soil prior to construction of the aggregate base.

surprising given that the section over the rubblized concrete is a thicker structural section (see Figure 2).

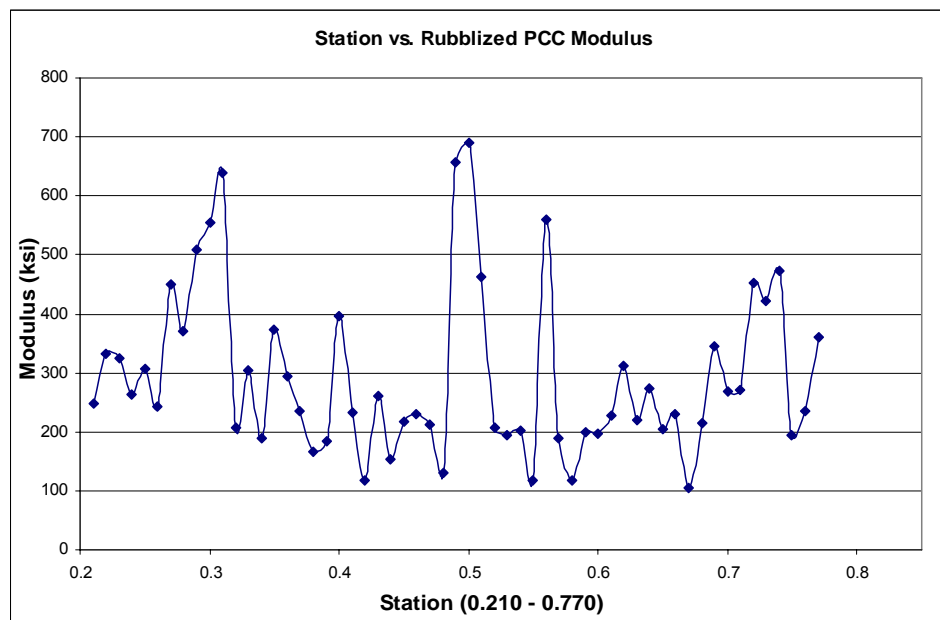
**FIGURE 3 Rubblized PCC Moduli.**

Falling weight deflection (FWD) data from previous a rubblization project was utilized to estimate the modulus for the rubblized JRC layer for this project. Figure 3 shows the back-calculated modulus values using Evercalc (WESLEA) (6) for numerous deflection measurements along a PCC rubblization project that had similar characteristics to that reported in this paper. As evidenced from Figure 3, there existed considerable variability in the back-calculated moduli. However, given that 57 deflections and resultant moduli were obtained, it was reasoned that the mean of this sample (i.e., 294 ksi) would be representative of the modulus value for the rubblized JRC layer for this project.

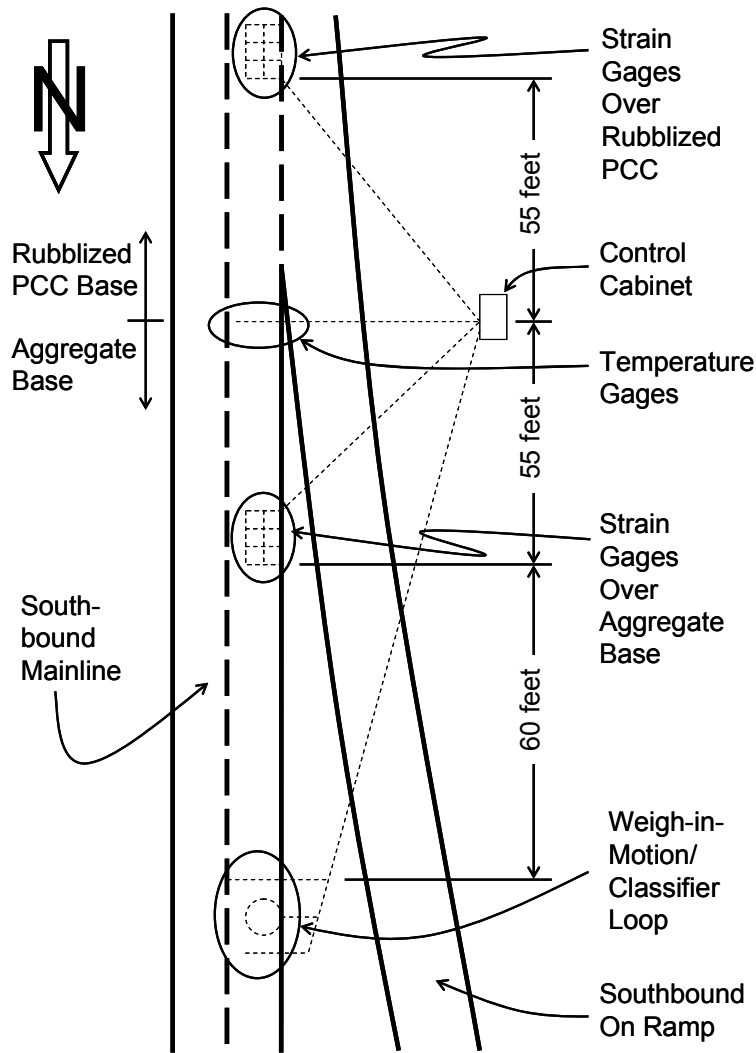
**FIGURE 5 Layout of Instruments at the Site.**

Using the procedures developed by the National Center for Asphalt Technology (NCAT) (8) as an installation guide, four temperature gages and 24 strain gages (12 over the aggregate base and 12 over the rubblized JRCF) were installed at the site as illustrated in Figure 5. In addition, a weigh-in-motion (WIM) device and classifier loops were installed upstream of the strain gages (Figure 5) so that the WIM device could trigger data collection.

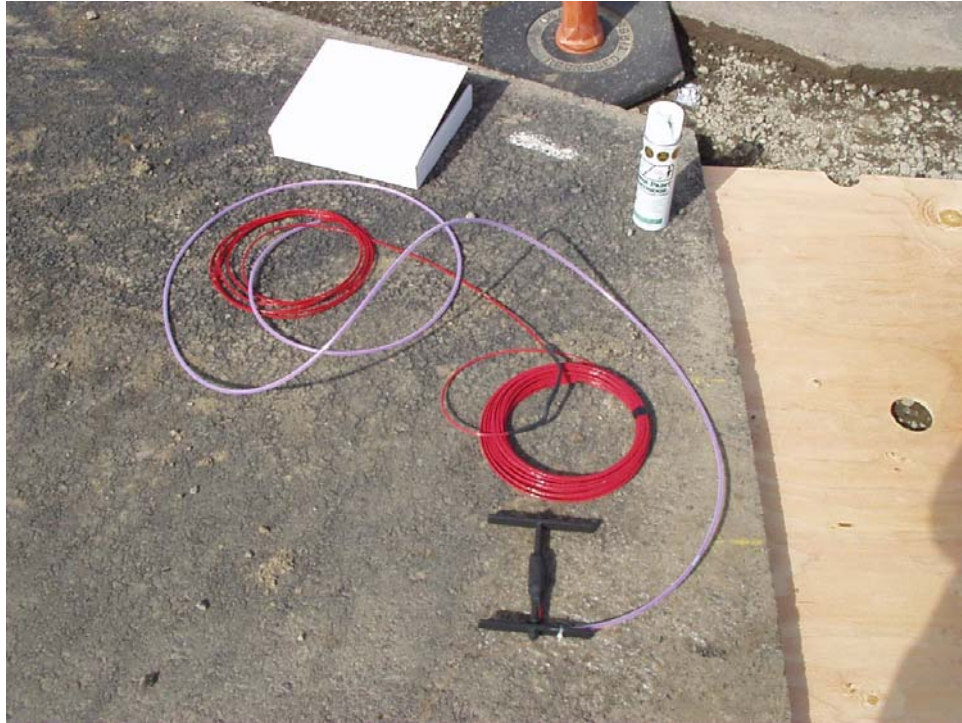
**FIGURE 6 Strain Gage with Protective Nylon Sheath.**

ASG-152 asphalt full-bridge strain gages purchased from Construction Technology Laboratories were used at the site. Prior to installation, the gages were checked for proper operation using a Vishay Instruments strain indicator and fitted with a 12 foot nylon sheath over the lead wire (Figure 6) to protect it from heat and abrasion during the paving and compaction operations. The encased lead wire was then tied to one of the bars of the strain gage (Figure 7) to prevent it from crossing over the bar and becoming damaged during the compaction operation. An additional 100 feet of lead wire was spliced to the 30 foot factory installed lead wire to provide the necessary length from each gage to the control cabinet.

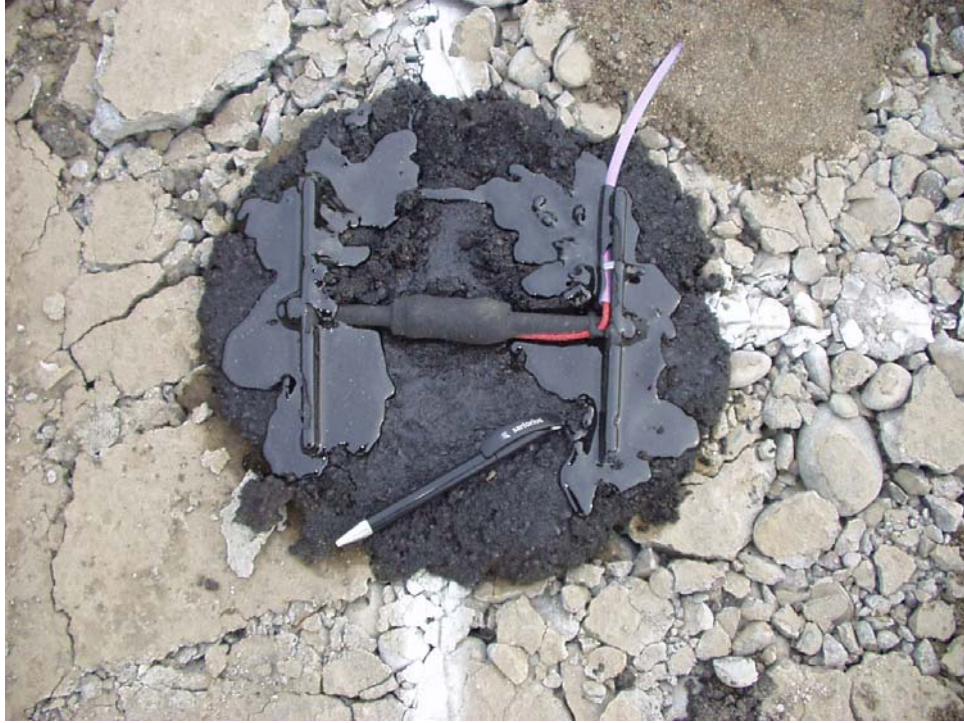
**FIGURE 8 Placement of Strain Gage on Mastic.**

A four- by six-foot grid with two foot spacing was marked on the base rock using a wooden template to assure spacing and orientation. Each gage was placed on a thin mastic mix consisting of a mixture of CSS-1 emulsion and aggregate passing the No.10 sieve (Figure 8) to prevent damage to the gage from the base rock and to aid in maintaining the gage orientation. Figure 9 shows the final orientation of the gages. As shown, six gages were oriented to measure longitudinal strain whereas the remaining six gages were oriented to measure transverse strain. In the aggregate base installation, the lead wires were routed in a shallow trench. For the rubblized concrete base installation the lead wires were covered with sand. In both cases the lead wires were routed from the paved lane to the control cabinet through a conduit installed in a trench as shown in Figure 10.

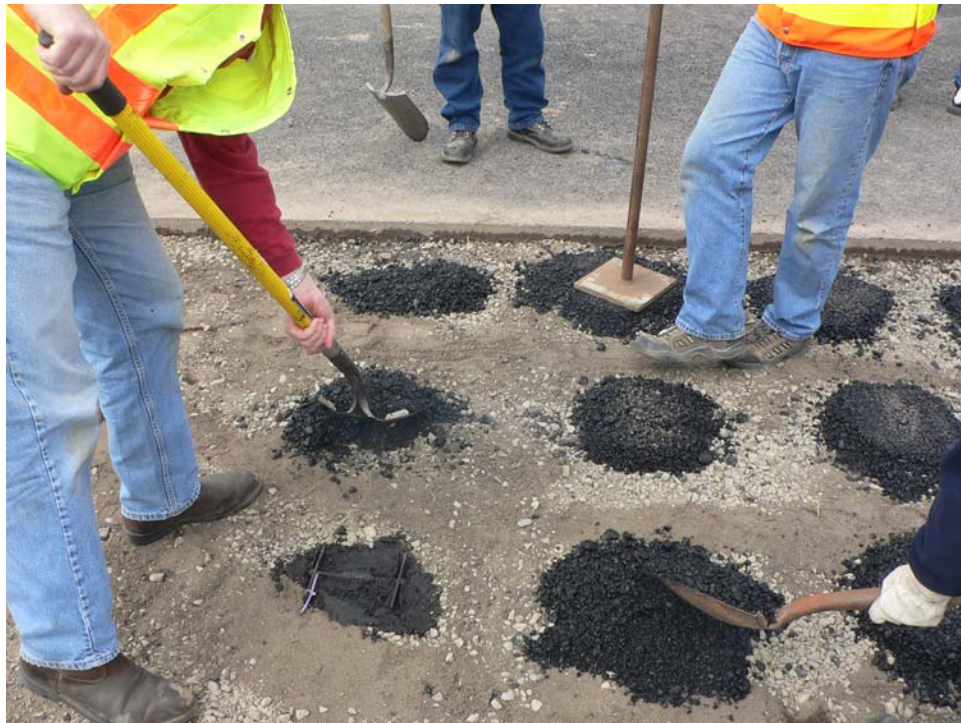
**FIGURE 11 Initial HMA Placement and Compaction.**

Hot mix from the paver was placed approximately two inches thick over and around each gage (Figure 11) followed by light compaction using a one foot square steel plate. For the strain gage grid over aggregate base, the trench fill was completed and rolled (Figure 10). For the strain gage grid over rubblized base, additional material was placed around the gages and light rolling was performed prior to the paving train passing over the gages. For the first pavement lift a vibratory roller was not used over the gages.

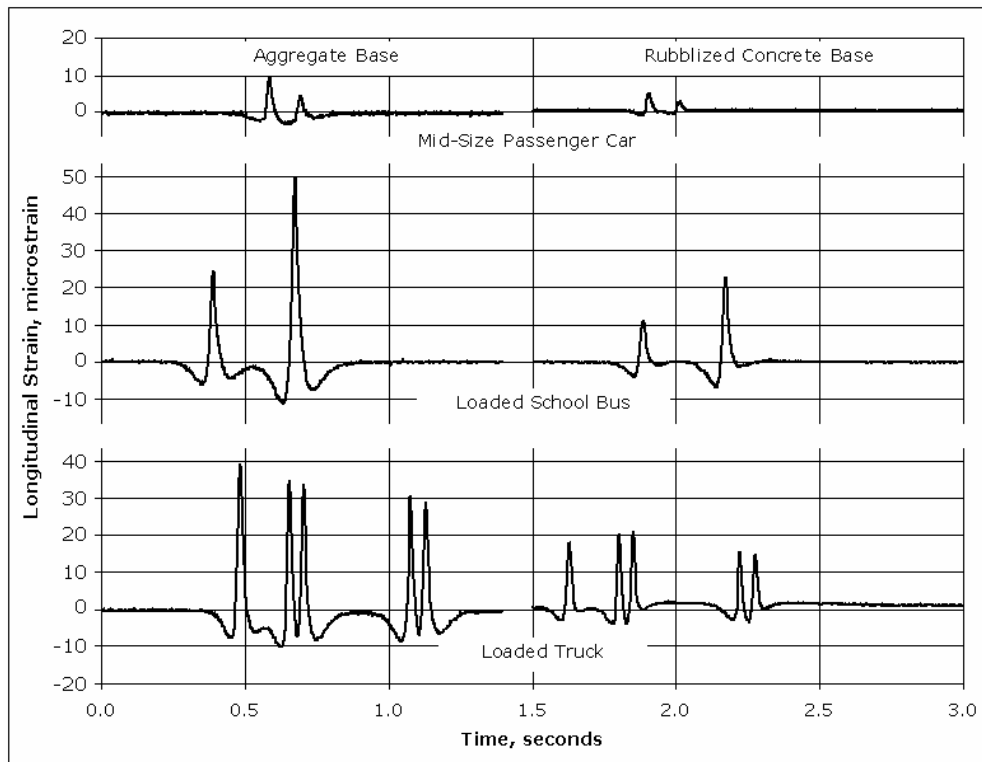
**FIGURE 12 Strain Measurement Obtained from Vehicles of Different Weights.**

Once the strain gages were properly balanced using the shunt resistors, all gages could be sufficiently amplified to obtain high quality data as evidenced in Figure 12 showing the response of the gages under loads applied by different types of vehicles. Several observations can be made from these data including:

- The axle loads in all cases are clearly discernable. For example, the passenger car and school bus were two-axle vehicles, whereas the loaded truck was a five-axle vehicle (standard 18-wheeler). With vehicle velocity information provided by the weigh-in-motion device, it will be possible to obtain highly accurate axle spacing information.

- The pavement experienced compression in the longitudinal direction several feet ahead of the wheel load applied by the steering axle before experiencing tension (characterized by the large, upward spikes in the data). This is also true between axle loads. This response is consistent with that found by the researchers at the NCAT Test Track (9). As will be shown later, the pavement does not necessarily experience compressive strain in the transverse direction.

- The maximum strain induced by the passenger vehicle (e.g., Pontiac Grand Prix) was only about a quarter of that induced by the loaded truck.
- The maximum tensile strain induced by the drive axle of the loaded school bus was actually higher (by about 30%) than that induced by the steering axle of the loaded truck.

- In all cases, the magnitude of longitudinal tensile strain was greater in the HMA over aggregate base relative to that in the HMA over the rubblized JRCF. This is not

- Also evident from the data is that the strain energy quickly dissipated to a state consistent with that before loading, indicating the structure was behaving in an essentially elastic manner. It should be noted that the air temperature at the time this data was obtained was about 62°F (17°C), so it would be expected that the pavement temperature was somewhat higher.

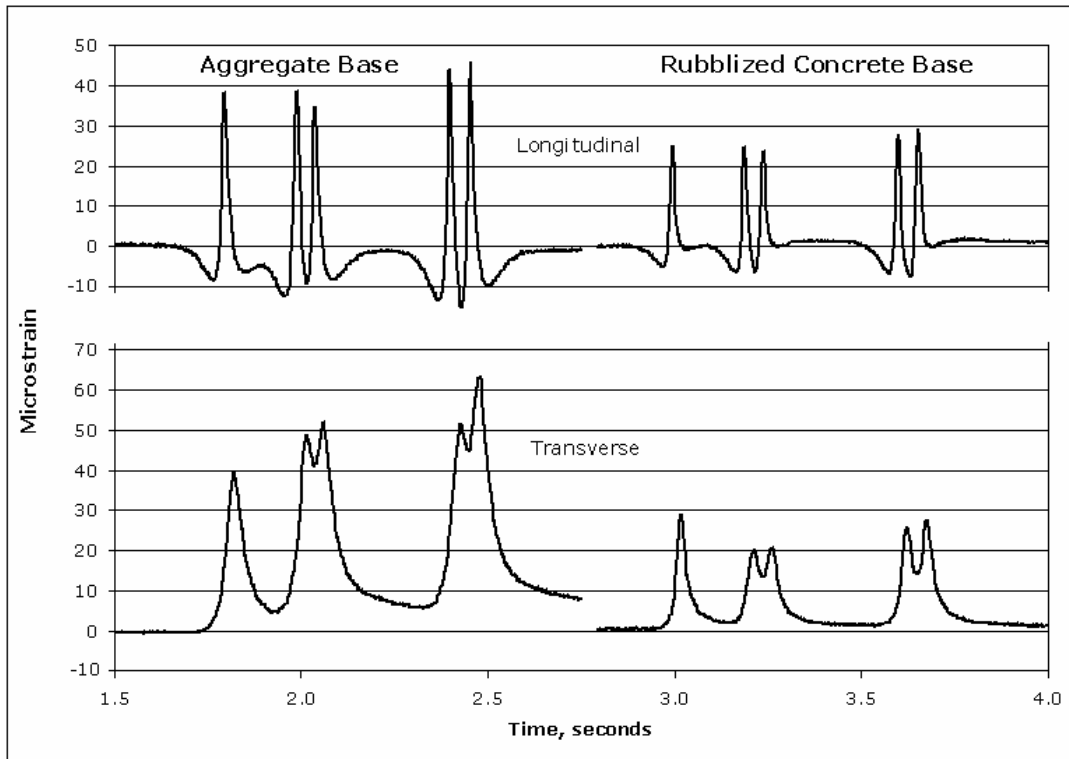
**FIGURE 13 Comparison of Longitudinal and Transverse Strain.**

Figure 13 shows a comparison between the longitudinal and transverse strain induced by a loaded, five-axle truck over both types of base course. The pavement experienced compressive strain ahead of the steering axle and between axles in the longitudinal direction, but in the transverse direction, the pavement only experienced tensile strain. It is also clear from the data that the strain energy dissipated more slowly in the transverse direction as compared with the longitudinal direction, particularly over the aggregate base, likely indicating a more viscous response in the transverse direction.

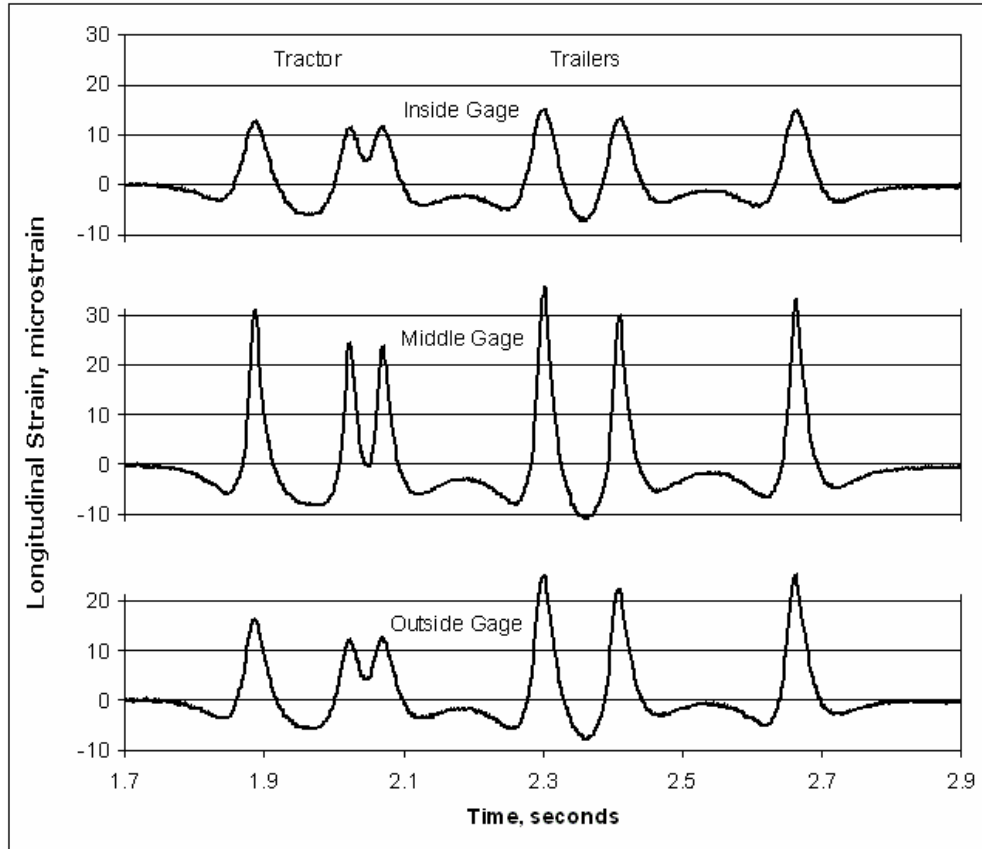
**FIGURE 14 Relative Longitudinal Strain Magnitude in the Transverse Direction.**

Figure 14 shows the longitudinal strains as measured by the first set of three strain gages a vehicle encounters (i.e., the northernmost set of strain gages over aggregate base). The data indicate that the “inside gage” registered a tensile strain approximately three-quarters the magnitude of that registered by the “outside gage”. Given that the “outside gage” and “inside gage” are four feet (1.2 m) apart, it is hypothesized that the wheel load is offset from the “middle gage” and closer to the “outside gage” by 1 foot (0.3 m). Further research is planned to verify this hypothesis.
