Effect of Carbon Steel Composition and Microstructure on CO<sub>2</sub> Corrosion

A dissertation presented to  
the faculty of  
the Russ College of Engineering and Technology of Ohio University

In partial fulfillment  
of the requirements for the degree  
Doctor of Philosophy

August 2014

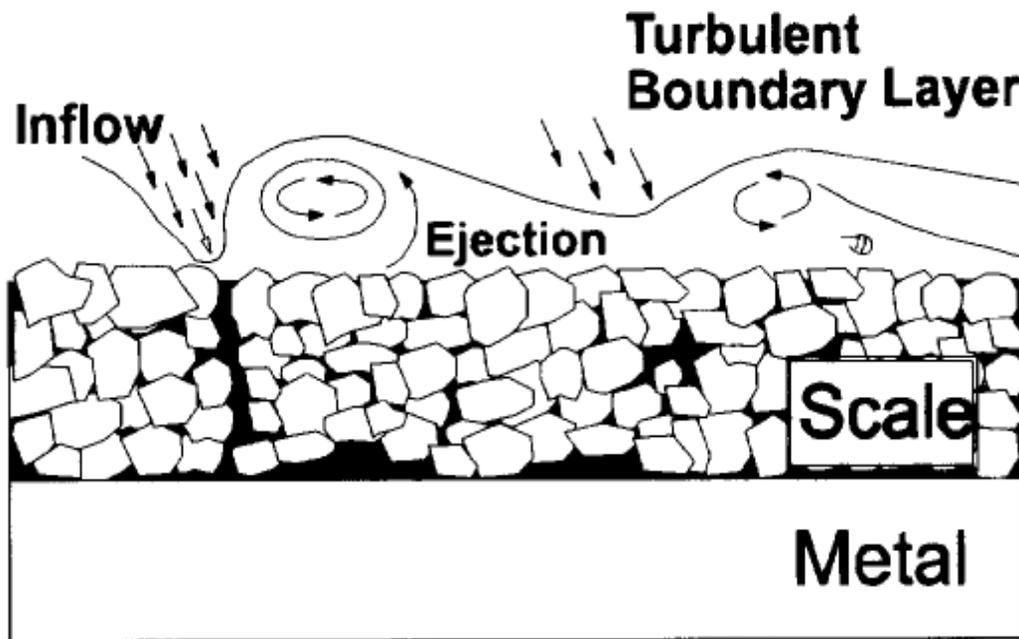
Figure 1: Diagram of the destruction mechanisms for surface layer caused by pressure changes near the steel surface [45].

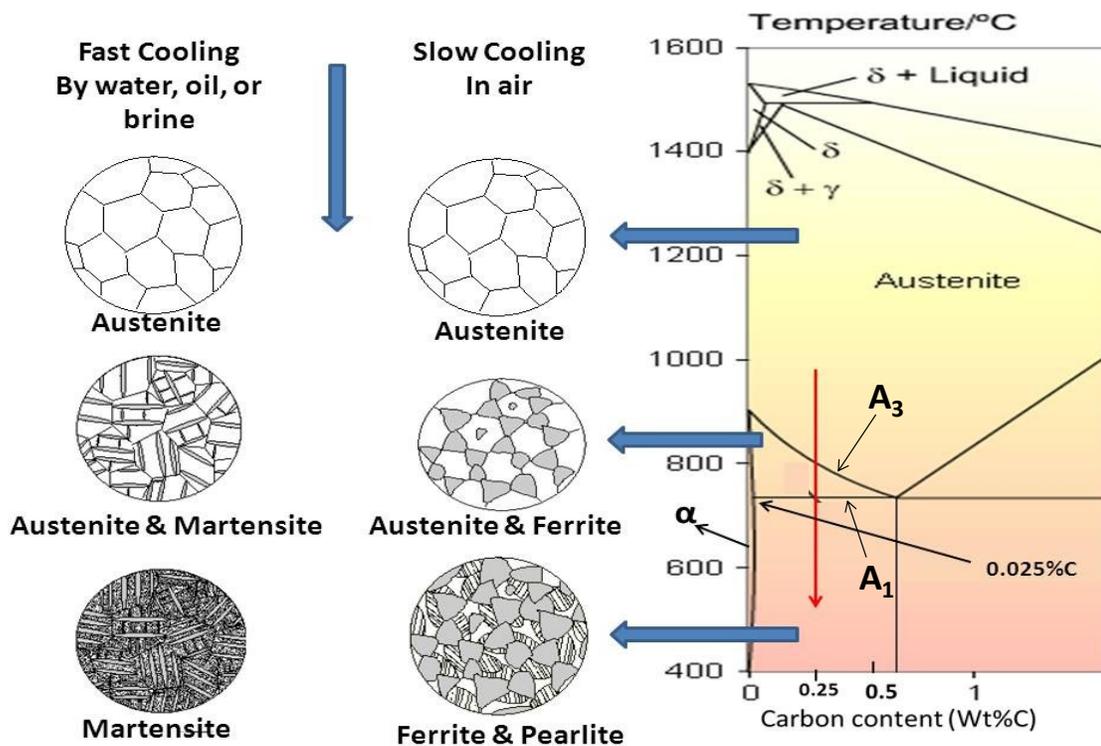
Figure 3: Fe-C phase diagram shows the phase transformation from austenite to ferrite/pearlite (slow cooling) and from austenite to martensite (fast cooling), where; white = ferrite, gray = pearlite [60].

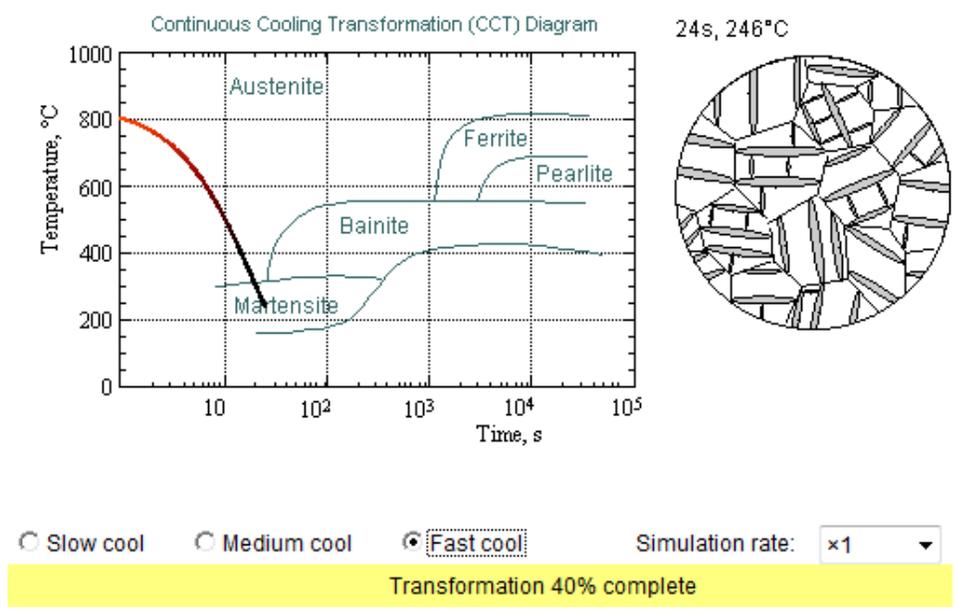
Figure 4: CCT diagram for 0.4wt% C steel shows the phase transformation from austenite to martensite in the fast cooling processes.

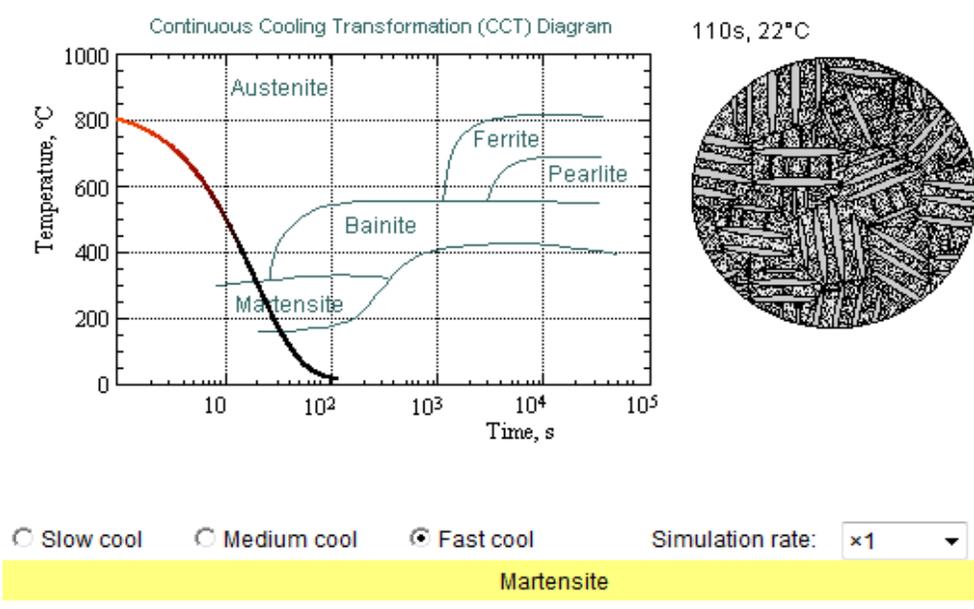
Figure 5: CCT diagram for 0.4wt% C steel shows the final obtained microstructure (martensite) in the fast cooling processes.

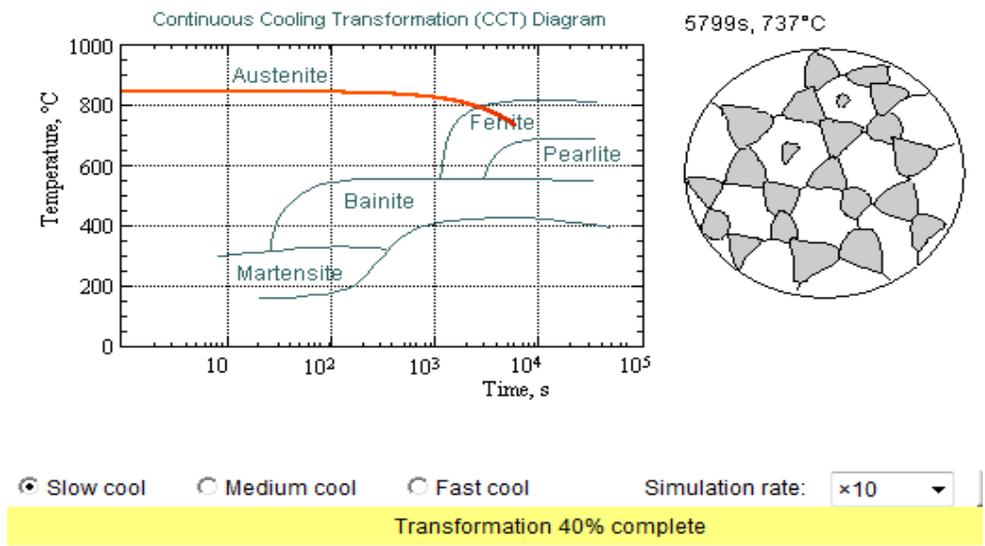
Figure 6: CCT diagram for 0.4wt% C steel shows the phase transformation from austenite to ferrite in the slow cooling processes.

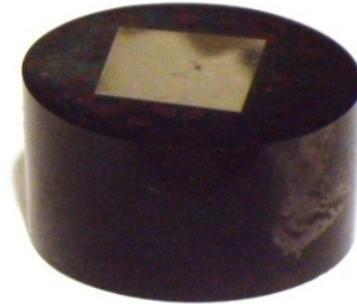
Figure 8: Preparation of samples for metallographic analysis.

b-Mounted in Bakelite

Three sections from different planes were cut from each material, Figure 8, and mounted in Bakelite\* for metallographic analysis using polishing and etching procedures described in APPENDIX A [64]. Metallurgical studies were conducted using an Alicona Infinite Focus Microscope (IFM) with subsequent data analysis with ImageJ software.

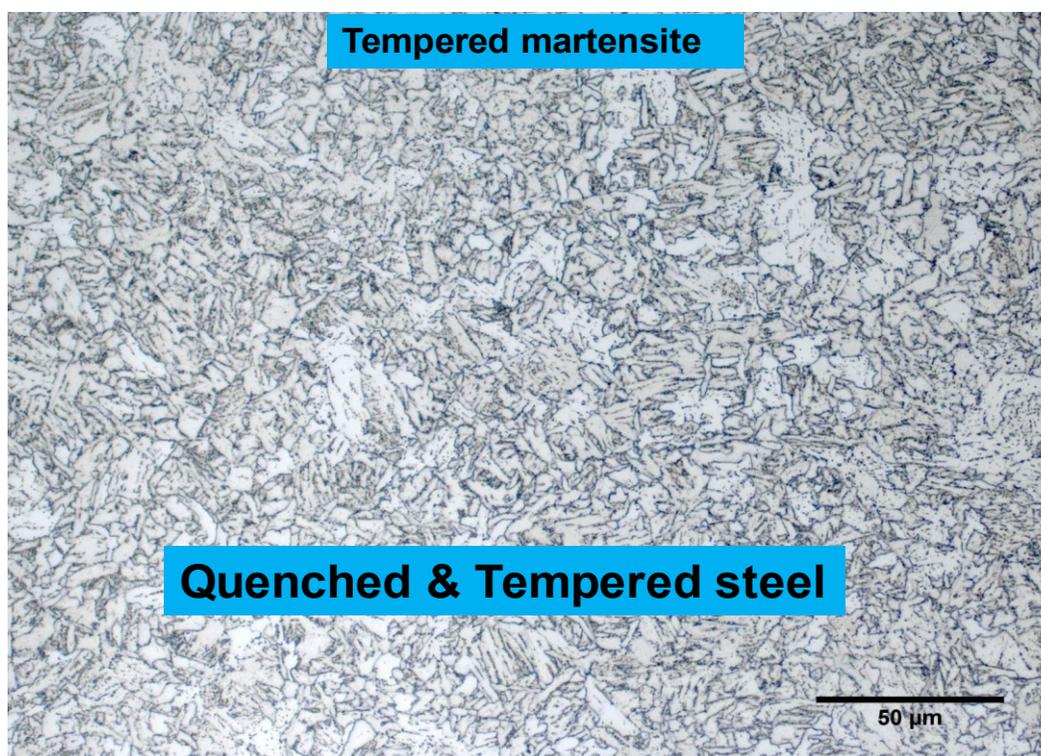
Figure 10: X65I steel, microstructure consists of tempered martensite.

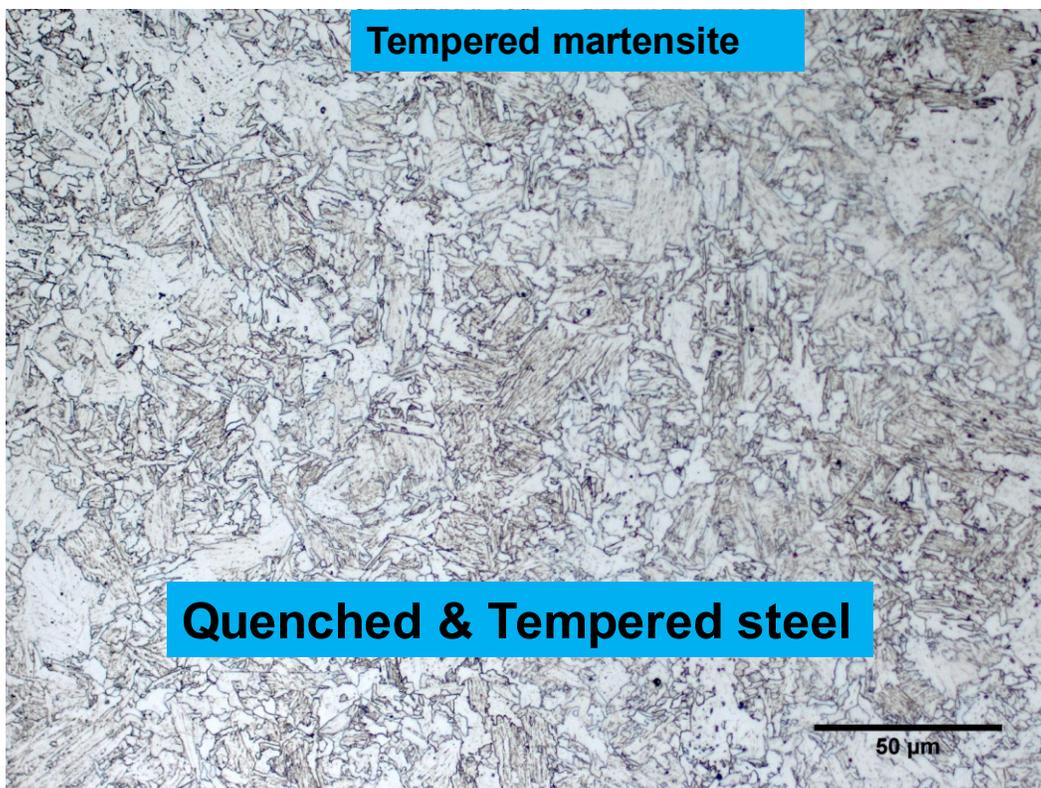
Figure 12: X70 steel, microstructure consists of tempered martensite.

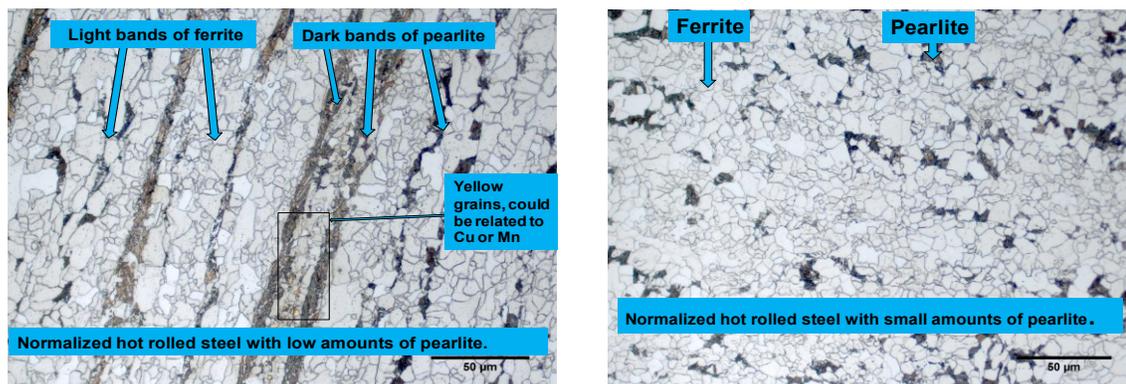
Plane-A steel, microstructure consists of thick light colored bands of ferrite and thin dark colored bands of pearlite.

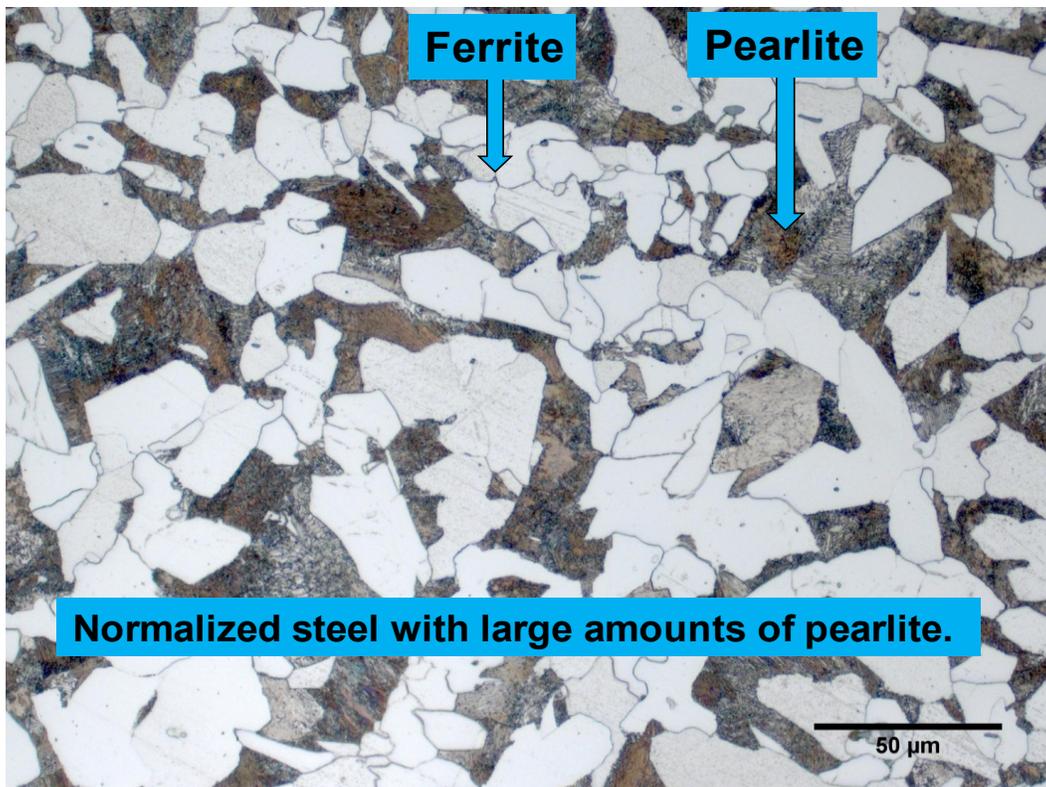
Figure 16: X52 steel, microstructure consists of large dark pearlite surrounded by large bright ferrite.

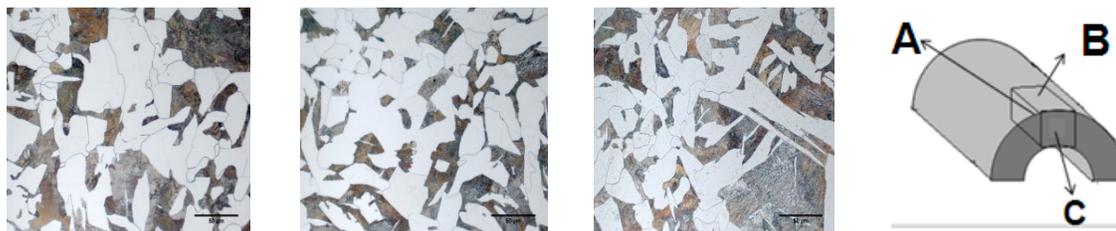
Plane A.

Plane B.

X52: This steel contains higher amounts of carbon (0.26 wt% C). The microstructure of planes A, B, and C are the same as shown in Figure 15. As shown in Figure 16, the structure of this steel is similar to the ferrite/pearlite structure that shown in Figure 7. The steel was normalized by increasing its temperature to 50°C above  $A_3$  then letting it cool in air. The microstructure of X52 consists of large, dark grains of pearlite surrounded by large, light grains of ferrite as shown in Figure 16.

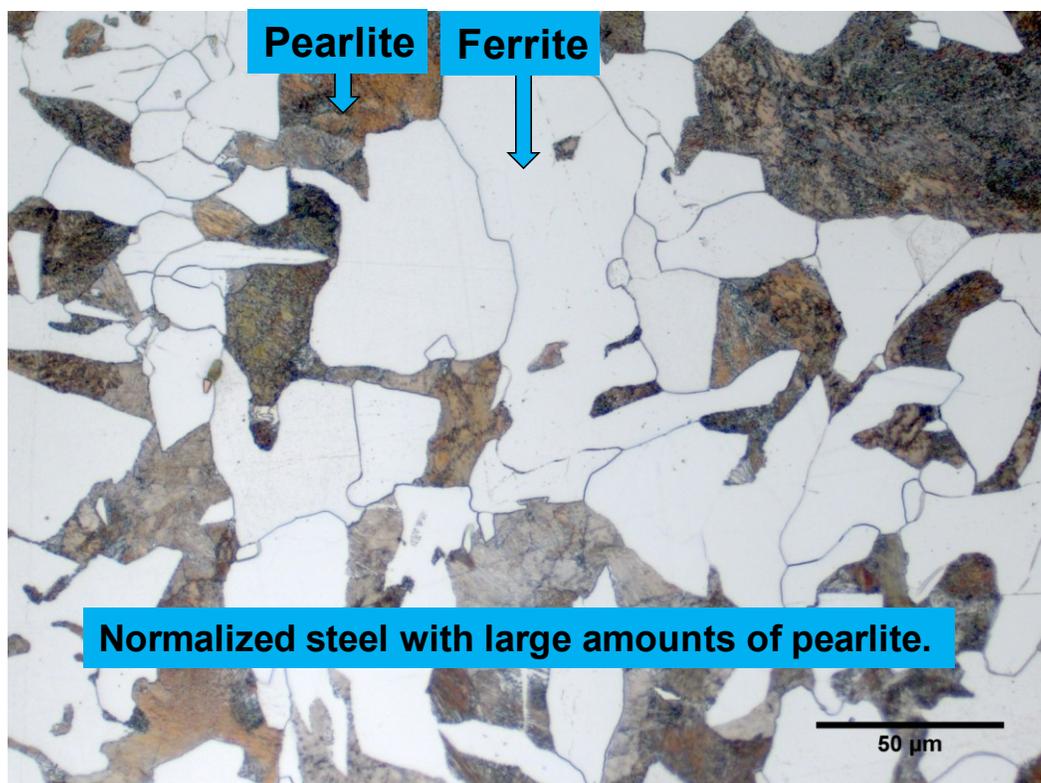
Figure 18: A106GRB steel, microstructure consists of large dark pearlite surrounded by large bright ferrite.

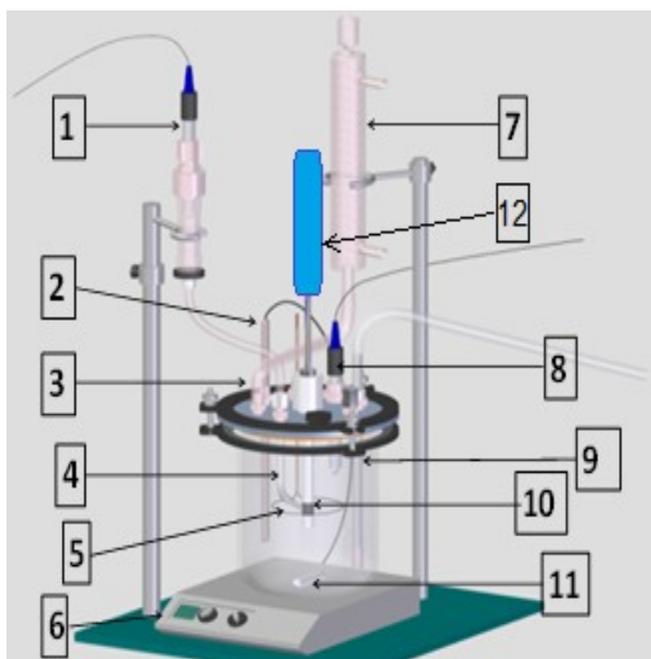
1. Reference electrode.
2. Temperature probe.
3. Gas outlet.
4. Luggin capillary.
5. Platinum counter electrode.
6. Hot plate.
7. Condenser.
8. pH electrode.
9. CO<sub>2</sub> sparge tube.
10. Sample.
11. Magnetic stir bar.
12. Rotating motor

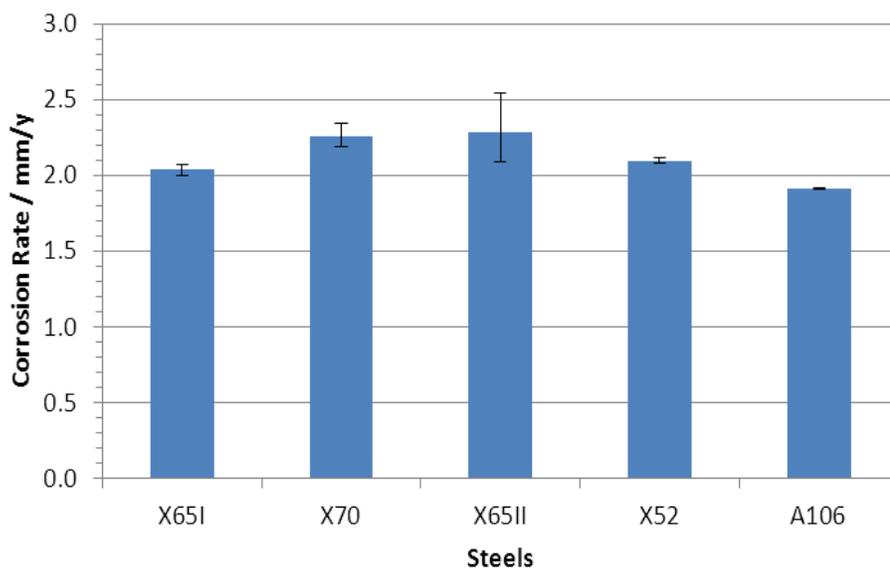
Figure 21: RCE corrosion rate at 25°C, 0.95 bar CO<sub>2</sub>, pH 4.0, 1000 rpm, and B=26 mV/decade.

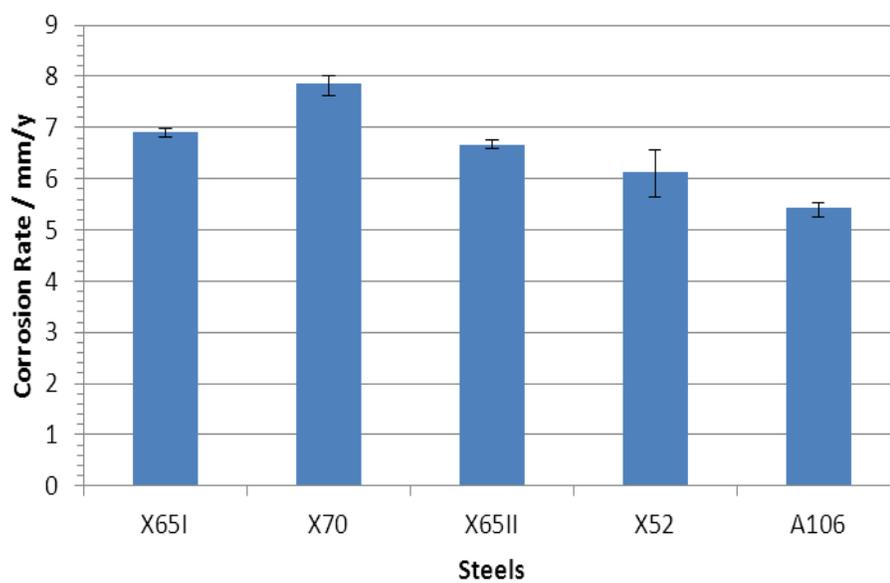
Figure 22: RCE corrosion rate at 80°C, 0.5 bar CO<sub>2</sub>, pH 4.0, 1000 rpm, and B=26 mV/decade.

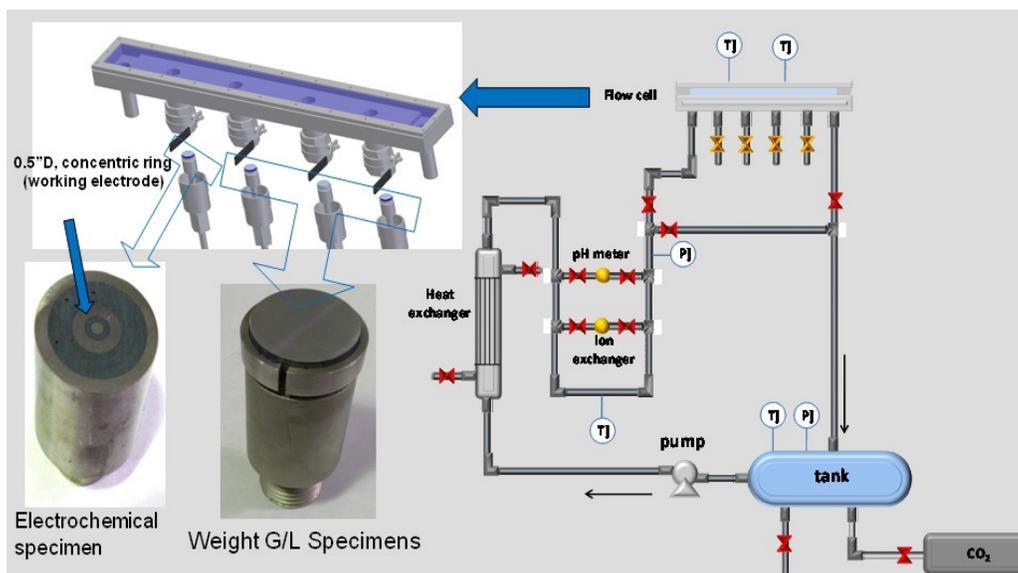
Figure 23: Schematic diagram of the thin channel flow cell (TCFC) system and samples used to conduct corrosion experiments.

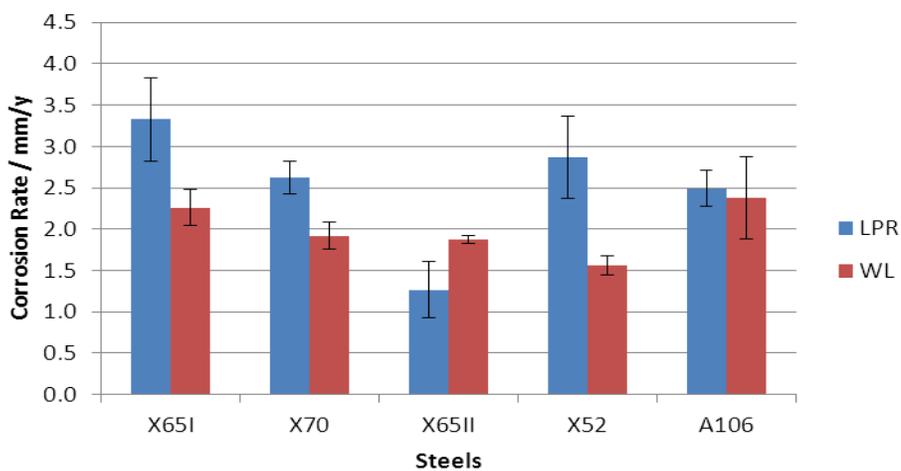
Figure 24: TCFC corrosion rate measured by LPR, weight loss (WL), at 25°C, 0.95 bar CO<sub>2</sub>, pH 4.0, 0.63 m/s, B=26 mV/decade.

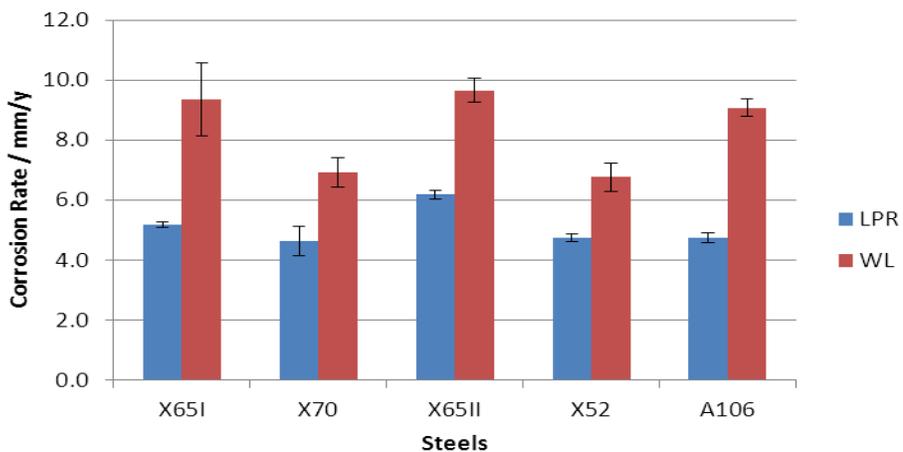
Figure 25: TCFC corrosion rate measured by LPR, weight loss (WL), at 80°C, 0.5 bar CO<sub>2</sub>, pH 4.0, 0.63 m/s, B=26 mV/decade.

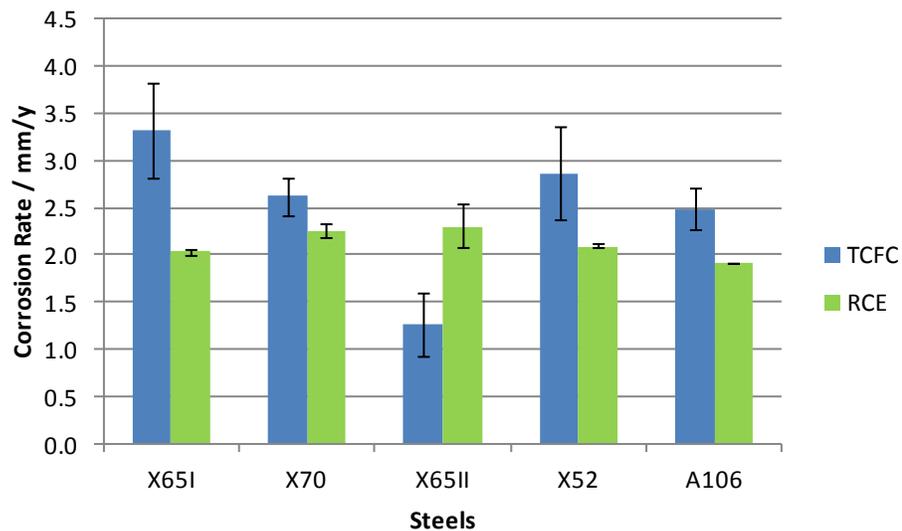
Figure 26: Comparison between RCE & TCFC corrosion rates measured by LPR, at 25°C, 0.95 bar CO<sub>2</sub>, pH 4.0, 0.63m/s, B=26 mV/decade.

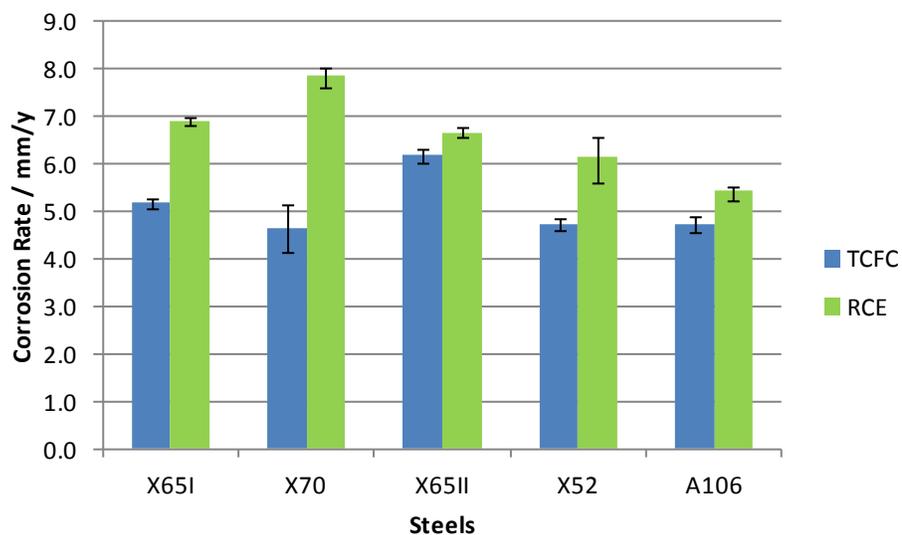
Figure 27: Comparison between RCE & TCFC corrosion rates measured by LPR, at 80°C, 0.5 bar CO<sub>2</sub>, pH 4.0, 0.63 m/s, B=26 mV/decade.

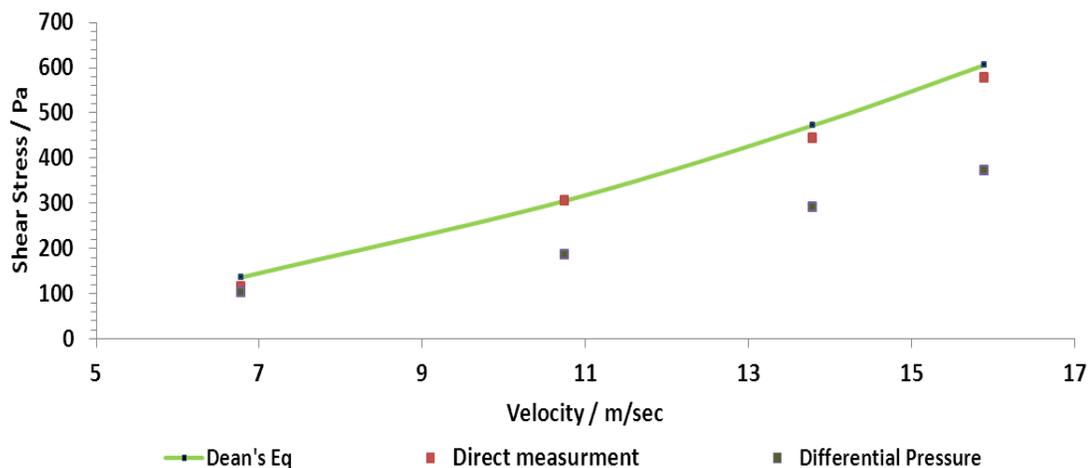
Figure 29: Wall shear stresses in the TCFC measured at 25° C with different methods for various flow velocities.

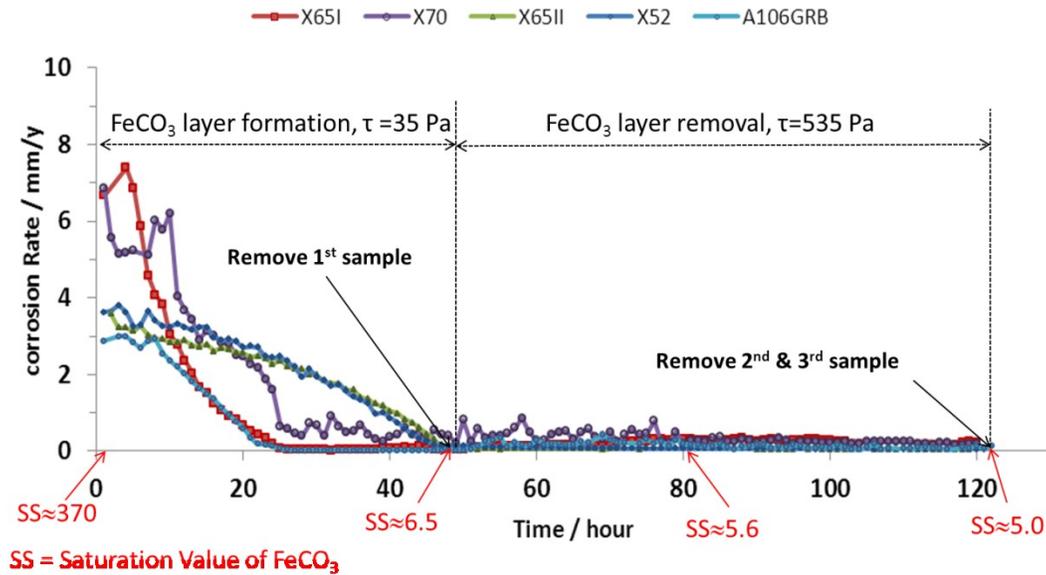
Figure 30: Corrosion rate obtained from LPR measurements versus exposure time at 80°C, 1.5 bar CO<sub>2</sub>, pH 6.6, B=26 mV/decade,  $\tau=35$  Pa for the first 2 days,  $\tau=535$  Pa for another 3 days.

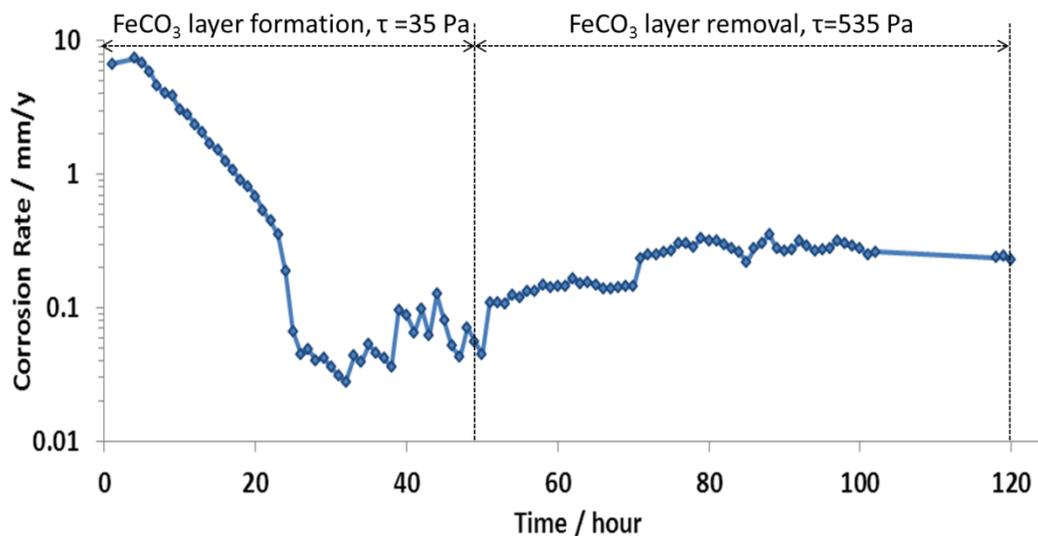
Figure 31: LPR Corrosion rate of X651 steel during 5 days of exposure at 80°C, 1.5 bar  $\text{CO}_2$ , pH 6.6,  $B=26$  mV/decade,  $\tau= 35$  Pa for the first 2 days,  $\tau= 535$  Pa for another 3 days.

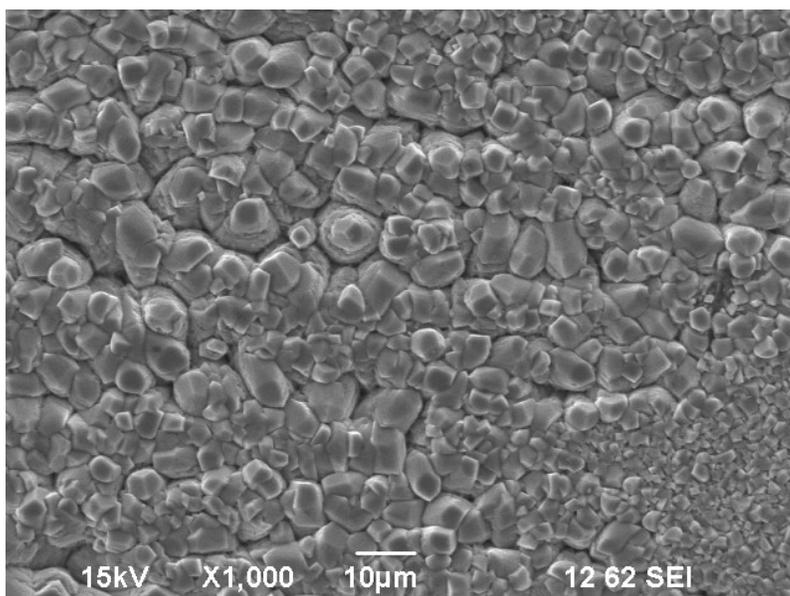
Figure 32: SEM top surface analysis of  $\text{FeCO}_3$  layer after 2 days of exposure at  $80^\circ\text{C}$ , X65I steel, 1.5 bar  $\text{CO}_2$ , pH 6.6,  $\tau = 35$  Pa for the first 2 days.

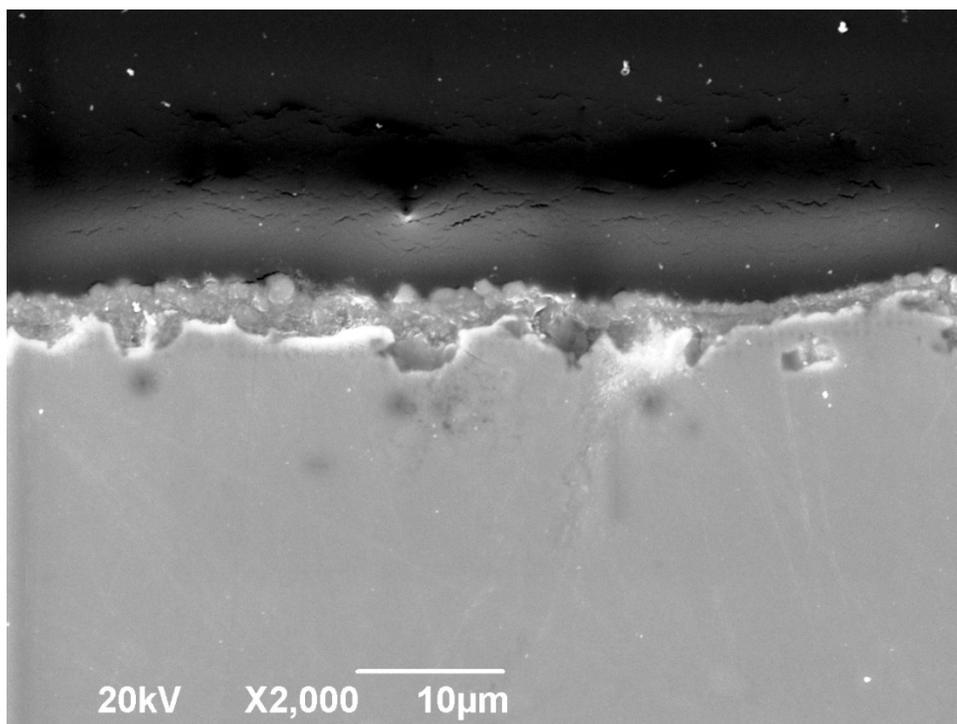
Figure 34: SEM cross section analysis of  $\text{FeCO}_3$  layer after 2 days of exposure at  $80^\circ\text{C}$ , X65I steel, 1.5 bar  $\text{CO}_2$ , pH 6.6,  $\tau = 35$  Pa for the first 2 days.

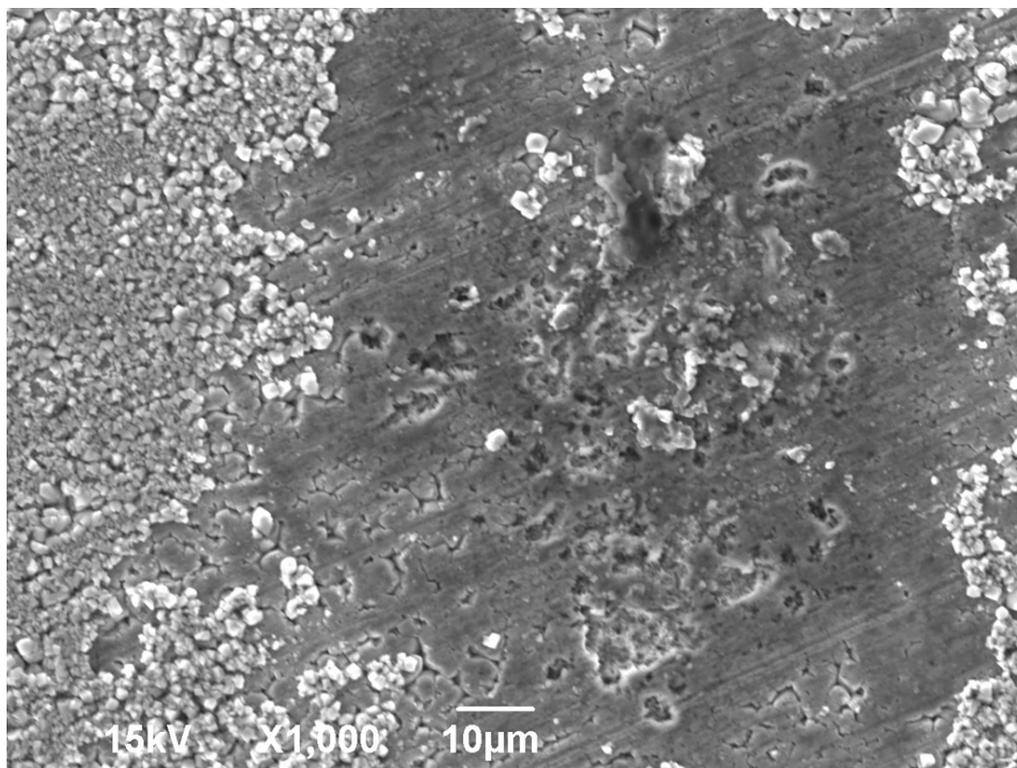
Figure 36: SEM top surface analysis of FeCO<sub>3</sub> layer after 5 days of exposure at 80°C, X65I steel, 1.5 bar CO<sub>2</sub>, pH 6.6,  $\tau = 35$  Pa for the first 2 days,  $\tau = 535$  Pa for another 3 days.

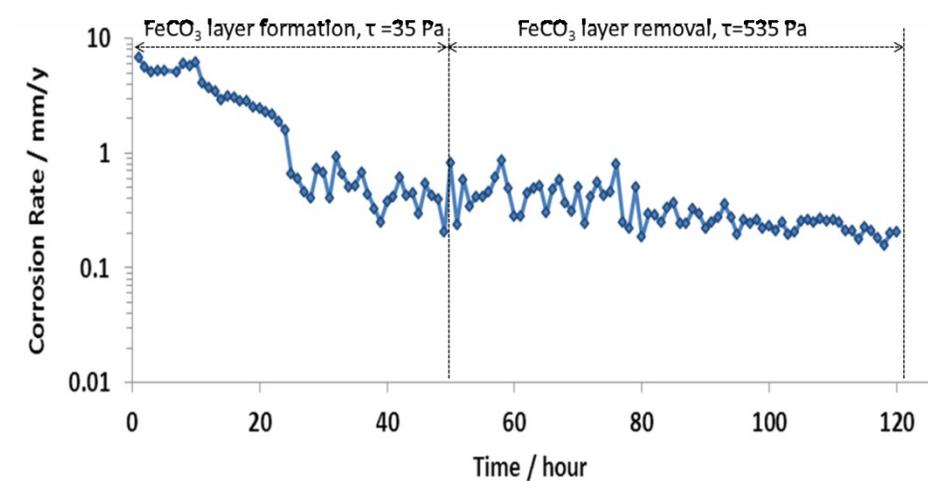
Figure 40: LPR Corrosion Rate of X70 steel during 5 days of exposure at  $80^\circ\text{C}$ , 1.5 bar  $\text{CO}_2$ , pH 6.6,  $B=26$  mV/decade,  $\tau= 35$  Pa for the first 2 days,  $\tau= 535$  Pa for another 3 days.

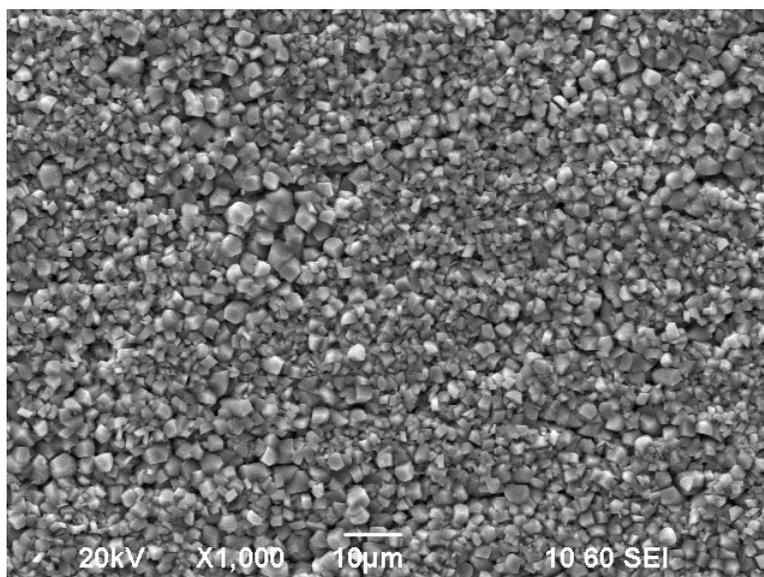
Figure 41: SEM analysis of X70 steel after 2 days of exposure at  $80^\circ\text{C}$ , 1.5 bar  $\text{pCO}_2$ , pH 6.6,  $\tau = 35$  Pa showing top surface view of  $\text{FeCO}_3$  layer.

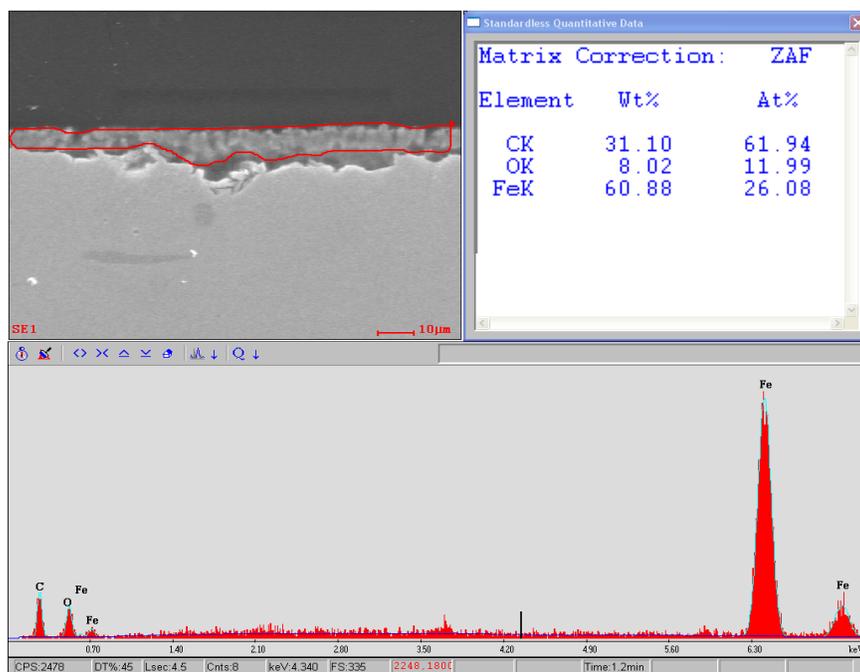
Figure 43: SEM & EDS cross section analysis of X70 steel after 2 days of exposure at 80°C, 1.5 bar CO<sub>2</sub>, pH 6.6,  $\tau=35$  Pa for the first 2 days.

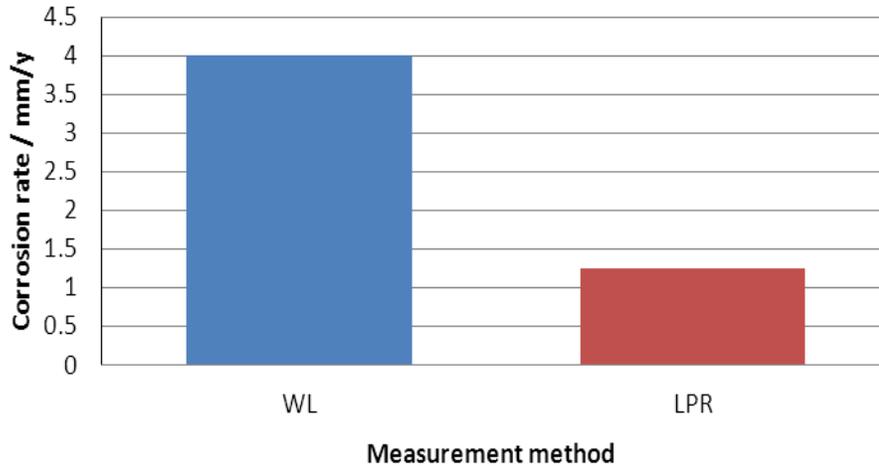
Figure 44: Comparison between corrosion rates of X70 measured by weight loss (WL) and integrated LPR after 5 days of exposure at 80°C, 1.5 bar CO<sub>2</sub>, pH 6.6, B=26 mV/decade,  $\tau=35$  Pa for the first 2 days,  $\tau=535$  Pa for another 3 days.

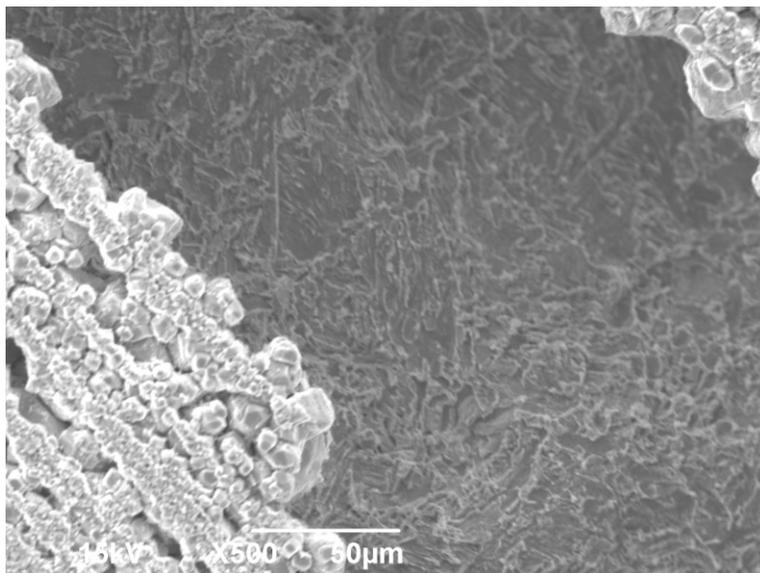
Figure 45: SEM top surface analysis of  $\text{FeCO}_3$  layer after 5 days of exposure at  $80^\circ\text{C}$ , X70 steel, 1.5 bar  $\text{CO}_2$ , pH 6.6,  $\tau= 35$  Pa for the first 2 days,  $\tau= 535$  Pa for another 3 days.

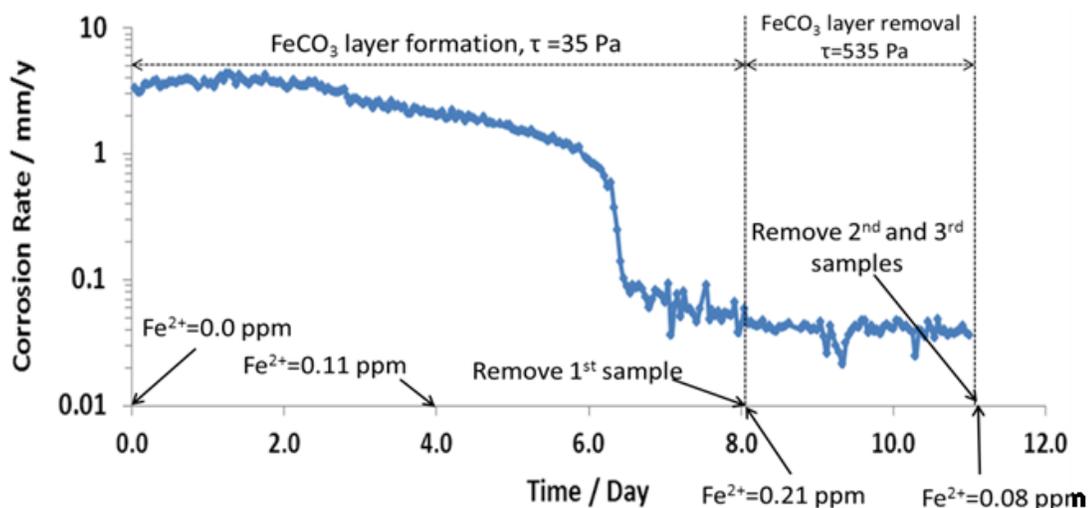
Figure 49: LPR Corrosion Rate of X70 steel (without initial  $\text{Fe}^{2+}$  additions) during 11 days of exposure at  $80^\circ\text{C}$ , 1.5 bar  $\text{CO}_2$ , pH 6.6,  $B=26$  mV/decade,  $\tau=35$  Pa for the first 8 days,  $\tau=535$  Pa for another 3 days.

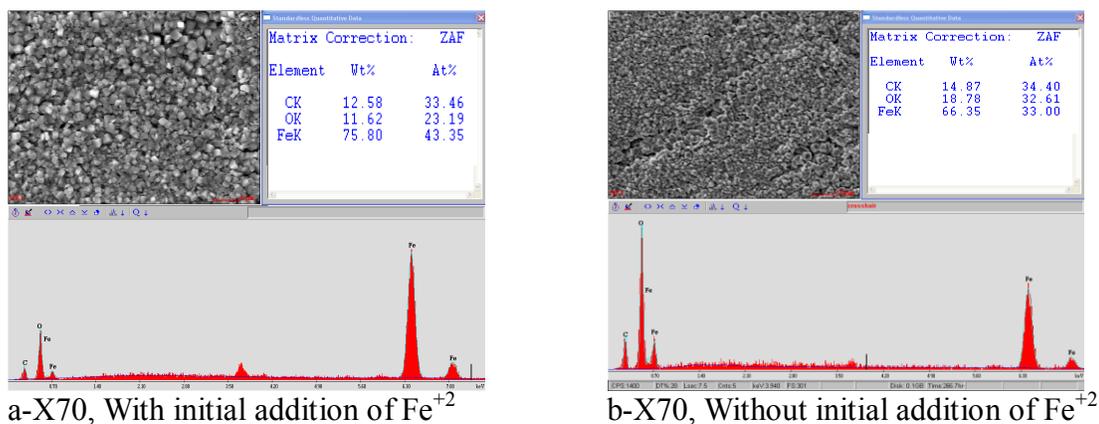
Figure 50: Comparison between SEM & EDS top surface analysis of  $\text{FeCO}_3$  layer at  $80^\circ\text{C}$ , X70 steel, 1.5 bar  $\text{CO}_2$ , pH 6.6,  $\tau= 35$  Pa for the  $\text{FeCO}_3$  layer formation.

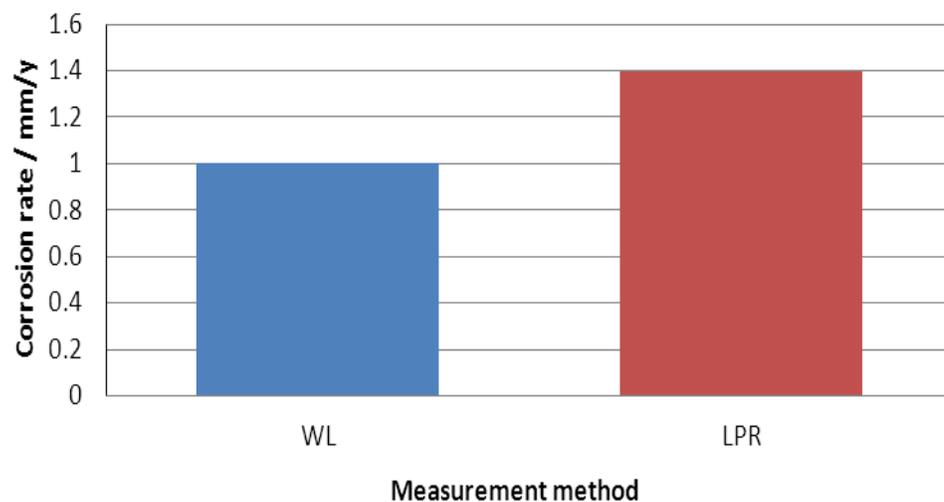
Figure 52: Comparison between corrosion rates measured by weight loss (WL) and integrated LPR (without initial  $\text{Fe}^{2+}$  additions), after 5 days of exposure at  $80^\circ\text{C}$ , X70 steel, 1.5 bar  $\text{CO}_2$ , pH 6.6,  $B=26$  mV/decade,  $\tau=35$  Pa for the  $\text{FeCO}_3$  layer formation,  $\tau=535$  Pa for the  $\text{FeCO}_3$  layer removal.

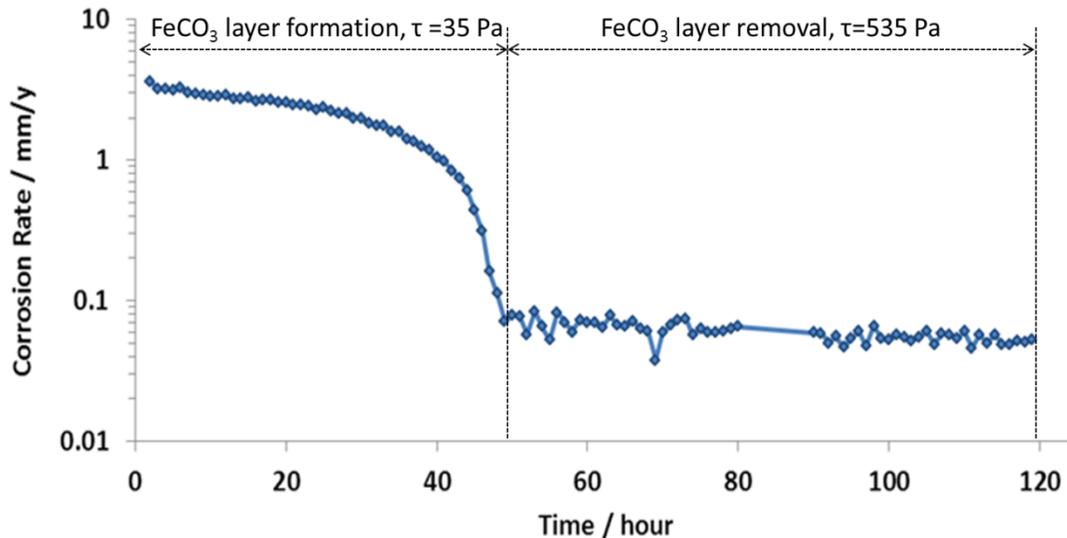
Figure 57: LPR Corrosion rate of X65II steel during 5 days of exposure at 80°C, 1.5 bar CO<sub>2</sub>, pH 6.6, B=26 mV/decade,  $\tau= 35$  Pa for the FeCO<sub>3</sub> layer formation,  $\tau= 35$  Pa for the first 2 days,  $\tau= 535$  Pa for another 3 days.

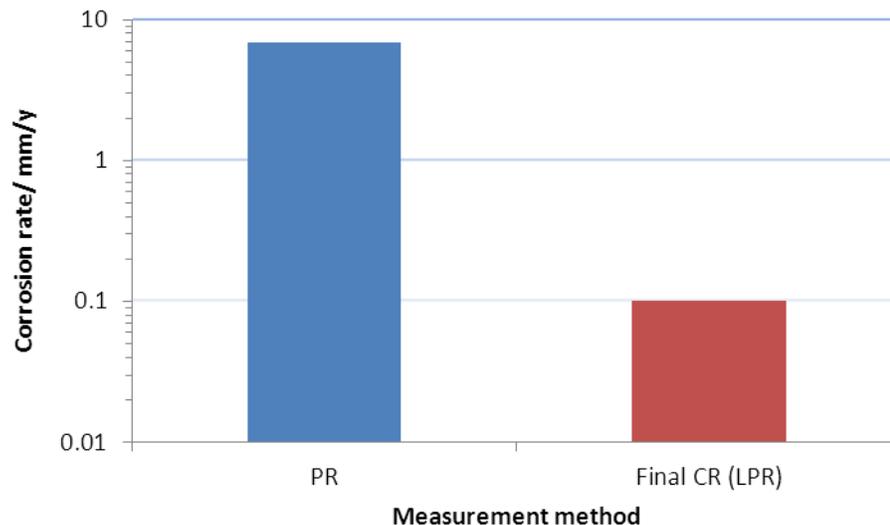
Figure 67: Comparison between corrosion rates measured by weight loss (WL), integrated LPR and average penetration rate of the deepest pits on each steel (Experiments I, II) (PR) after 5 days of exposure at 80°C, X65II steel, 1.5 bar CO<sub>2</sub>, pH 6.6, B =26 mV/decade,  $\tau = 35$  Pa for the first 2 days,  $\tau = 535$  Pa for another 3 days.

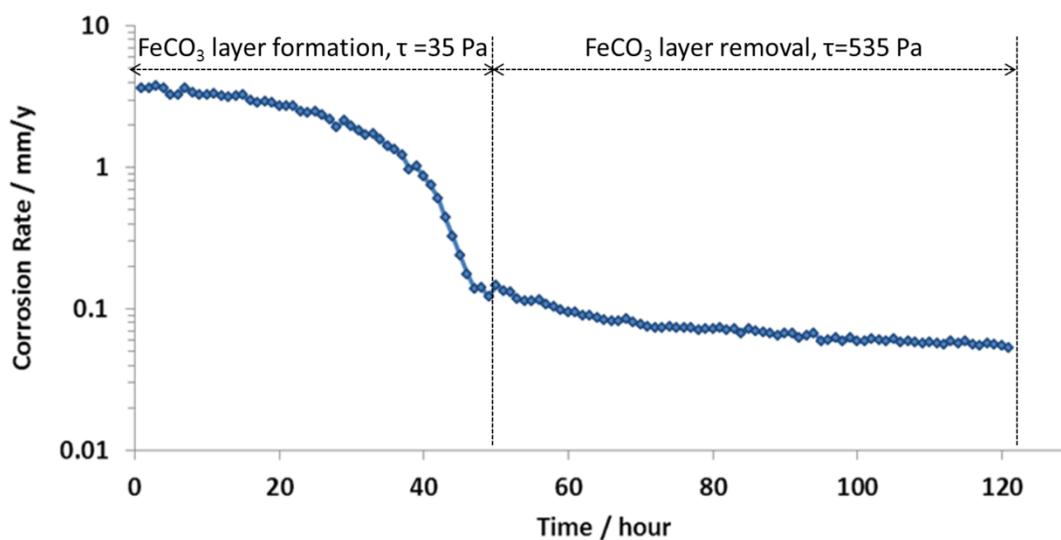
Figure 68: LPR corrosion rate of X52 steel during 5 days of exposure at 80°C, 1.5 bar CO<sub>2</sub>, pH 6.6, B=26 mV/decade,  $\tau=35$  Pa for the first 2 days,  $\tau=535$  Pa for another 3 days.

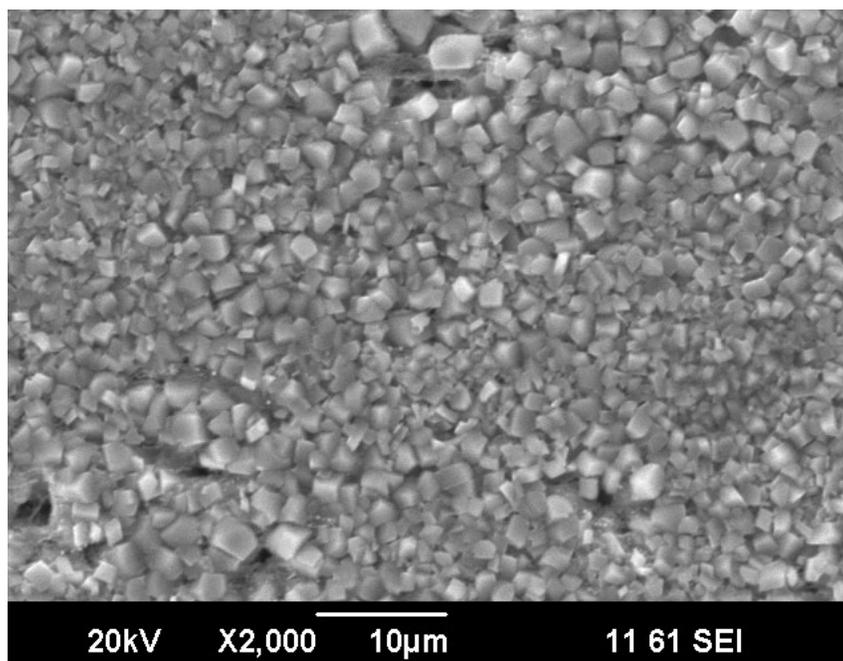
Figure 69: SEM top surface analysis of  $\text{FeCO}_3$  layer after 2 days of exposure at  $80^\circ\text{C}$ , X52 steel, 1.5 bar  $\text{CO}_2$ , pH 6.6,  $\tau = 35$  Pa.
