Effect of Carbon Steel Composition and Microstructure on CO<sub>2</sub> Corrosion

A dissertation presented to  
the faculty of  
the Russ College of Engineering and Technology of Ohio University

In partial fulfillment  
of the requirements for the degree  
Doctor of Philosophy

August 2014

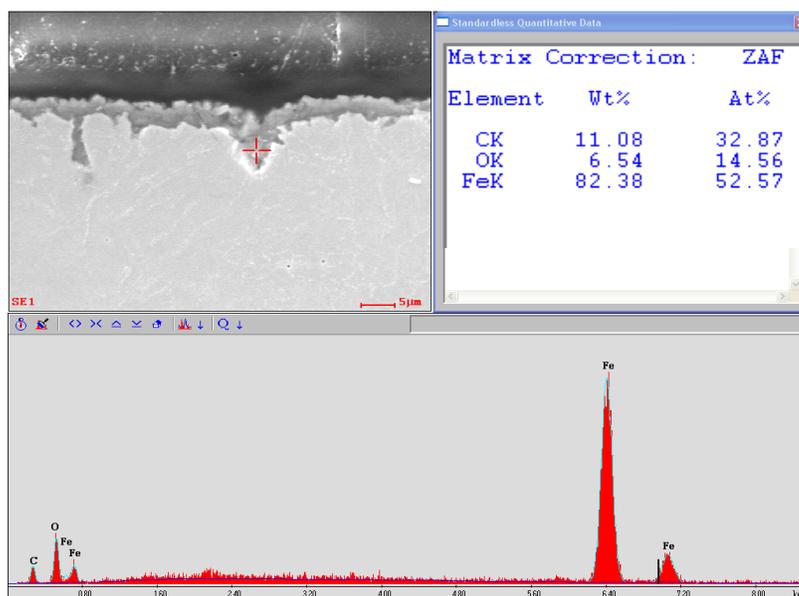
Figure 71: SEM& EDS cross section analysis of  $\text{FeCO}_3$  layer after 2 days of exposure at  $80^\circ\text{C}$ , X52 steel, 1.5 bar  $\text{CO}_2$ , pH 6.6,  $\tau = 35$  Pa for the first 2 days.

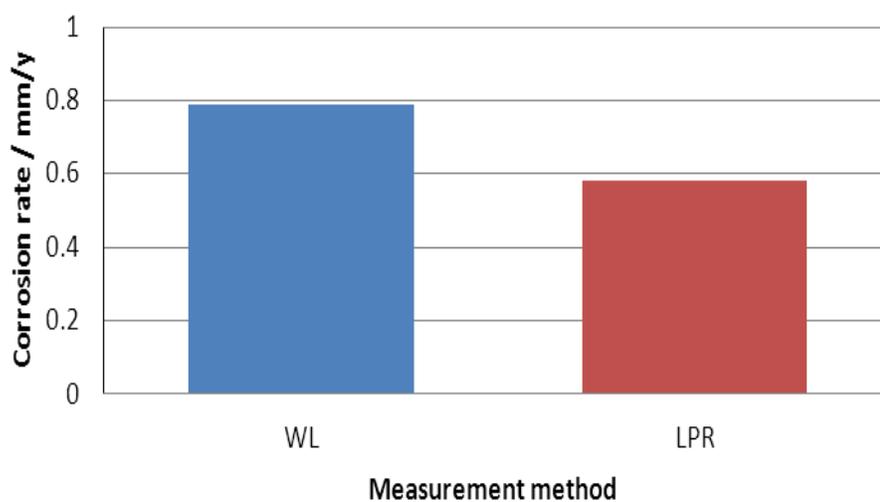
Figure 72: Comparison between corrosion rates measured by weight loss (WL) and integrated LPR after 5 days of exposure at 80°C, X52 steel, 1.5 bar CO<sub>2</sub>, pH 6.6, B=26 mV/decade,  $\tau = 35$  Pa for the first 2 days,  $\tau = 535$  Pa for another 3 days.

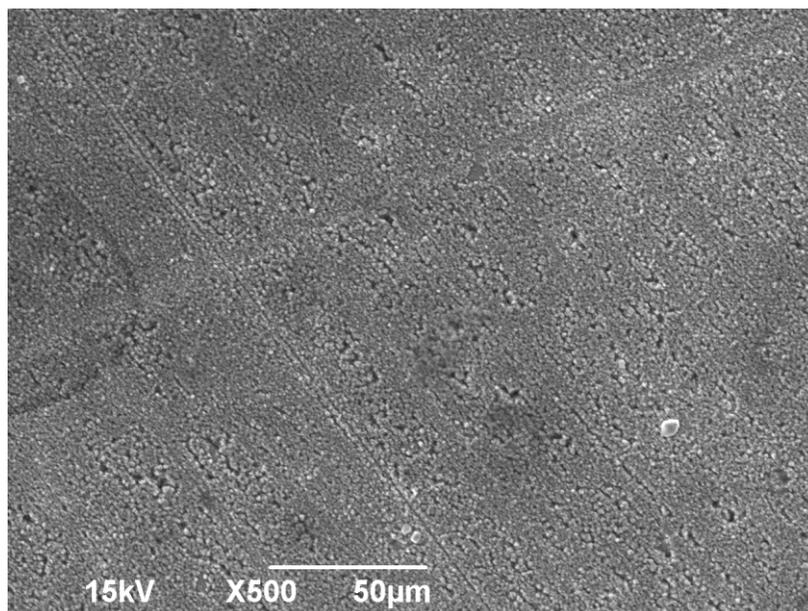
Figure 73: SEM top surface analysis of  $\text{FeCO}_3$  layer after 5 days of exposure at  $80^\circ\text{C}$ , X52 steel, 1.5 bar  $\text{CO}_2$ , pH 6.6,  $\tau=35$  Pa for the first 2 days,  $\tau=535$  Pa for another 3 days.

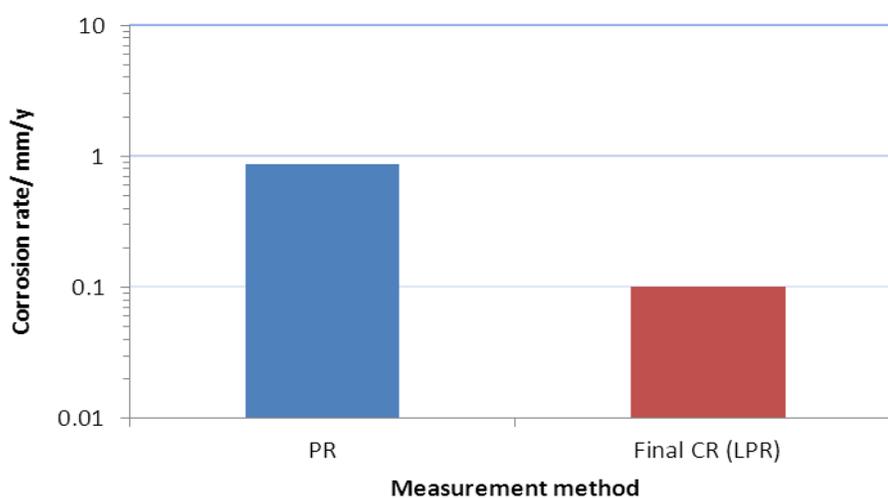
Figure 76: Comparison between corrosion rates measured by weight loss (WL), integrated LPR, and penetration rate of the deepest pit on each steel (PR) after 5 days of exposure at 80°C, X52 steel, 1.5 bar CO<sub>2</sub>, pH 6.6,  $B=26$  mV/decade,  $\tau= 35$  Pa for the first 2 days,  $\tau= 535$  Pa for another 3 days.

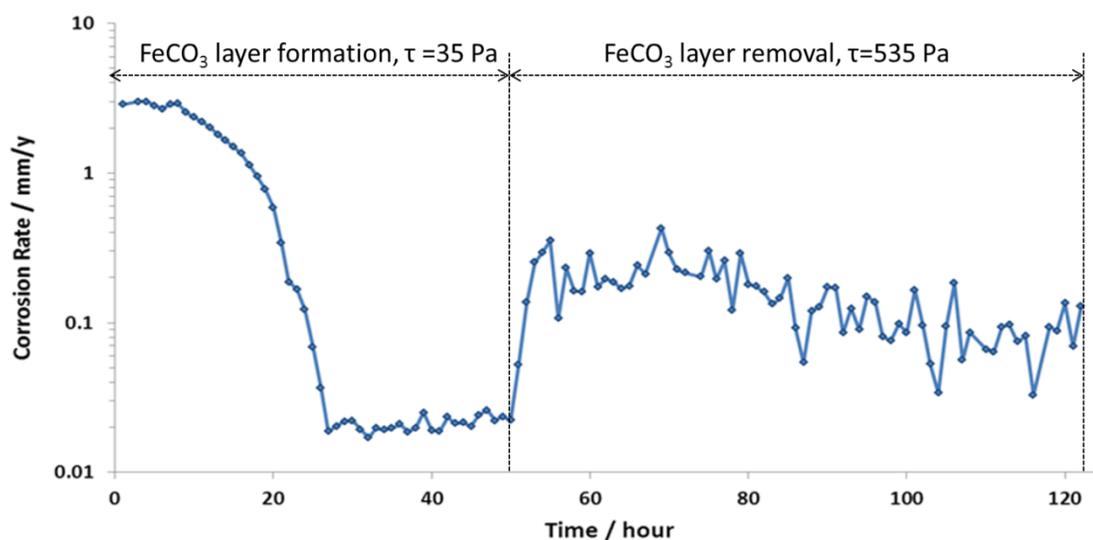
Figure 77: LPR corrosion rate during 5 days of exposure at 80°C, A106GRB steel, 1.5 bar CO<sub>2</sub>, pH 6.6, B=26 mV/decade,  $\tau = 35$  Pa for the first 2 days,  $\tau = 535$  Pa for another 3 days.

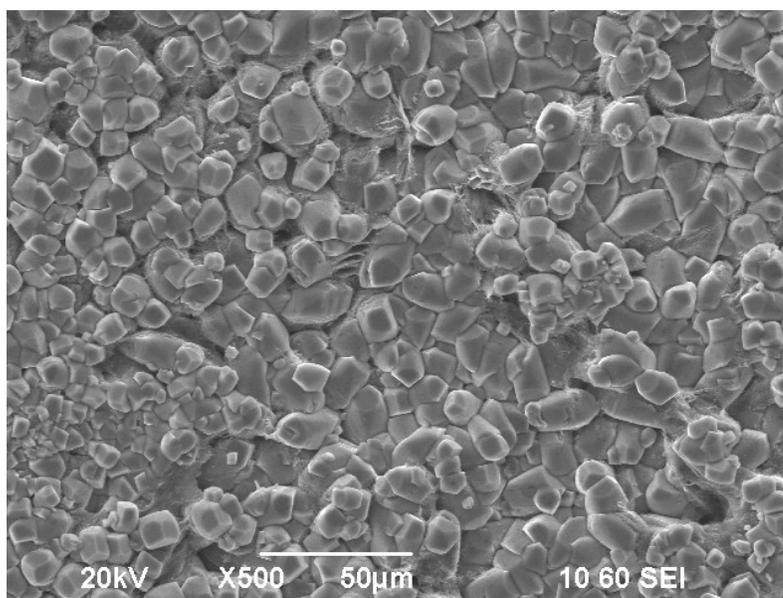
Figure 78: SEM top surface analysis of FeCO<sub>3</sub> layer after 2 days of exposure at 80°C, A106GRB steel, 1.5 bar CO<sub>2</sub>, pH 6.6,  $\tau = 35$  Pa.

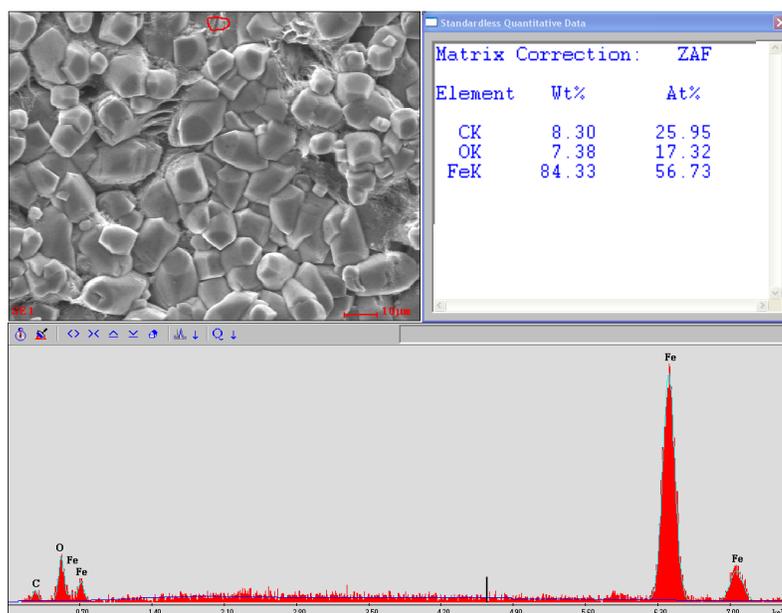
Figure 79: SEM & EDS top surface analysis of  $\text{FeCO}_3$  layer after 2 days of exposure at  $80^\circ\text{C}$ , A106GRB steel, 1.5 bar  $\text{CO}_2$ , pH 6.6,  $\tau = 35$  Pa.

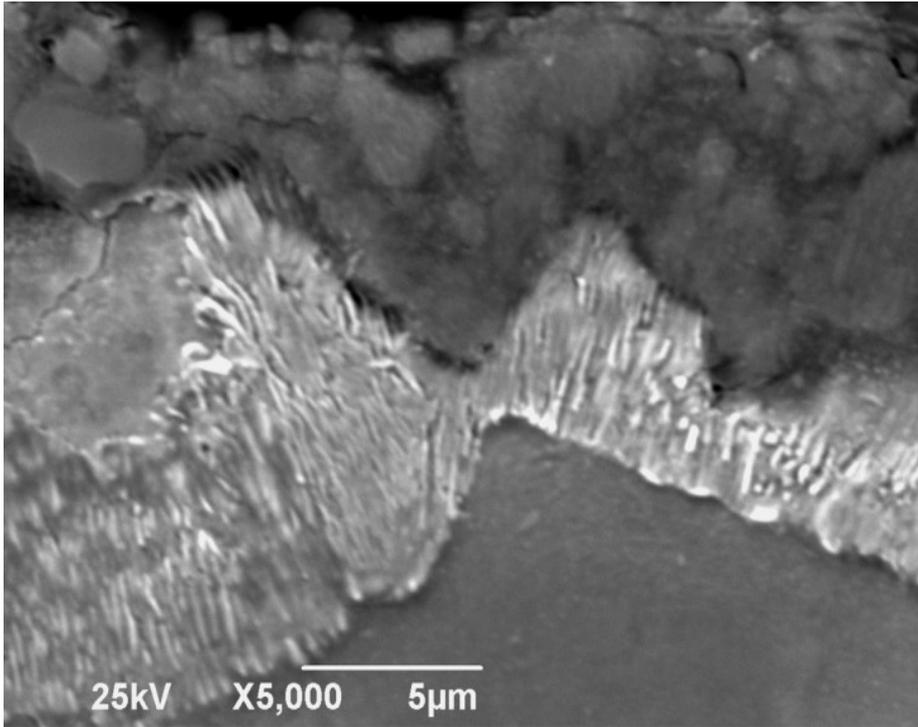
Figure 80: SEM of an etched cross section sample with  $\text{FeCO}_3$  layer & microstructure after 2 days of exposure at  $80^\circ\text{C}$ , A106GRB steel, 1.5 bar  $\text{CO}_2$ , pH 6.6,  $\tau = 35$  Pa.

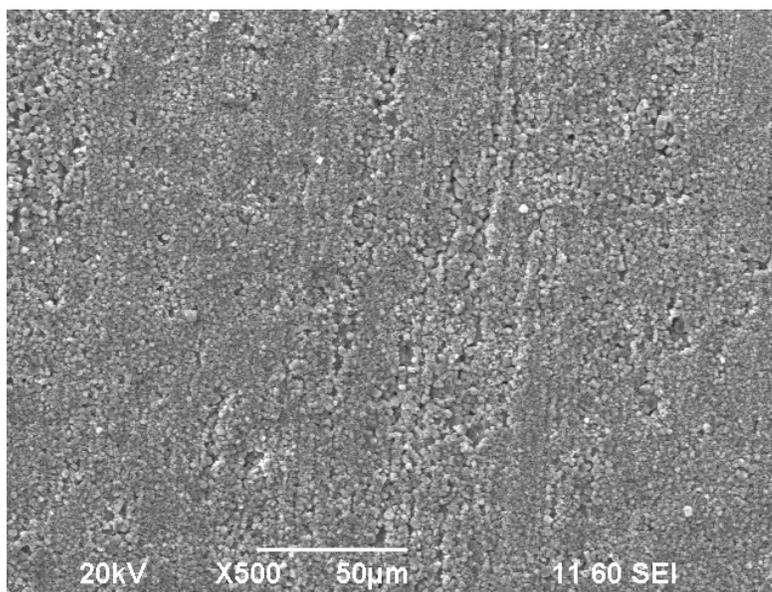
Figure 82: SEM top surface analysis of  $\text{FeCO}_3$  layer after 5 days of exposure at  $80^\circ\text{C}$ , A106GRB steel, 1.5 bar  $\text{CO}_2$ , pH 6.6,  $\tau= 35$  Pa for the first 2 days,  $\tau= 535$  Pa for another 3 days.

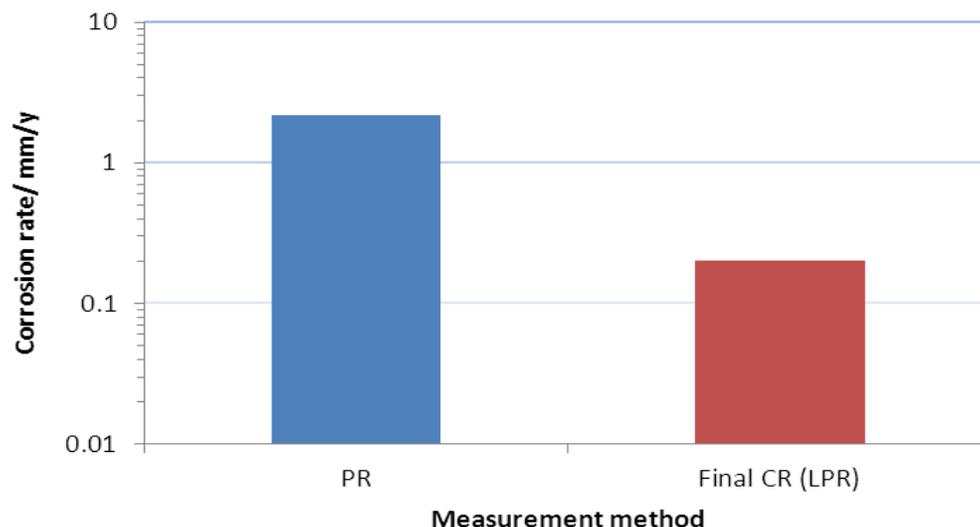
Figure 86: Comparison between corrosion rates measured by weight loss (WL), integrated LPR, and penetration rate of the deepest pit on each steel (PR) after 5 days of exposure at 80°C, A106GRB steel, 1.5 bar CO<sub>2</sub>, pH 6.6, B=26 mV/decade  $\tau = 35$  Pa for the first 2 days,  $\tau = 535$  Pa for another 3 days.

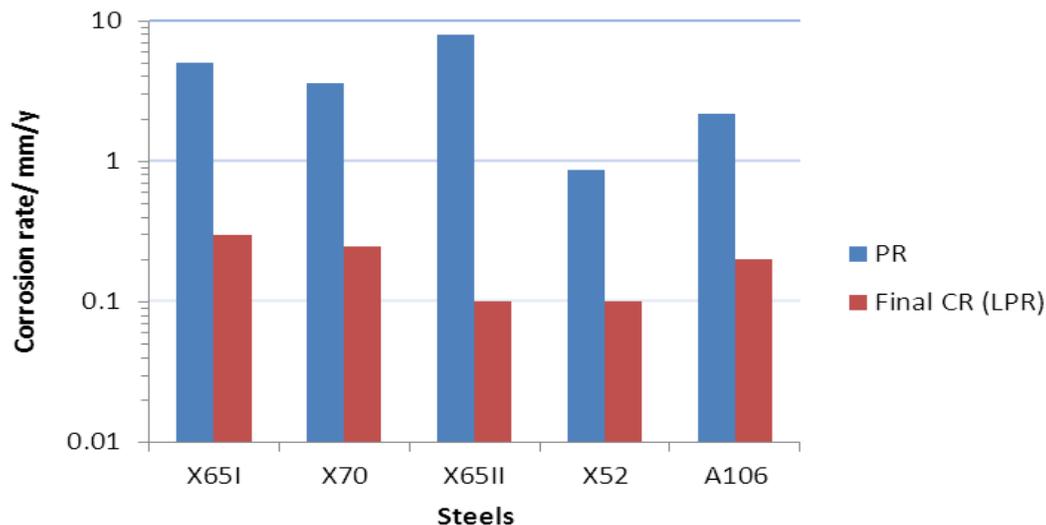
Figure 89: TCFC final corrosion rate measured by LPR & penetration rate (PR) of the deepest pit on each steel after 5 days of exposure at 80°C, 1.5 bar CO<sub>2</sub>, pH 6.6,  $\tau = 35$  Pa for the first 2 days,  $\tau = 535$  Pa for another 3 days.

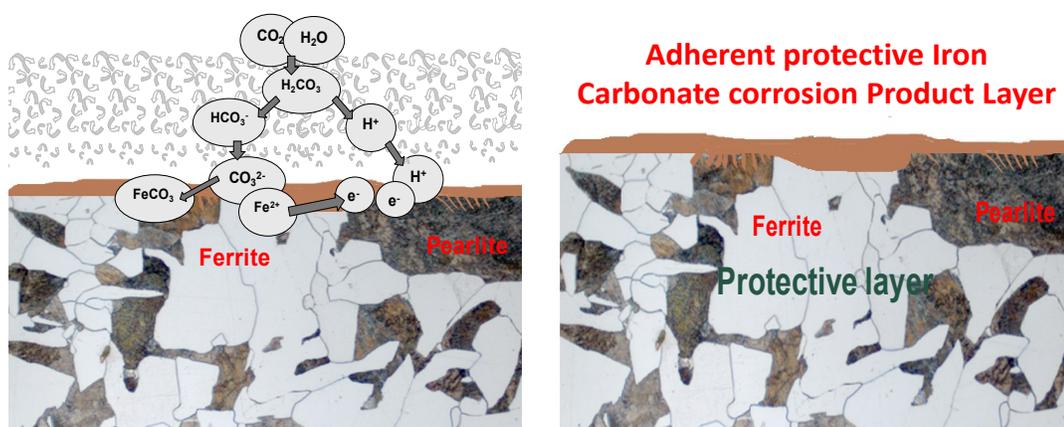
a- Mechanism of  $\text{FeCO}_3$  formation on normalized steel at low wall shear stress

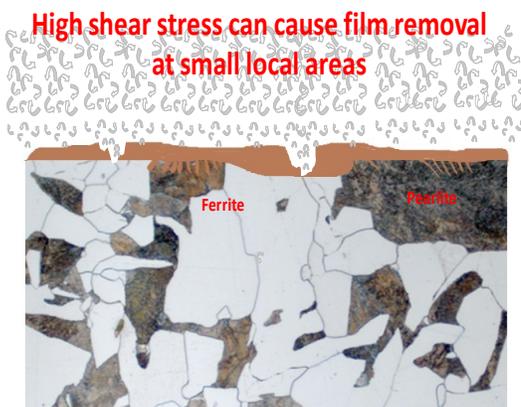
Figure 90: Mechanism of  $\text{FeCO}_3$  formations on normalized steel.

c- Local breakdown of  $\text{FeCO}_3$  caused by high wall shear stress

When a high flow rate, and thus a high wall shear stress, is applied on the FeCO<sub>3</sub> layers already formed on normalized steels (F-P microstructure), small areas of the FeCO<sub>3</sub> layer on ferrite grain locations may be removed since the attachment of the layer in these regions may be weaker than on pearlite grains, as shown in Figure 90-c. If local

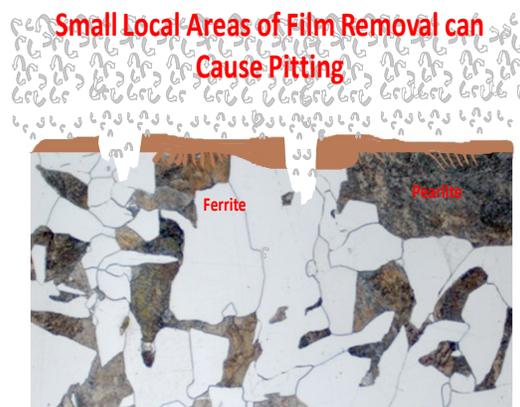
d- Localized corrosion where breakdown of  $\text{FeCO}_3$  areas (?? Not a complete idea or sentence)

breakdown of the  $\text{FeCO}_3$  has occurred, this will contribute to the onset of localized corrosion, see Figure 90-d.

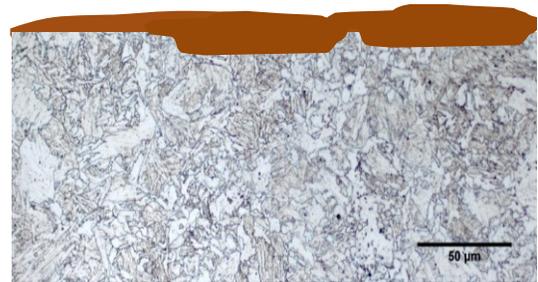
b- Protective iron carbonate product layer

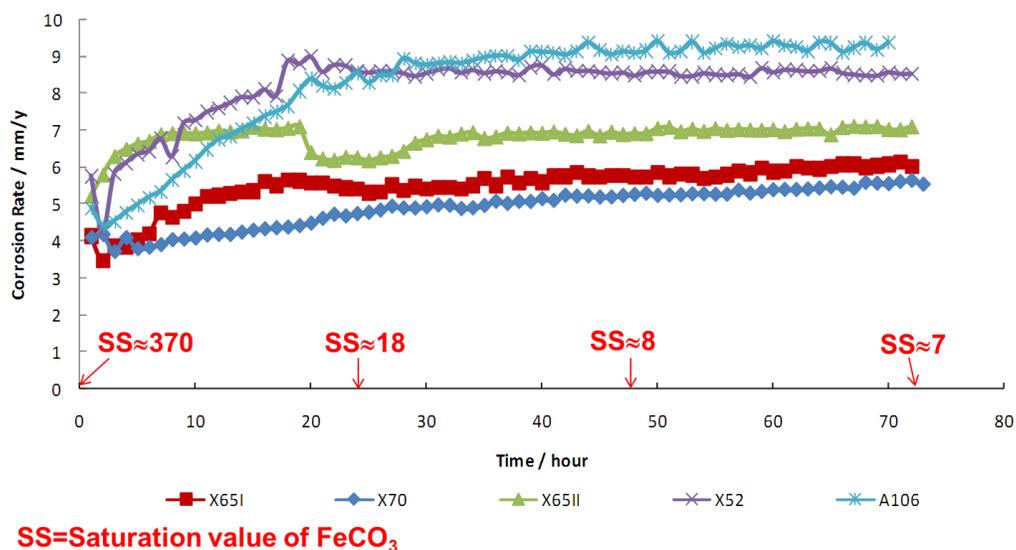
Figure 92: LPR measurement corrosion rates (CR) mm/y, five different steels, 3 days of exposure at  $80^\circ\text{C}$ , 1.5 bar  $\text{CO}_2$ , pH 6.6,  $B=26$  mV/decade,  $\tau = 535$  Pa.

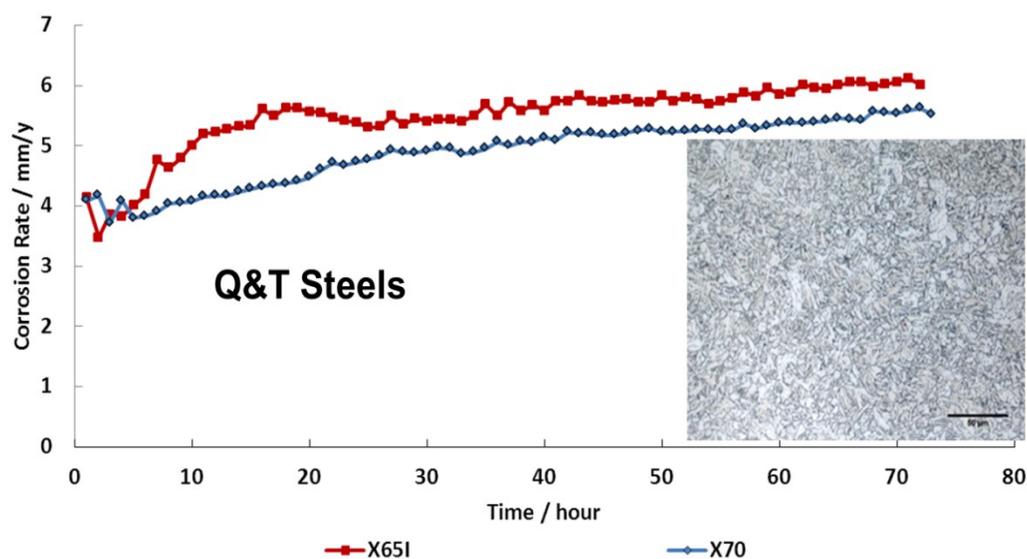
Figure 93: LPR measurements with time for Q&T steels. 3 days of exposure at 80°C, 1.5 bar CO<sub>2</sub>, pH 6.6, B=26 mV/decade,  $\tau = 535$  Pa.

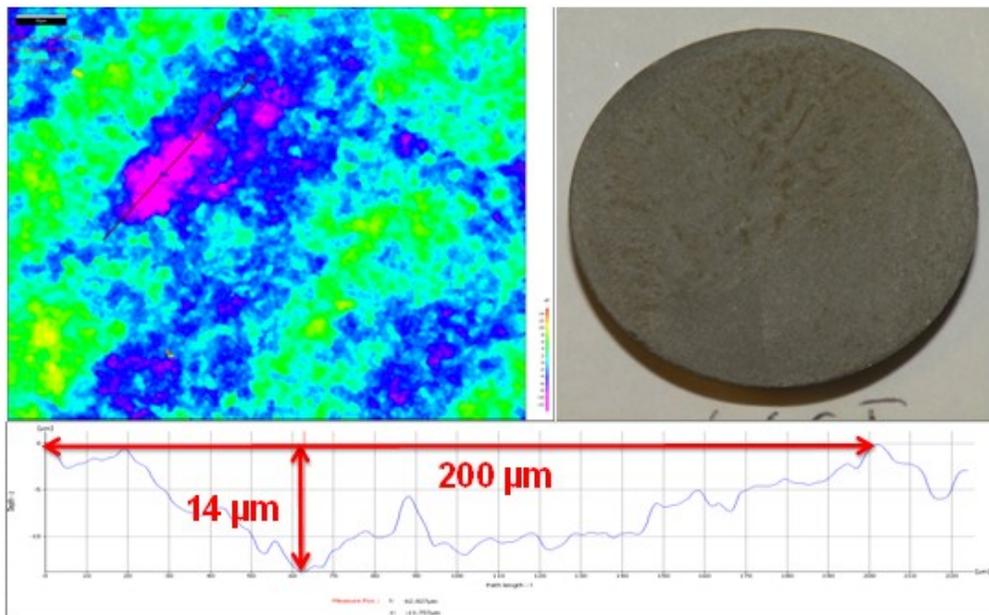
Figure 96: IFM top surface analysis shows wide shallow pits with 200  $\mu\text{m}$  in width & 14  $\mu\text{m}$  in depth. There is no  $\text{FeCO}_3$  layer formed on the steel surface after 3 days of exposure at 80°C, Q&T steel X65I, 1.5 bar  $\text{CO}_2$ , pH 6.6,  $\tau = 535$  Pa.

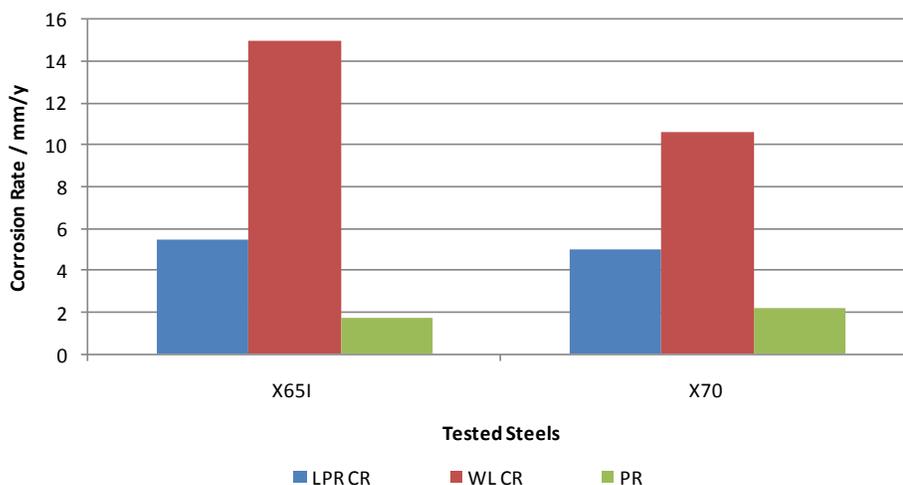
Figure 98: Comparison between corrosion rates measured by integrated LPR, weight loss (WL), and pit penetration rate (PR). After 3 days of exposure at 80°C, Q&T steels, 1.5 bar CO<sub>2</sub>, pH 6.6,  $\tau = 535$  Pa.

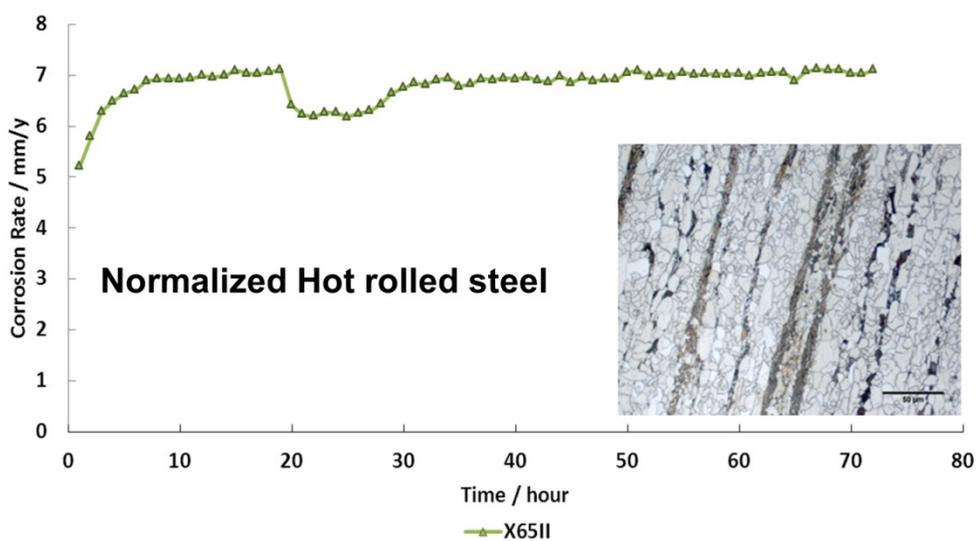
Figure 99: LPR measurements with time for Normalized hot rolled steel X65II, 3 days of exposure at  $80^\circ\text{C}$ , 1.5 bar  $\text{CO}_2$ , pH 6.6,  $B=26$  mV/decade,  $\tau = 535$  Pa.

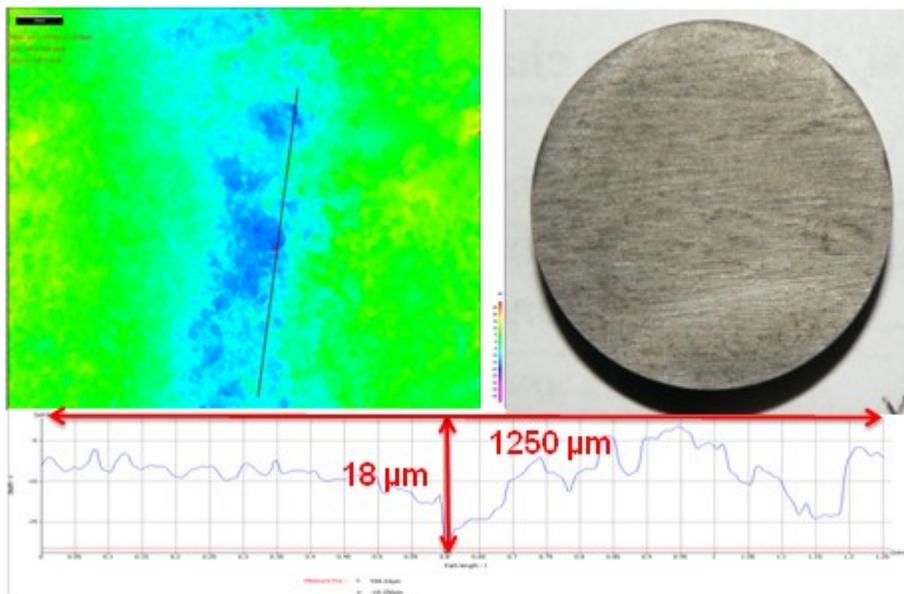
Figure 102: IFM top surface analysis shows large areas of shallow localized corrosion with 1250  $\mu\text{m}$  in width & 18  $\mu\text{m}$  in depth. No  $\text{FeCO}_3$  layer formed on the surface after 3 days of exposure at 80°C, NHR steel X65II, 1.5 bar  $\text{CO}_2$ , pH 6.6,  $\tau = 535$  Pa.

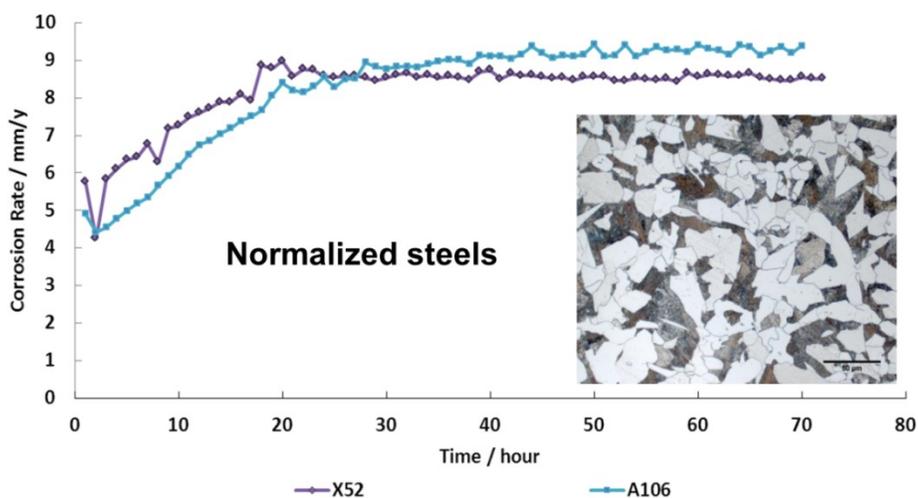
Figure 104: LPR measurements with time for Normalized steels.  
3 days of exposure at  $80^\circ\text{C}$ , 1.5 bar  $\text{CO}_2$ , pH 6.6,  $B=26 \text{ mV/decade}$ ,  $\tau = 535 \text{ Pa}$ .

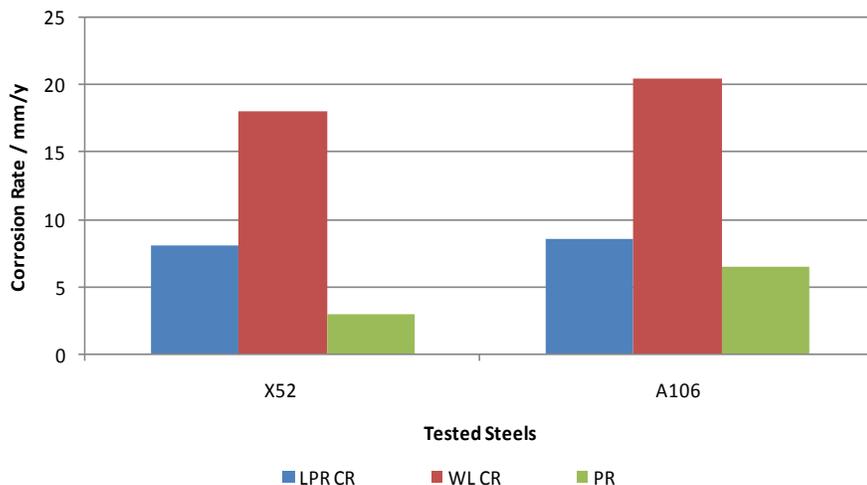
Figure 109: Comparison between corrosion rates measured by integrated LPR, weight loss (W/L), and pit penetration rate (PR). After 3 days of exposure at 80°C, Normalized steels, 1.5 bar CO<sub>2</sub>, pH 6.6, B=26 mV/decade,  $\tau = 535$  Pa.

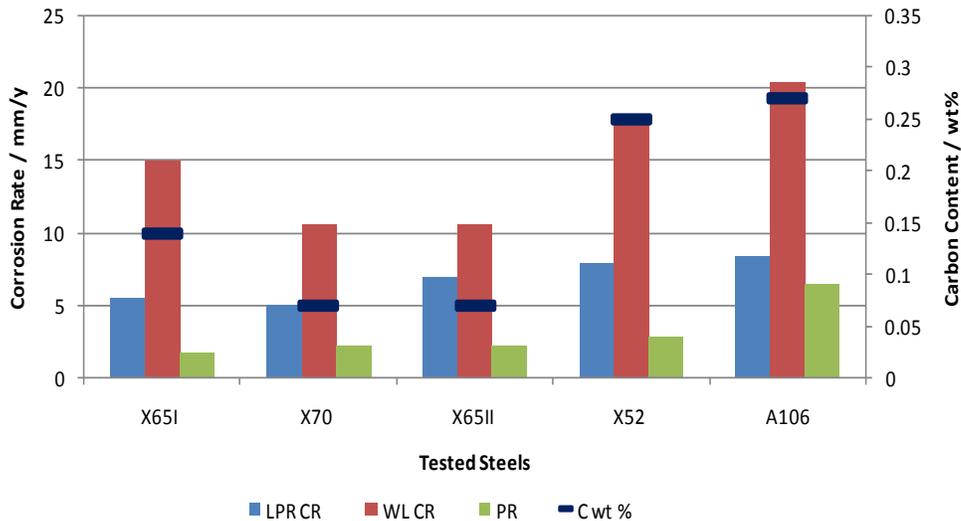
Figure 111: Comparison between corrosion rates measured by weight loss (W/L), integrated LPR, pit penetration rate (PR) and carbon content (wt. %). 3 days of exposure at 80°C, 1.5 bar CO<sub>2</sub>, pH 6.6,  $\tau = 535$  Pa.

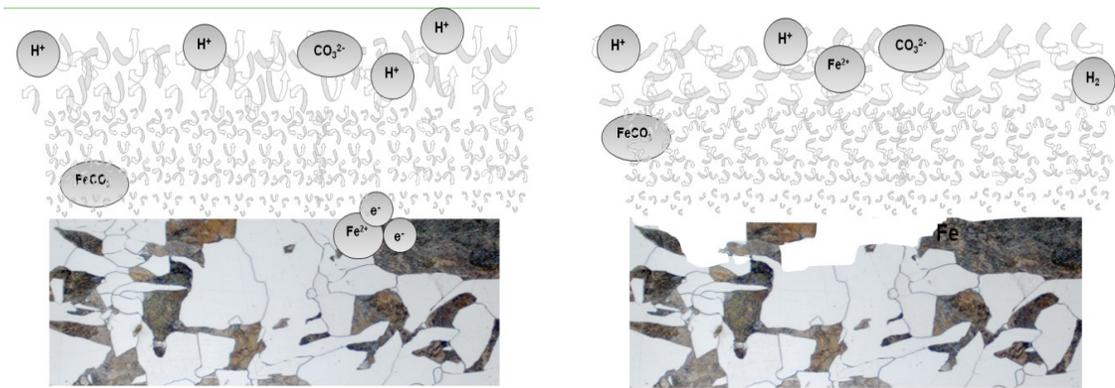
a- Fast movement of flow transports species from and towards the steel surface.

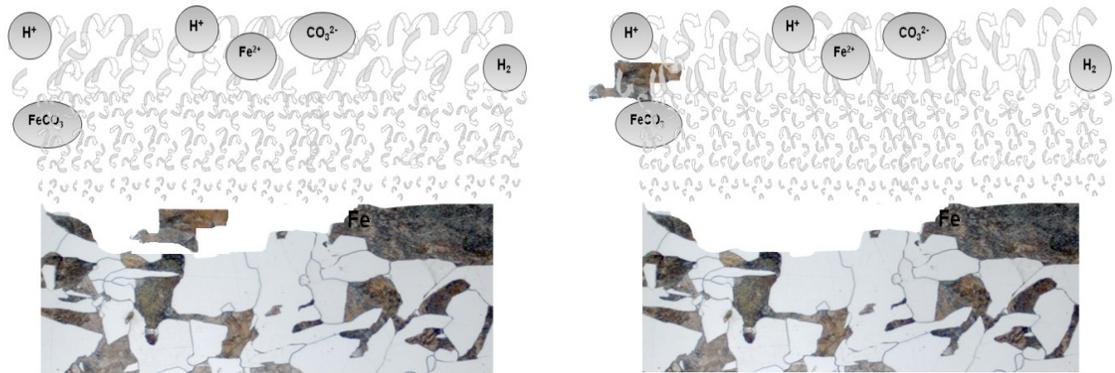
c- Ferrite that surrounds the iron carbide particles will corrode very fast, weak iron carbide is left behind.

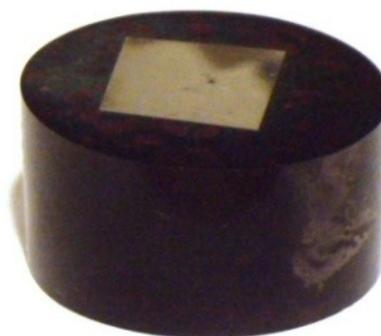
Figure A1: Schematic diagram show how the three different planes were cut and the samples after being mounted in Bakelite.

b- Mounted in Bakelite

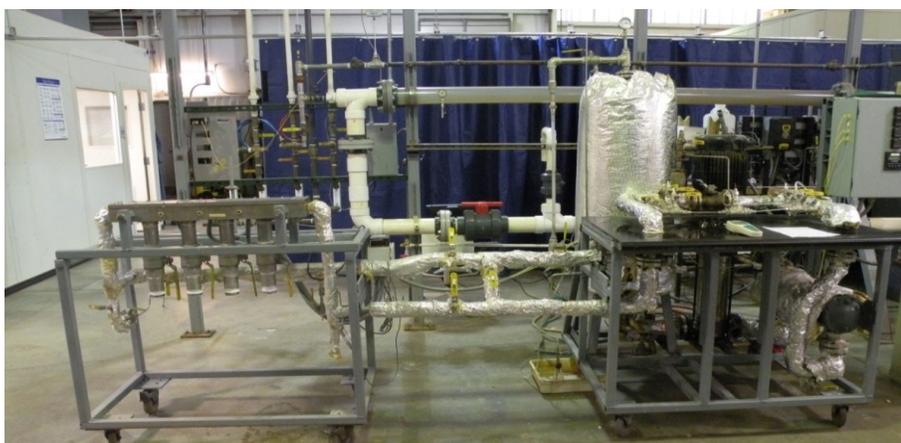
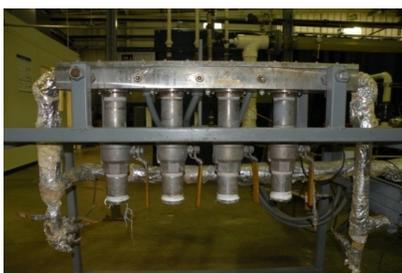
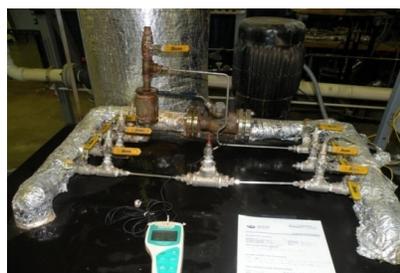
Figure C1: Images of the real thin channel flow cell (TCFC) system that used to conduct corrosion experiment.

TCFC: has four places with valves to install samples using sample holders

Piping system contain points for pH measurements and ion exchanger to control water chemistry

Two kinds of probes were used in the TCFC for corrosion study, a Linear Polarization Resistance (LPR) probe and Weight Loss (WL) probe, see Figure C2. This allows a variety of methods to be employed for measurements relating to corrosion processes. Sample holders were designed to hold a flush mounted, 1.25 inch (31 mm) diameter weight loss coupon, which makes the probes directly exchangeable with other flow loops.

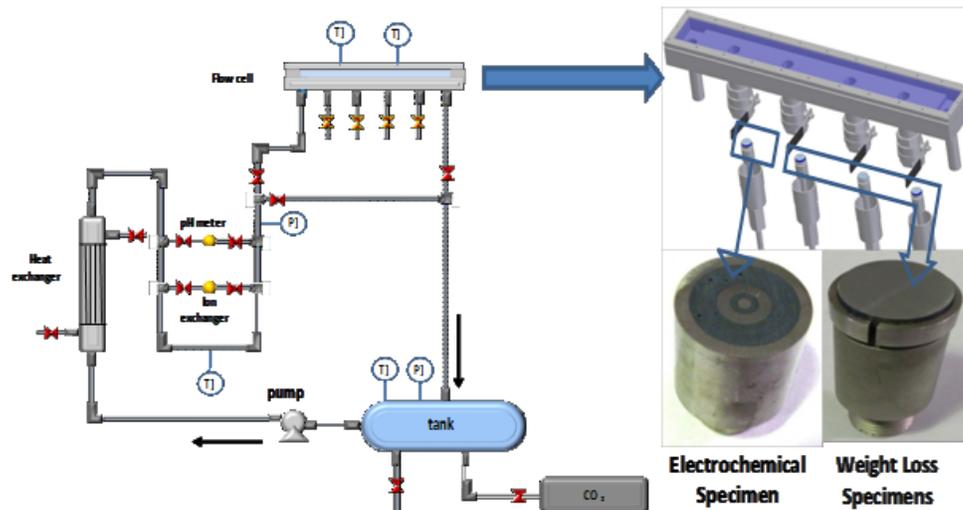
Figure C2: Schematic diagram of the thin channel flow cell (TCFC) system and samples used to conduct corrosion experiments [20].

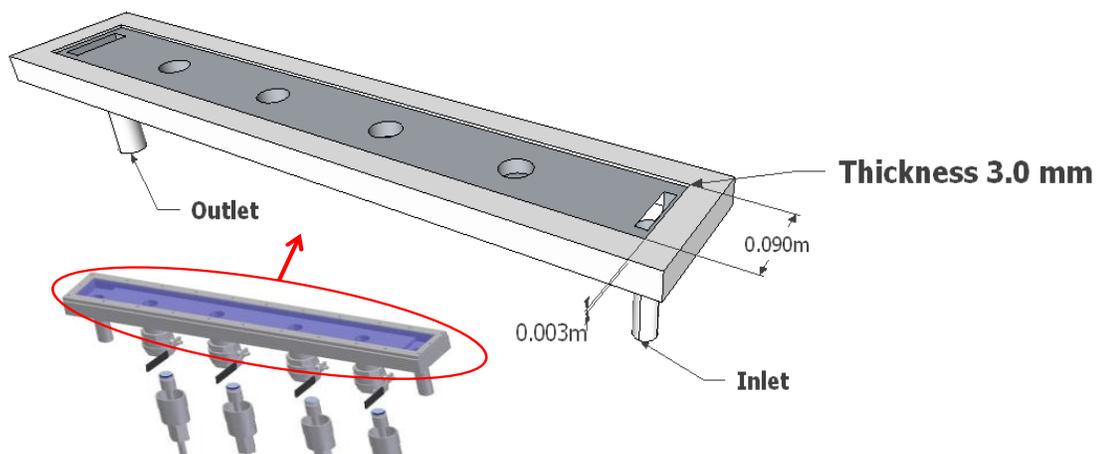
Figure C3: Schematic diagram show the dimensions of the thin channel that allow to obtain good control in flow conditions and to generate high wall shear stresses.
