Mechanistic Study of Under Deposit Corrosion of Mild Steel in Aqueous Carbon Dioxide
Solution

A dissertation presented to
the faculty of
the Russ College of Engineering and Technology of Ohio University

In partial fulfillment
of the requirements for the degree
Doctor of Philosophy

Jin Huang

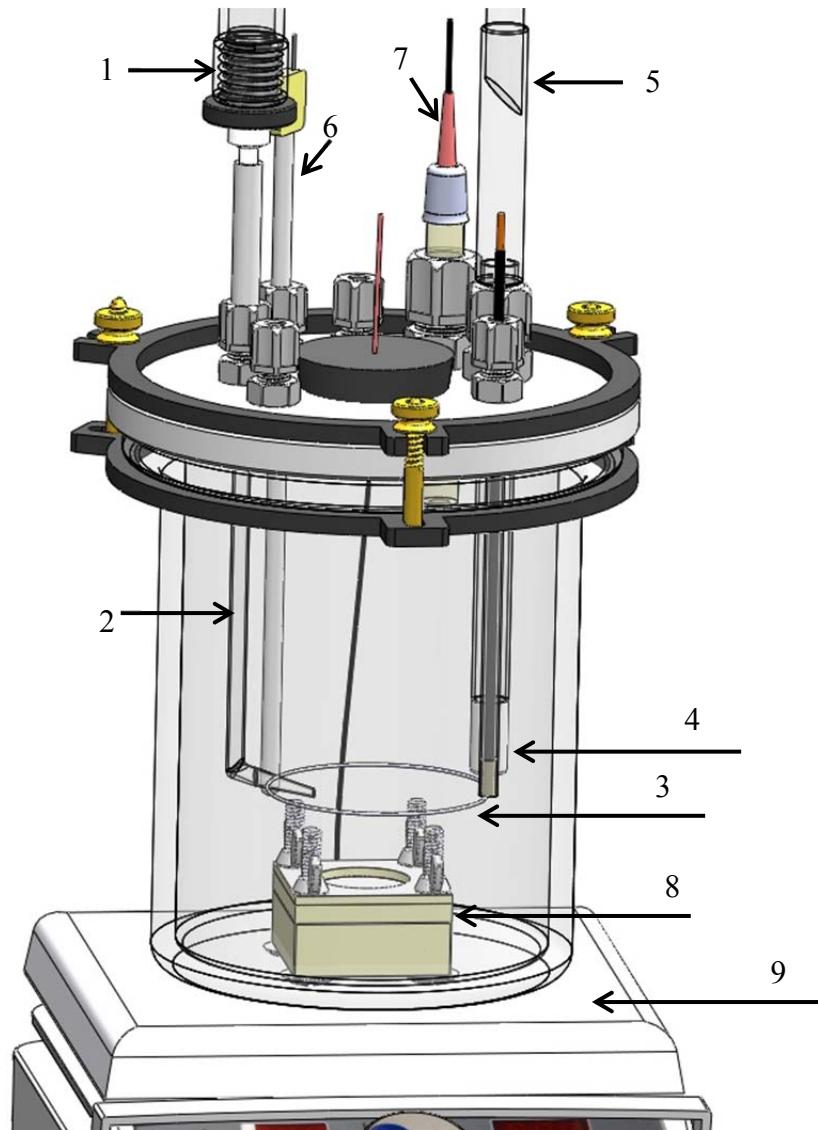
Figure 4.1 Standard three-electrode glass cell setup.

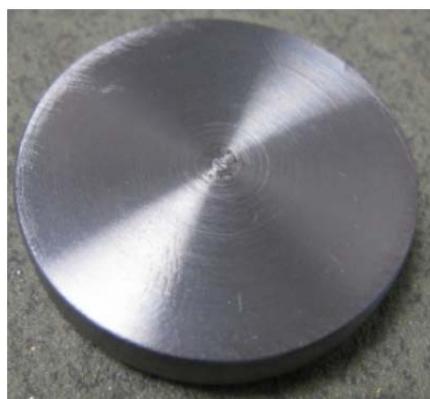
Figure 4.2 View of an API 5L X65 mild steel experiment specimen.

API 5L X65 pipeline steel was used to make working electrode specimens for all corrosion experiments. The exposed area of the specimen was 8 cm². The chemical composition of this pipeline steel is listed in Table 4.1. The specimens were machined from the parent material into cylindrical discs of 3 mm thick and 3.1 cm diameter, as shown in Figure 4.2.

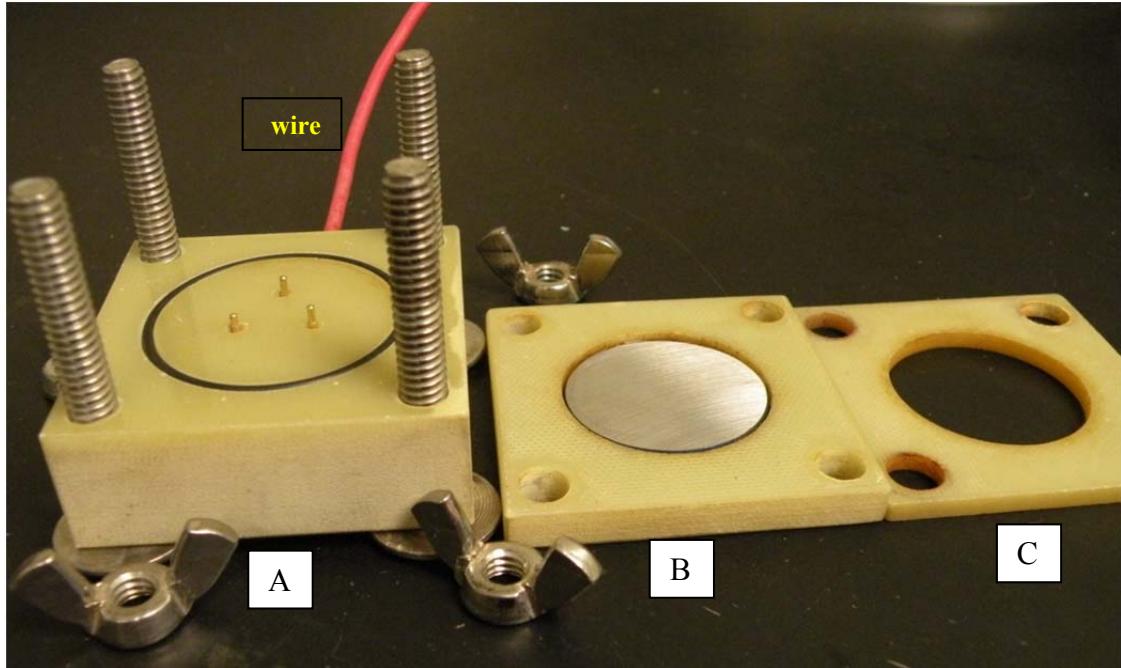
Figure 4.3 API 5L X65 mild steel specimen holder: (A) base, with three gold contacts to connect the steel specimen and wire for electrochemical measurement; (B) steel sample holder, where steel specimen is installed; (C) sand holder, which can be filled up to hold a 2 mm thick sand deposit.

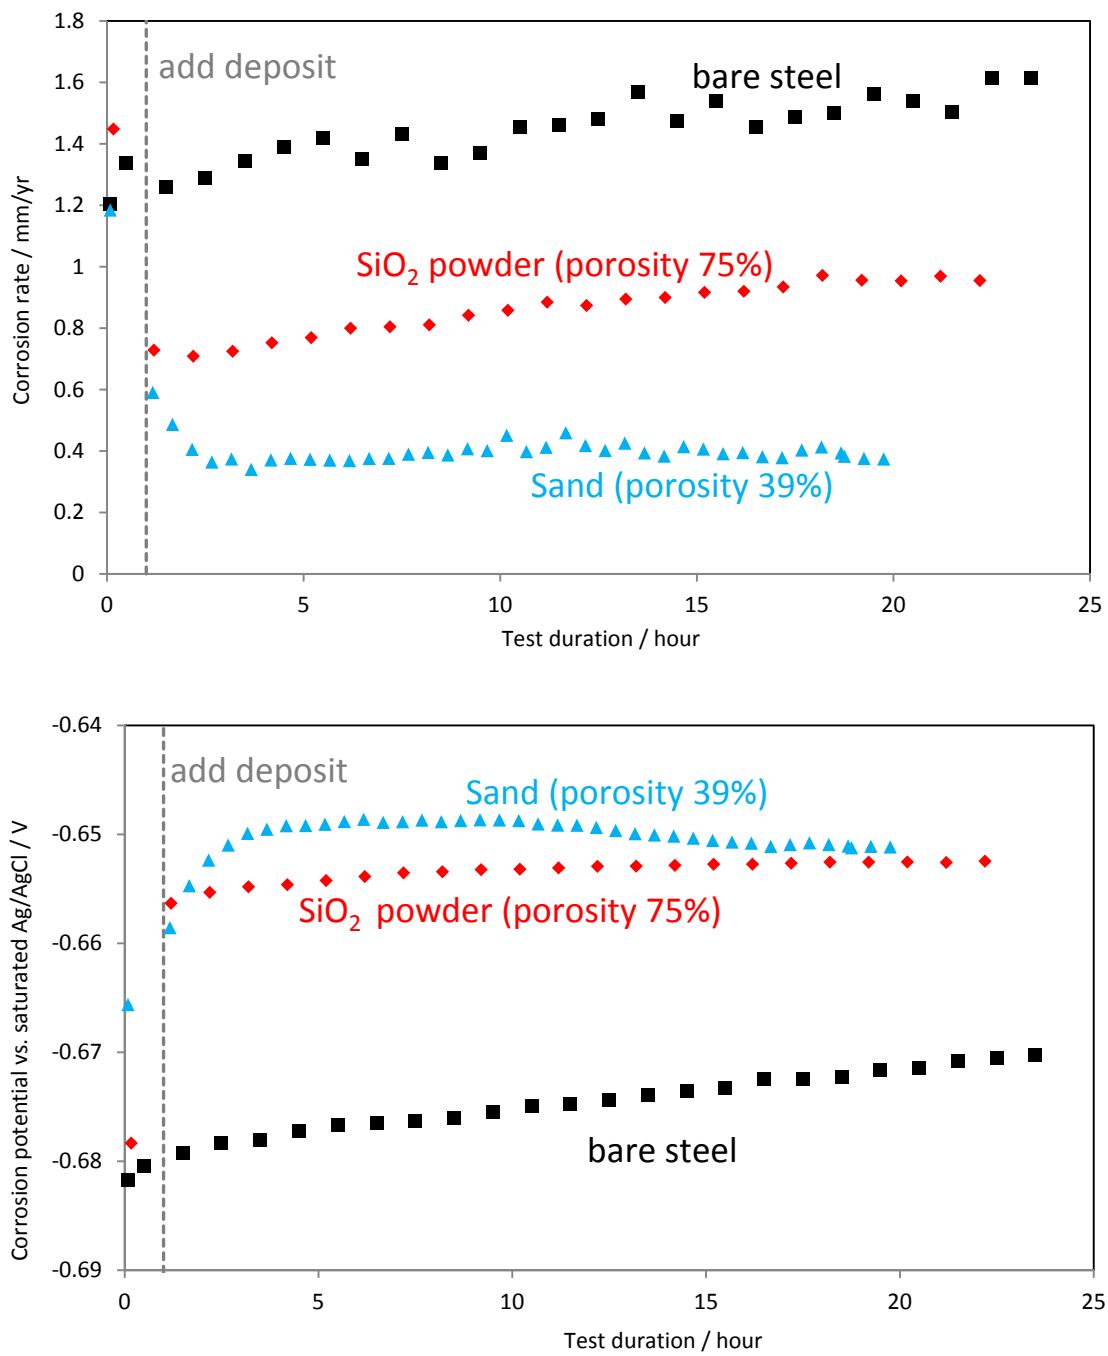
Figure 4.5 LPR corrosion rate and corrosion potential over time at test conditions T = 25°C, 1 wt% NaCl solution, pH = 5.0, 2 mm deposit.

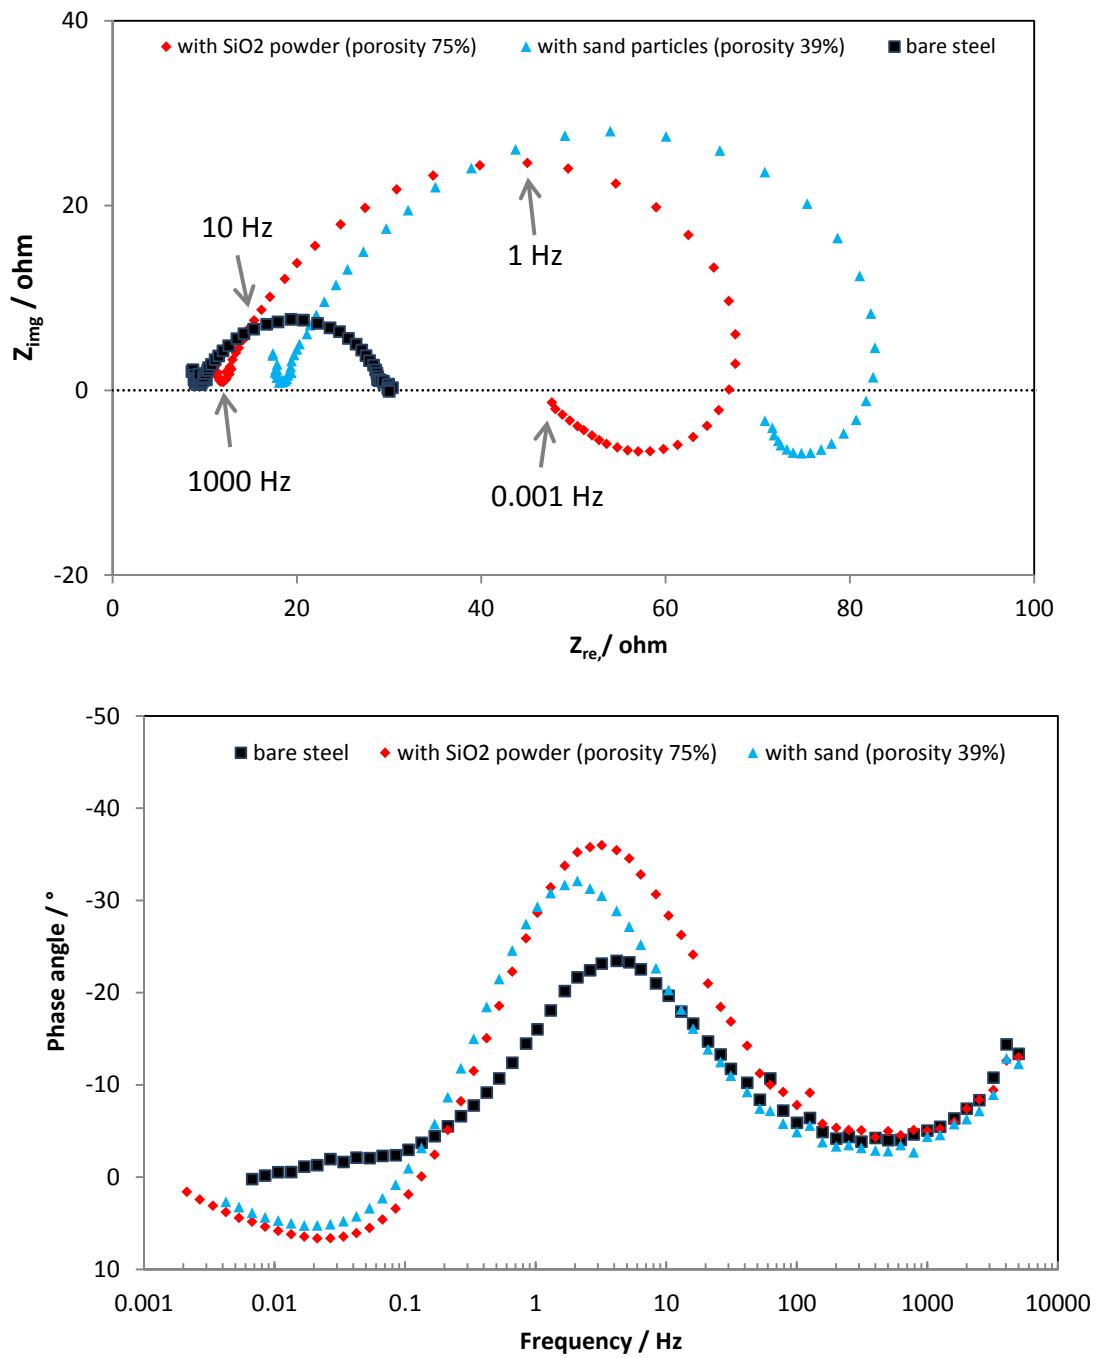
Figure 4.6 EIS Nyquist plots and Bode plots at test conditions 25°C, 1 wt% NaCl solution, pH = 5.0, 2 mm deposit, 20 hours exposure.

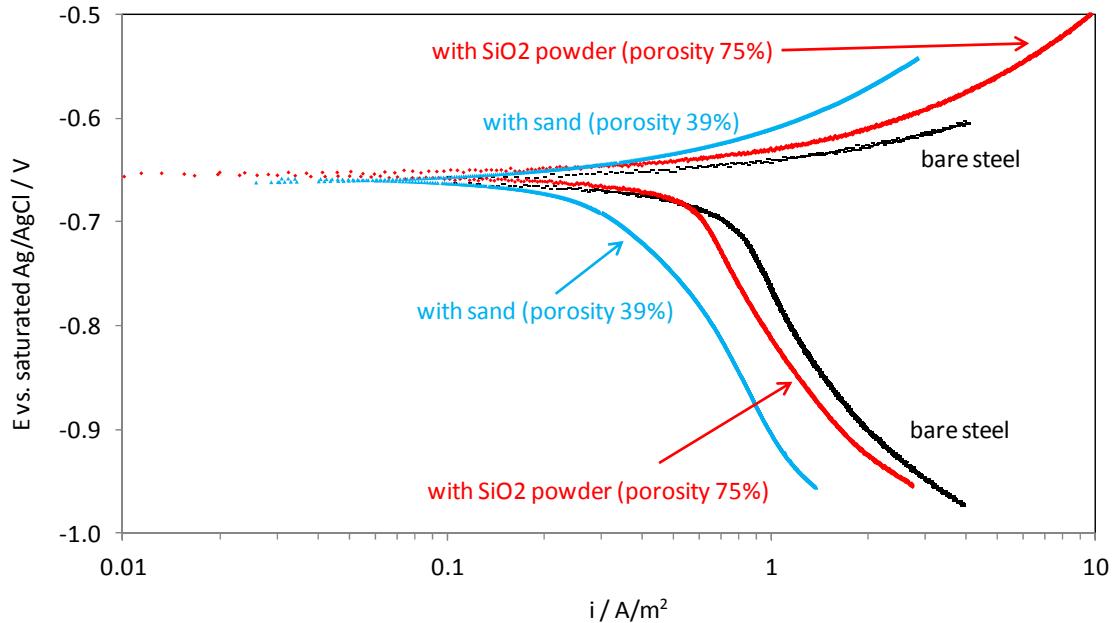
Figure 4.7 Potentiodynamic sweeps at test conditions 25°C, 1 wt% NaCl solution, pH = 5.0, 2 mm deposit, in the 24th hour of exposure.

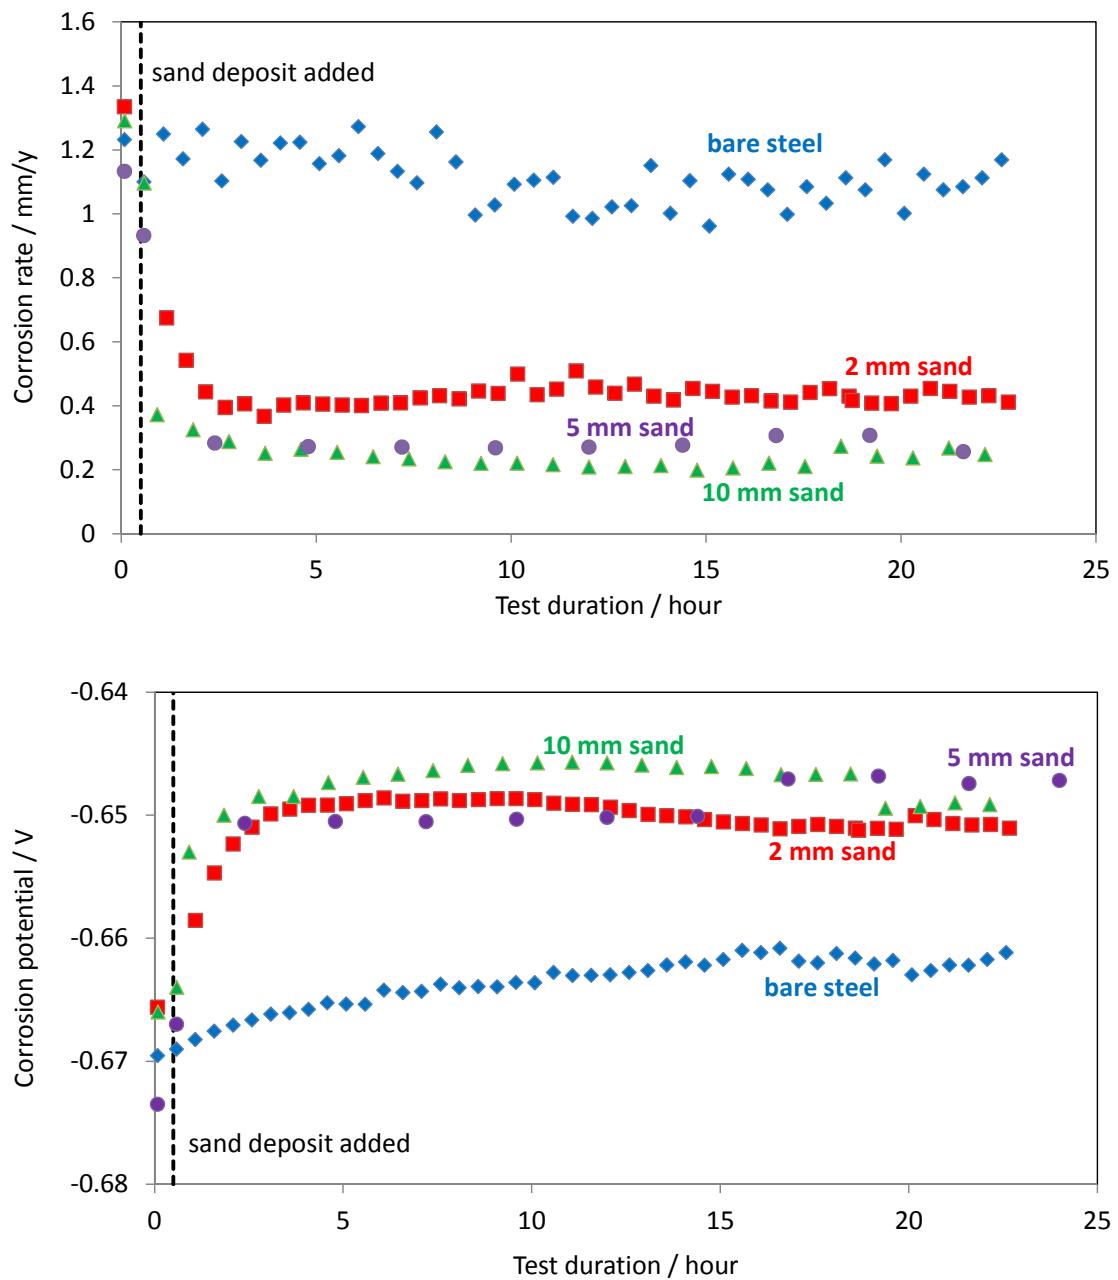
Figure 4.9 LPR corrosion rate and corrosion potential over time under sand deposit at test conditions T = 25°C, 1 wt% NaCl solution, pH = 5.0, 2 mm deposit.

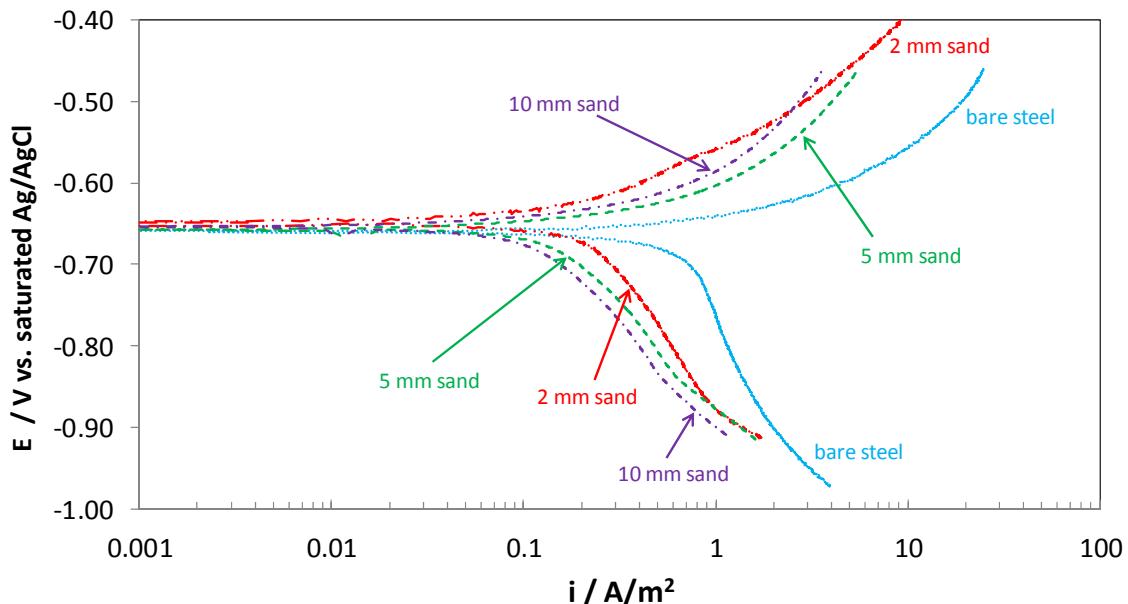
Figure 4.11 Potentiodynamic sweeps at test conditions 25°C, 1 wt% NaCl solution, pH 5.0, in the 24th hours exposure, under sand deposit.

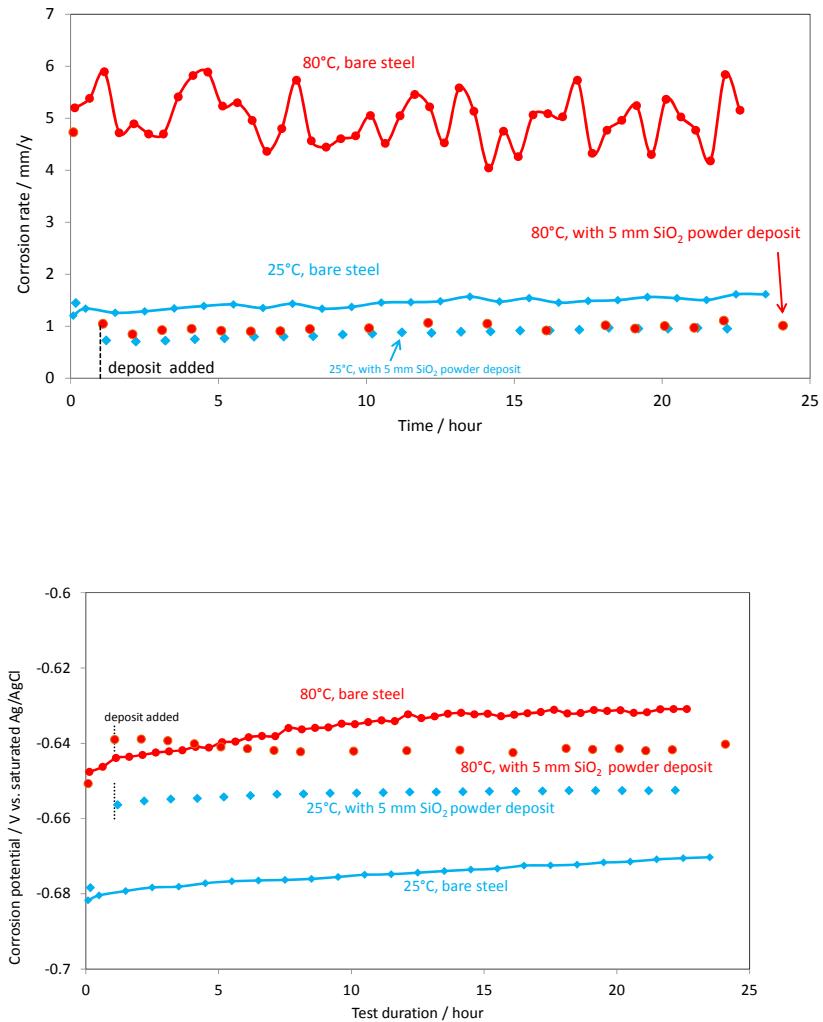
Figure 4.12 LPR corrosion rate and corrosion potential over time at test conditions 1 wt% NaCl solution, pH = 5.0, under 5 mm SiO₂ powder deposit at different temperatures.

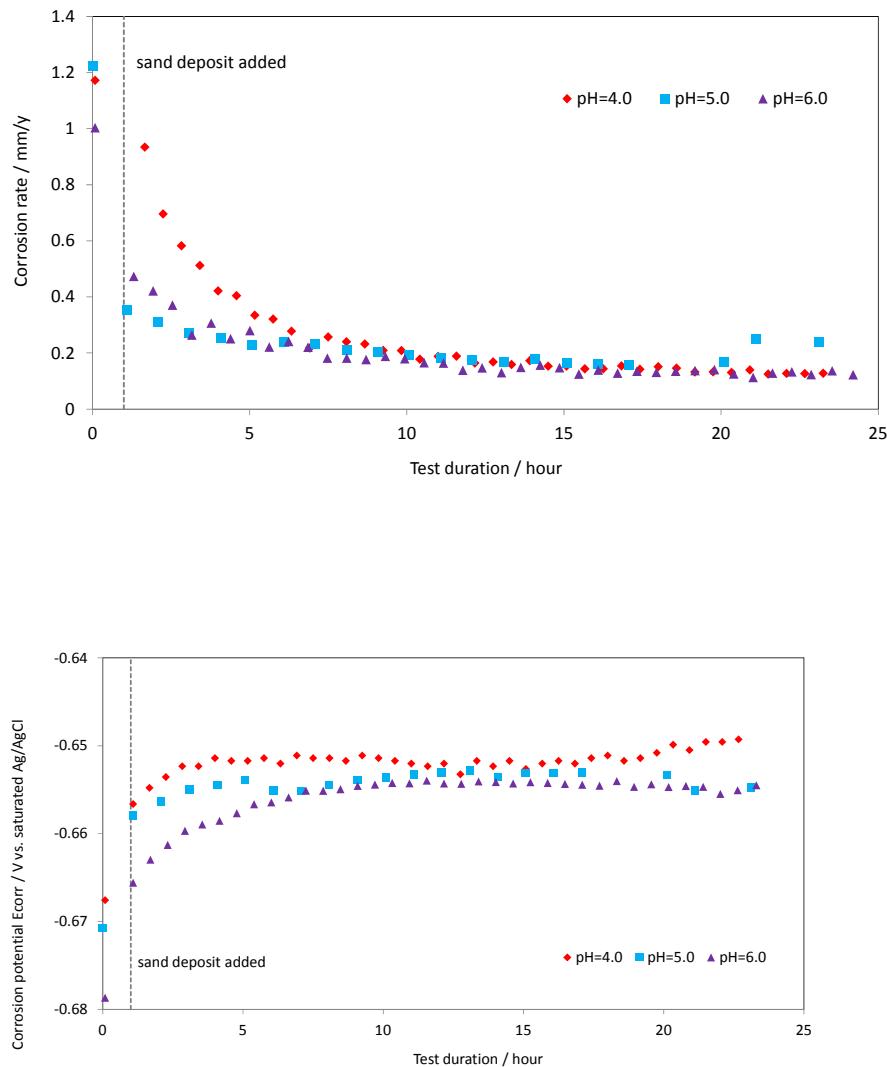
Figure 4.14 LPR corrosion rate and corrosion potential over time at test conditions T = 25°C, 1 wt% NaCl solution, with 10 mm sand deposit at different bulk solution pH.

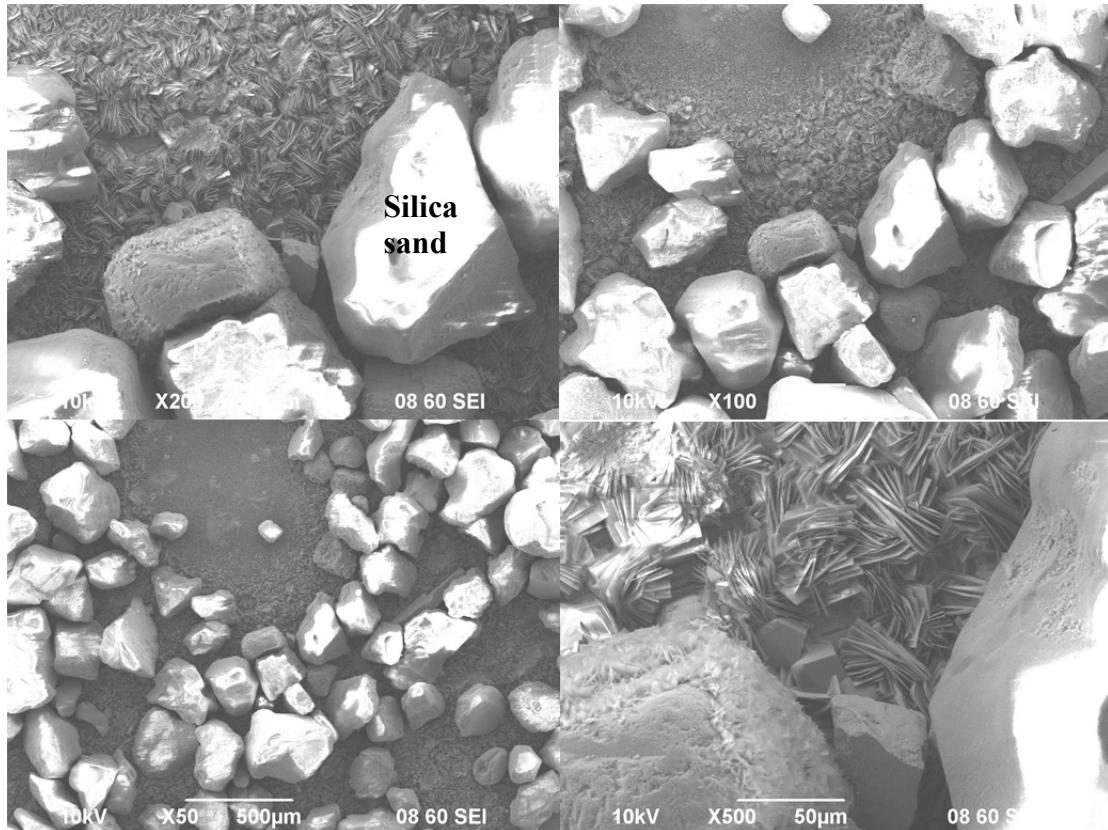
Figure 4.23 SEM images of the steel surface after 5 days exposure under 5mm silica sand deposit at 80°C, bulk solution pH 4.0, 1 wt% NaCl solution.

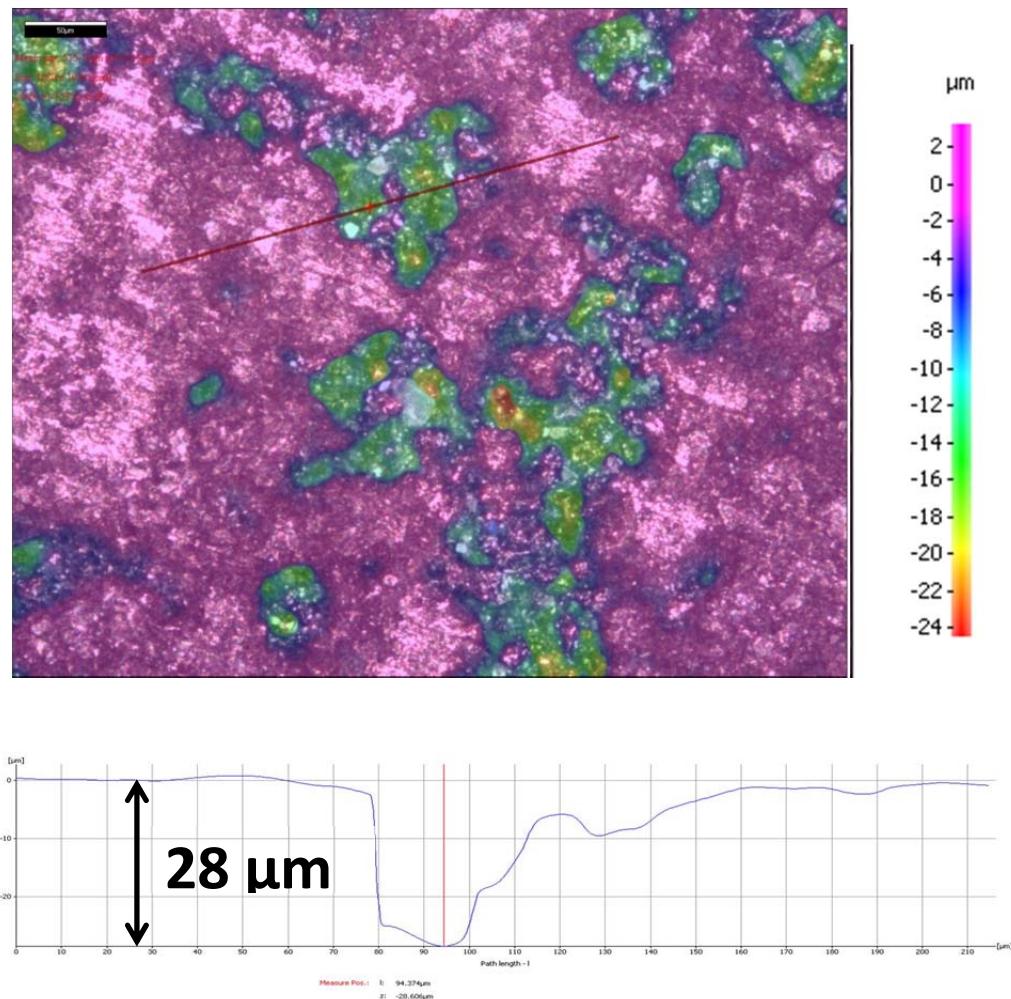
Figure 4.25 An image of infinite focusing microscopy scanning of the steel surface after 5 days exposure in 1 wt% NaCl solution, pH 4.0, at 80°C under 5 mm sand deposit (after surface scale was removed)

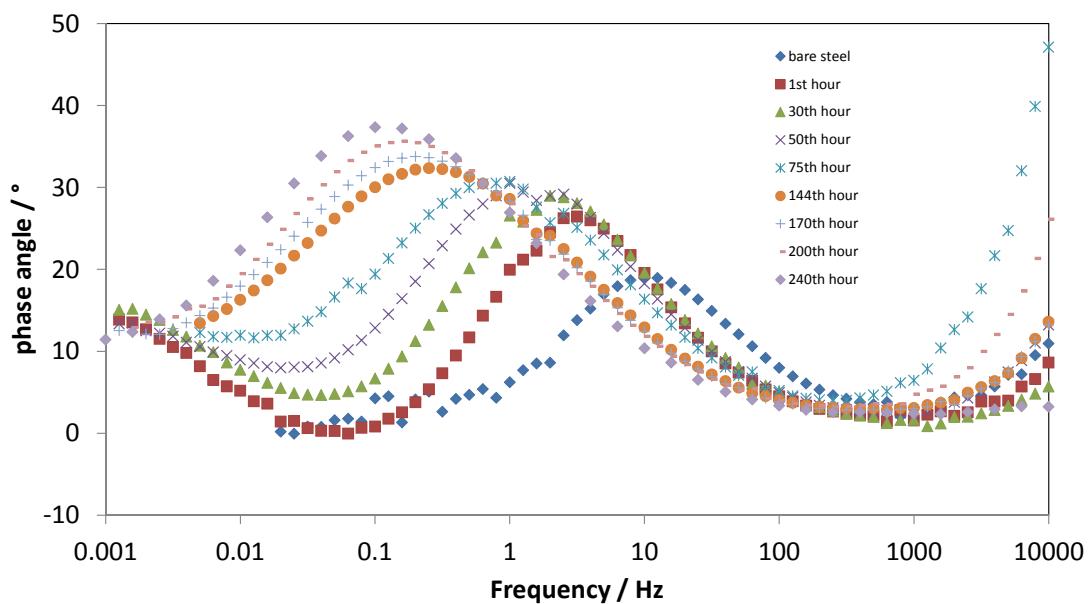
Figure 4.27 EIS Nyquist plots at different exposure time at test conditions 80°C, 1 wt%
NaCl solution, pH = 5.0, 5 mm silica sand deposit.

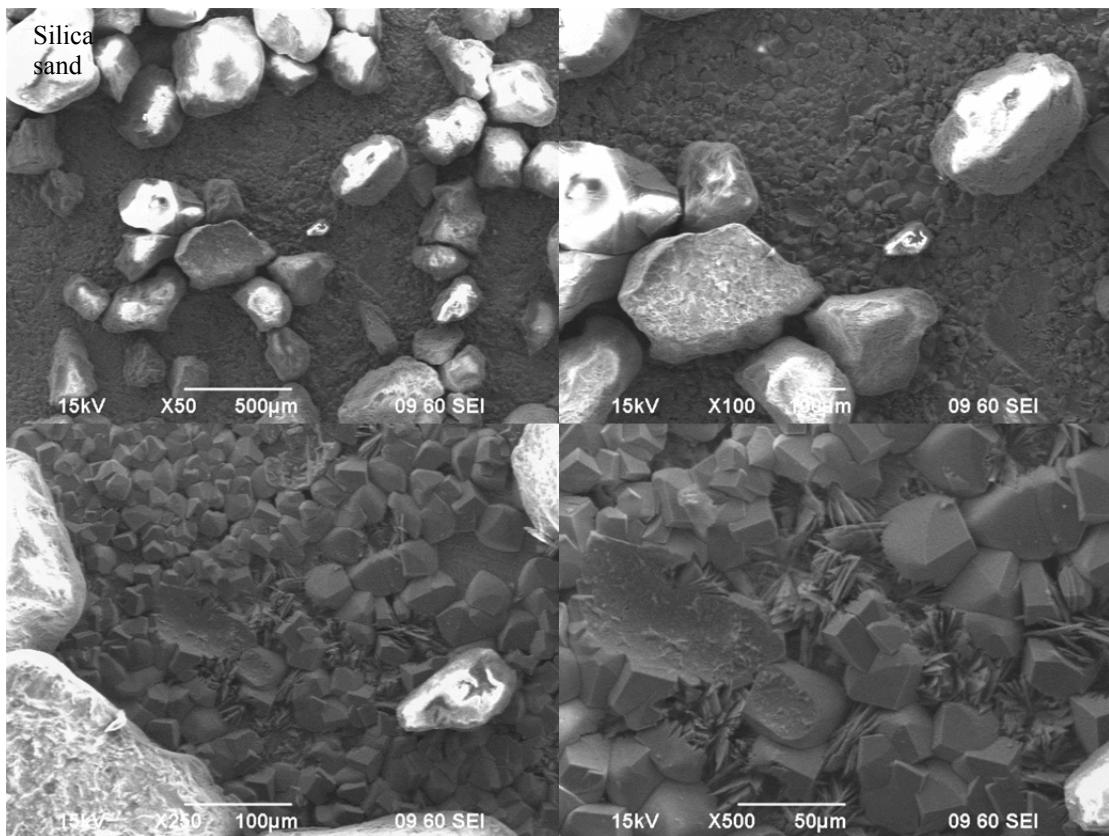
Figure 4.28 SEM image of steel surface after 10 days exposure at test conditions 80°C, 1 wt% NaCl solution, pH 5.0, 5 mm silica sand deposit.

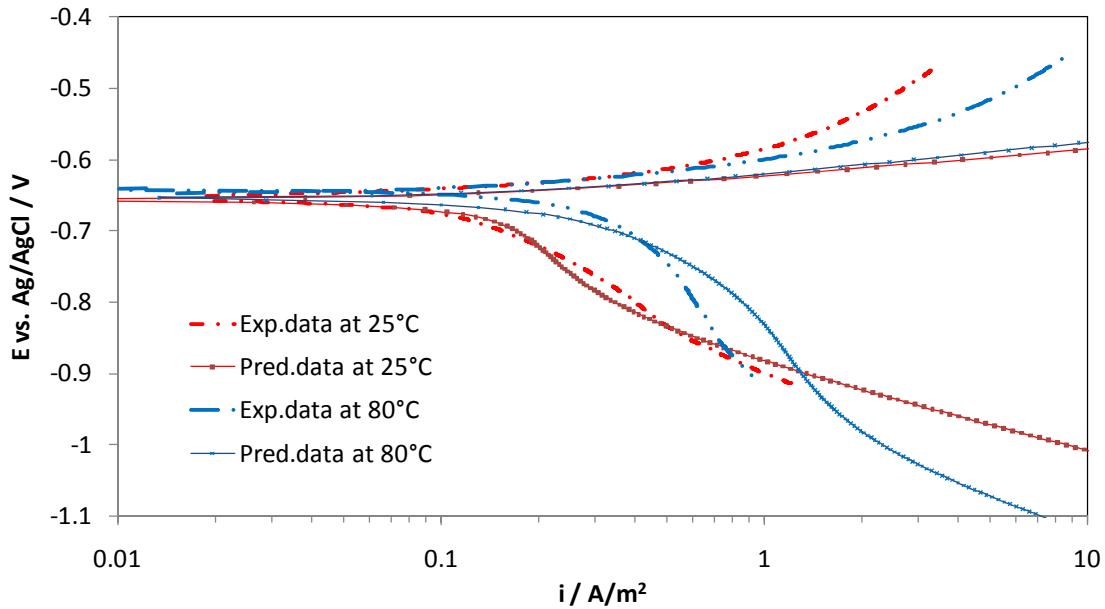
Figure 4.32 Potentiodynamic sweeps of CO_2 corrosion of X65 steel under 10 mm silica sand deposit at different temperature effect at bulk solution pH 5, 1 wt% NaCl, silica sand deposit porosity = 39%.

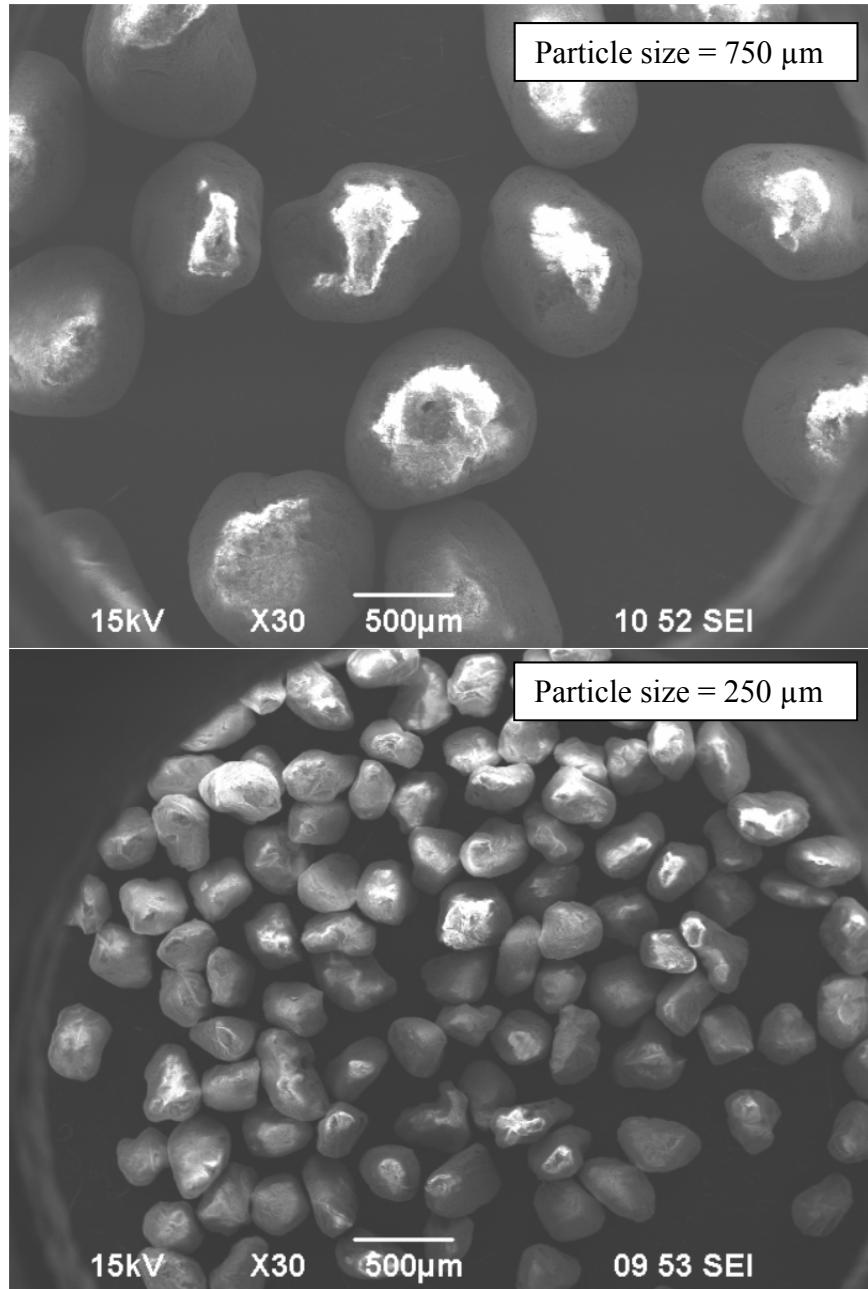
Figure 5.1 SEM images of silica particles of different sizes.

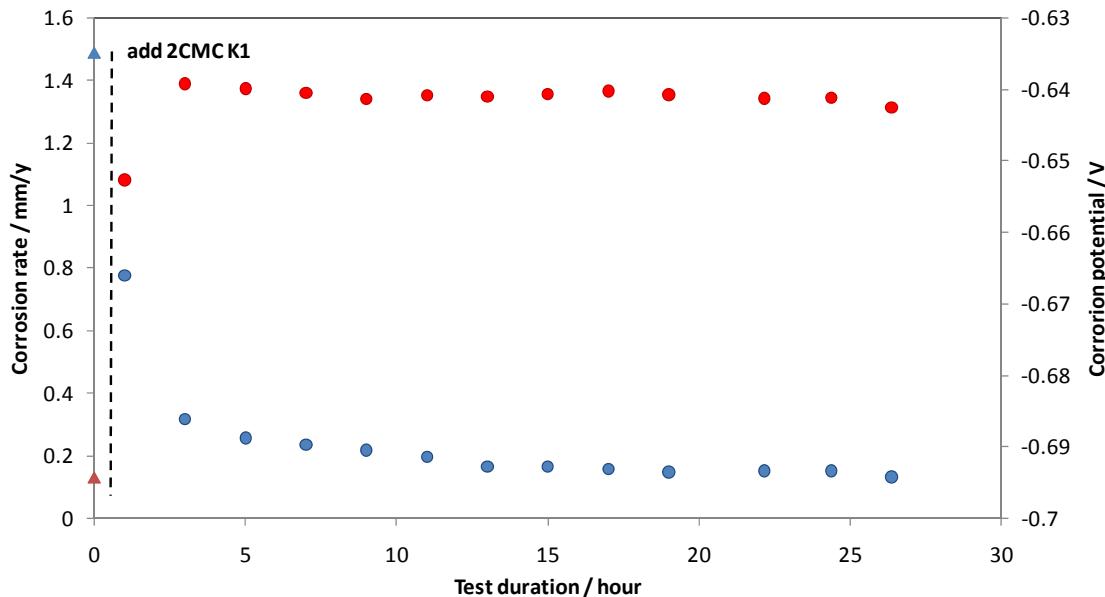
Figure 5.2 LPR corrosion rate and corrosion potential over time at test conditions T = 25°C, 1 wt% NaCl, pH 5.0, 70 ppm K1 added on a bare steel surface.

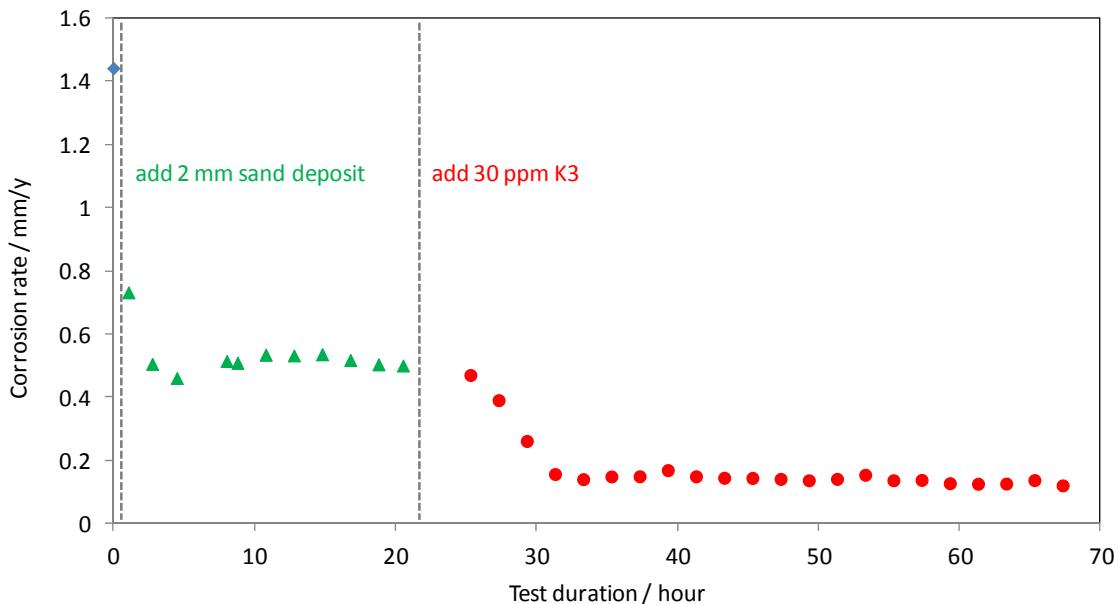
Figure 5.9 LPR corrosion rate over time at test conditions T = 25°C, 1 wt% NaCl, pH 5.0, 2 mm sand deposit presented prior to 30 ppm K3 (thiosulfate) addition.

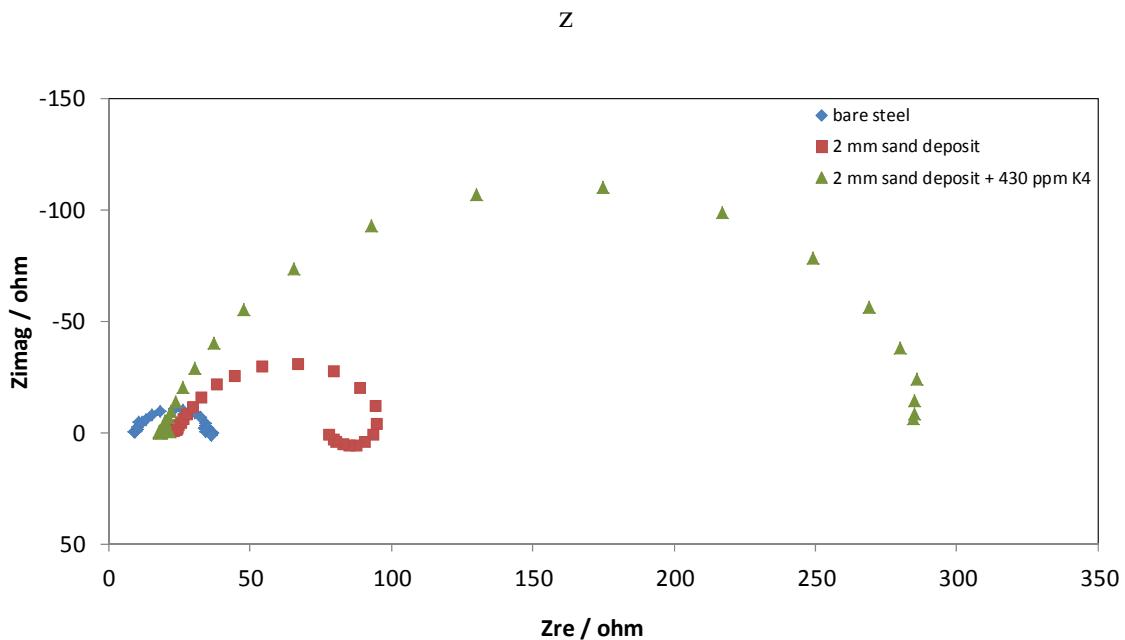
Figure 5.13 EIS Nyquist plots at 25°C, 1 wt% NaCl, pH = 5.0, 2 mm sand deposit presented prior to 430 ppm K4 (imidazoline + thiosulfate) addition.

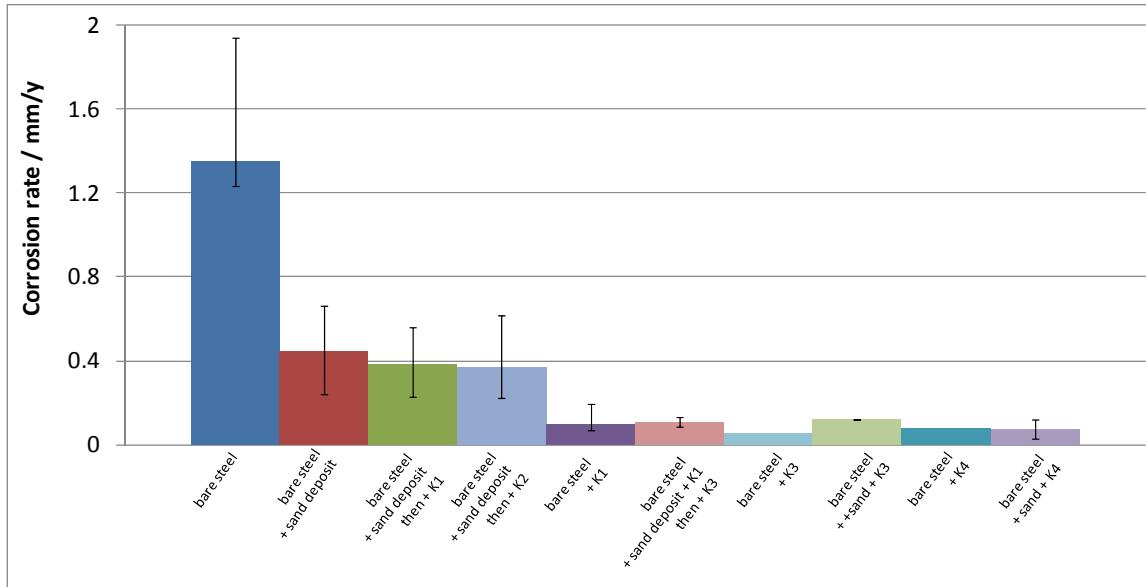
Figure 5.14 Comparison of the effect of sand deposit on different inhibitors at test conditions 25°C, 1 wt% NaCl solution, pH 5.0. 2 mm sand deposit present prior to inhibitor addition.

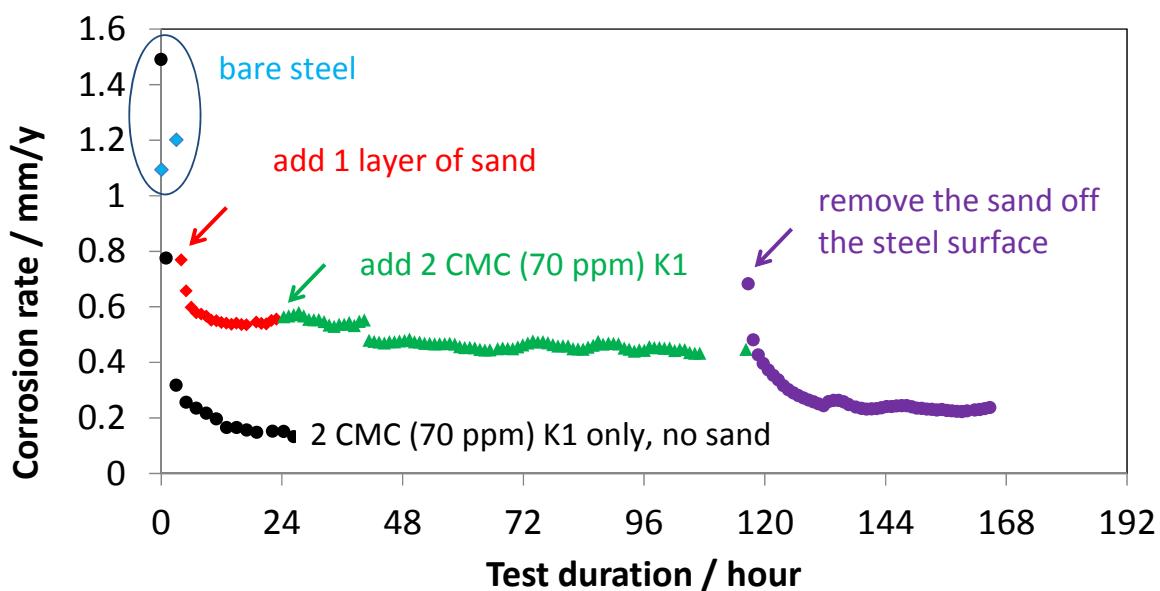
Figure 5.18 LPR corrosion rate over time at test conditions 25°C, 1 wt% NaCl solution, pH 5.0, under various amount of sand deposit which was present prior to 70 ppm K1 (imidazoline) addition.

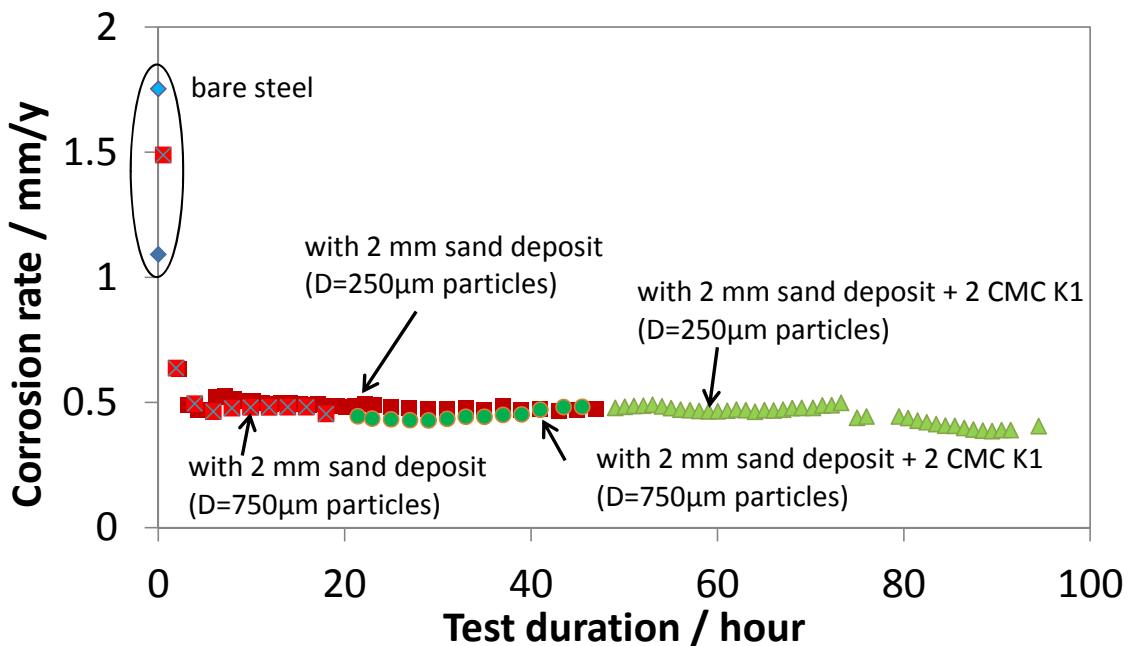
Figure 5.21 LPR corrosion rate over time at conditions 1 wt% NaCl solution, pH 5.0, 25°C at two different sizes of sand particles.

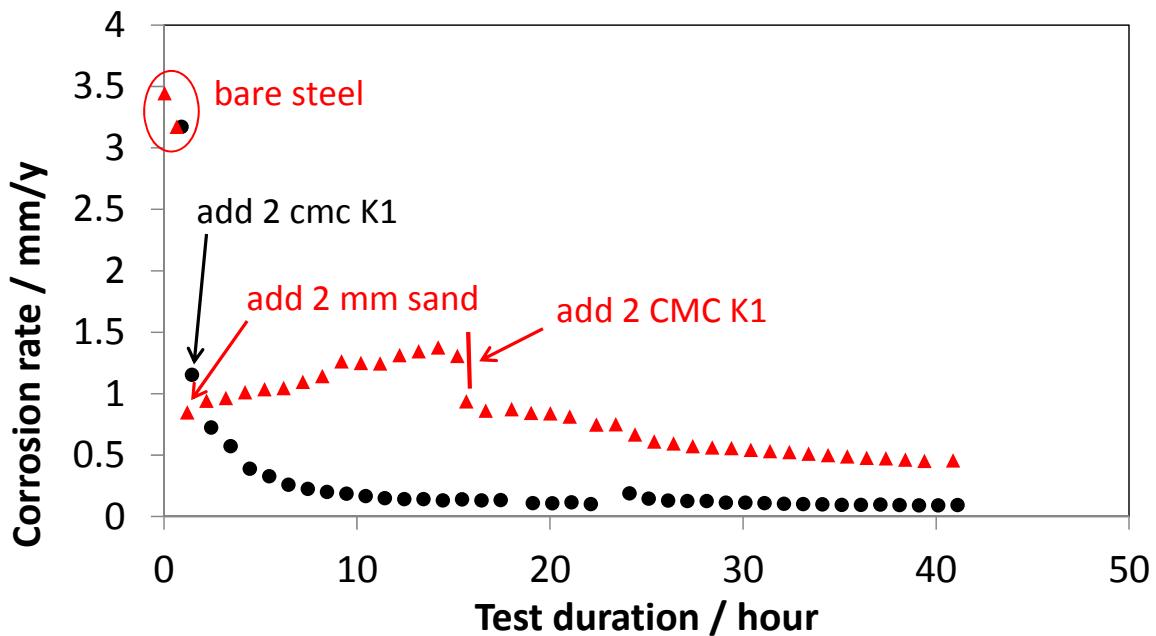
Figure 5.22 LPR corrosion rate at test conditions 1 wt% NaCl solution, pH 5.0, 80°C. 2 mm sand deposit present prior to 70 ppm K1 (imidazoline) addition.

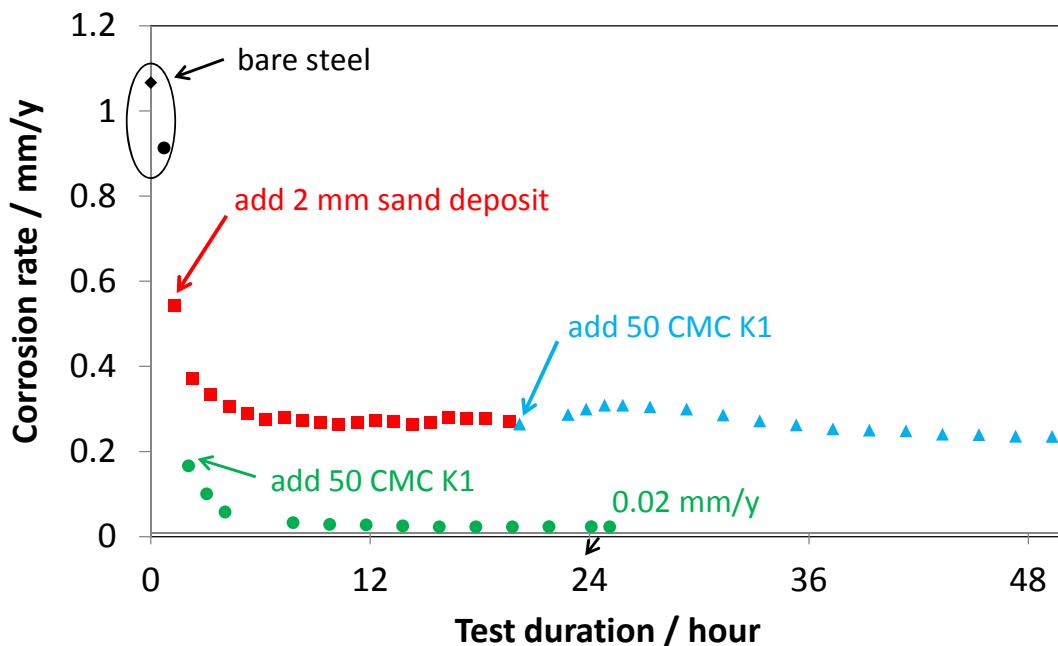
Figure 5.23 LPR corrosion rate over time at test conditions 1 wt% NaCl solution, bulk pH 5.0, 25°C, 2 mm sand deposit present prior to 1800 ppm K1 (imidazoline) addition.

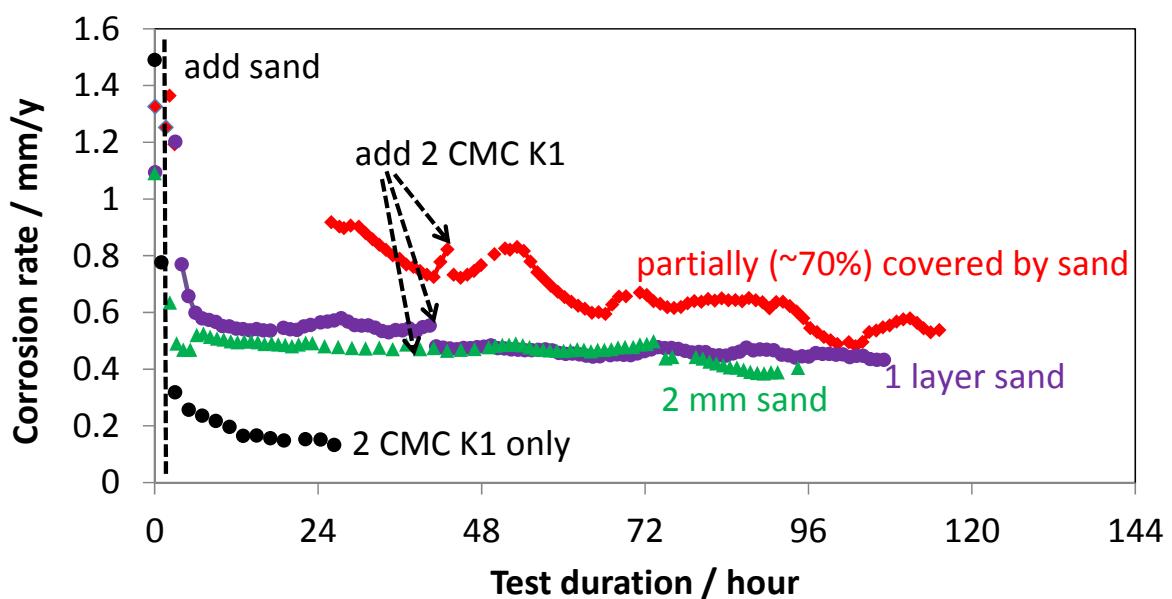
Figure 5.24 LPR corrosion rate over time at test conditions 25°C, 1 wt% NaCl solution, pH 5, sand deposit present prior to 70 ppm K1 (imidazoline) addition.

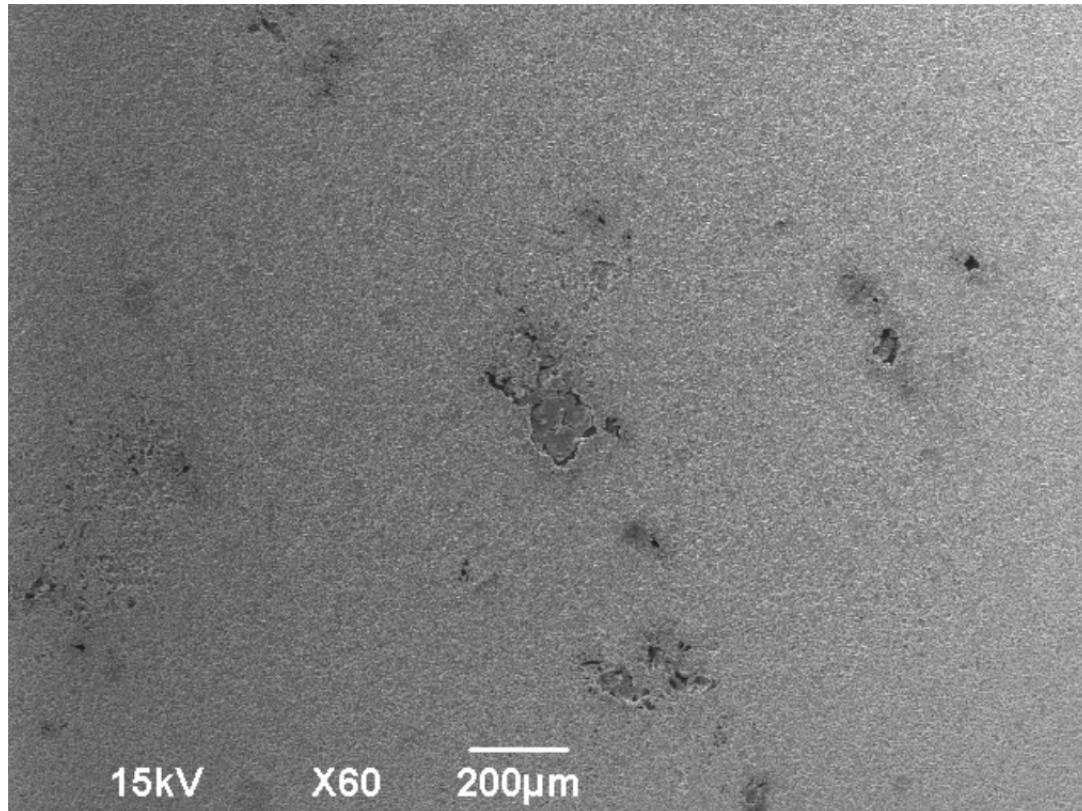
Figure 5.26 SEM of steel surface after 5 days exposure at test conditions 25°C, 1 wt% NaCl solution, pH 5.0, 1 layer sand deposit present prior to 70 ppm K1 (imidazoline) addition, corrosion product removed.
