Mechanistic Study of Under Deposit Corrosion of Mild Steel in Aqueous Carbon Dioxide
Solution

A dissertation presented to
the faculty of
the Russ College of Engineering and Technology of Ohio University

In partial fulfillment
of the requirements for the degree
Doctor of Philosophy

Jin Huang

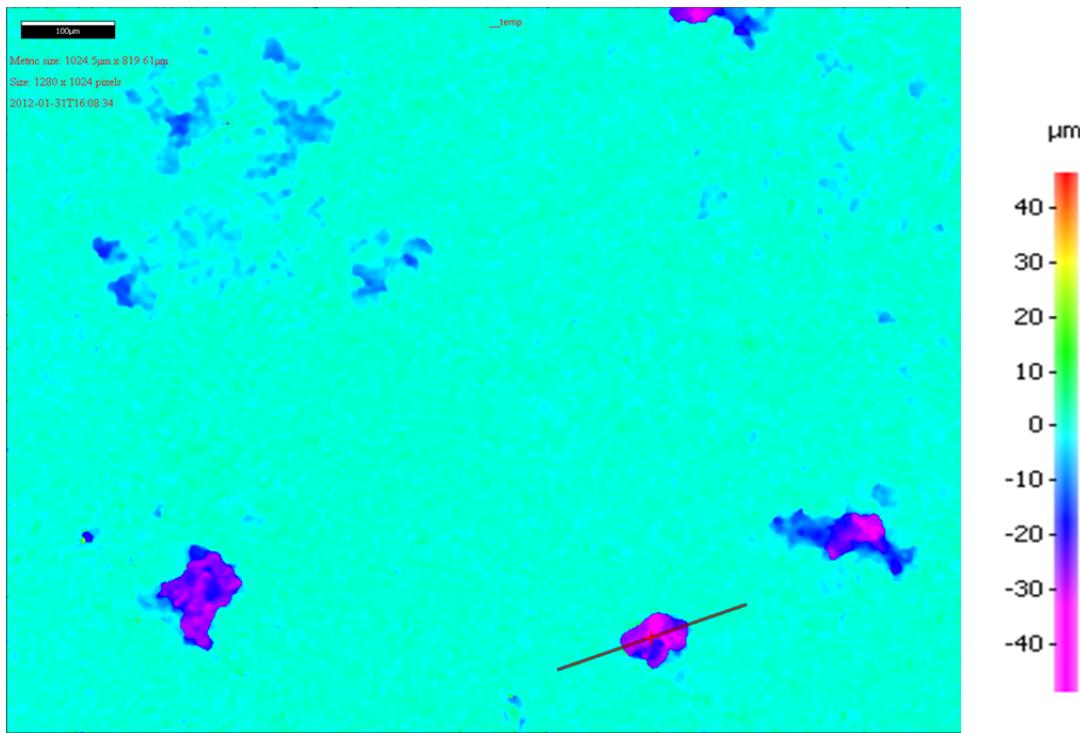
Figure 5.27 A image from infinite focusing microscopy scanning of pits on steel surface after 5 days exposure, at test conditions 25°C, 1 wt% NaCl solution, pH 5.0, 1 layer sand deposit present prior to 70 ppm K1 (imidazoline) addition.

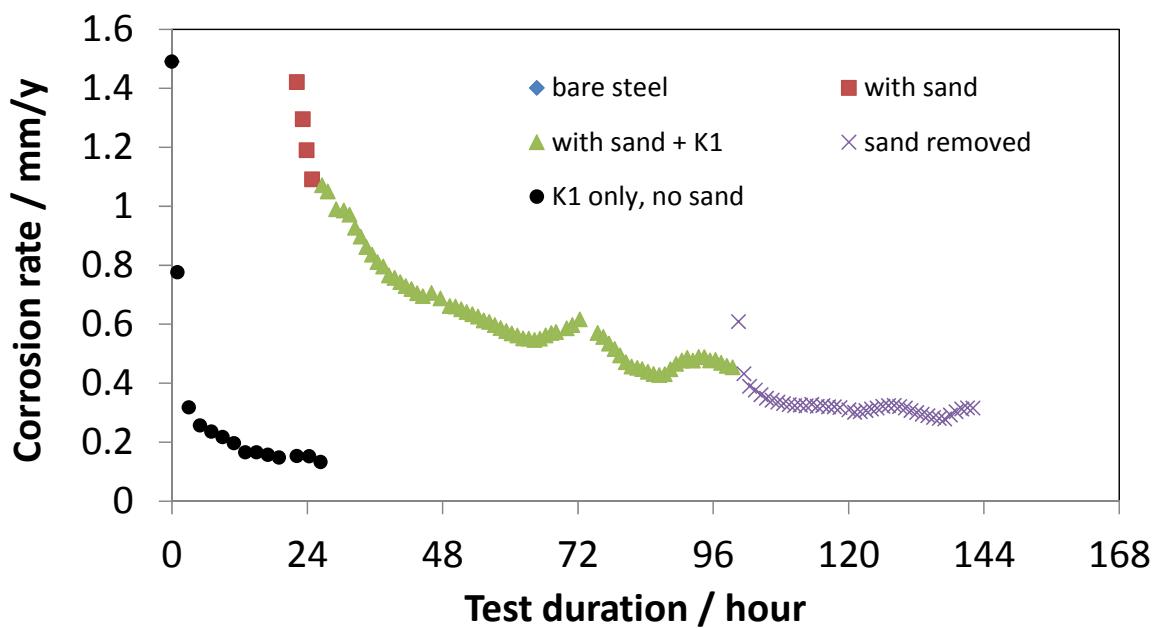
Figure 5.28 LPR corrosion rate over time at test conditions 25°C, 1 wt% NaCl solution, pH 5.0, steel surface is partially covered by sand particles.

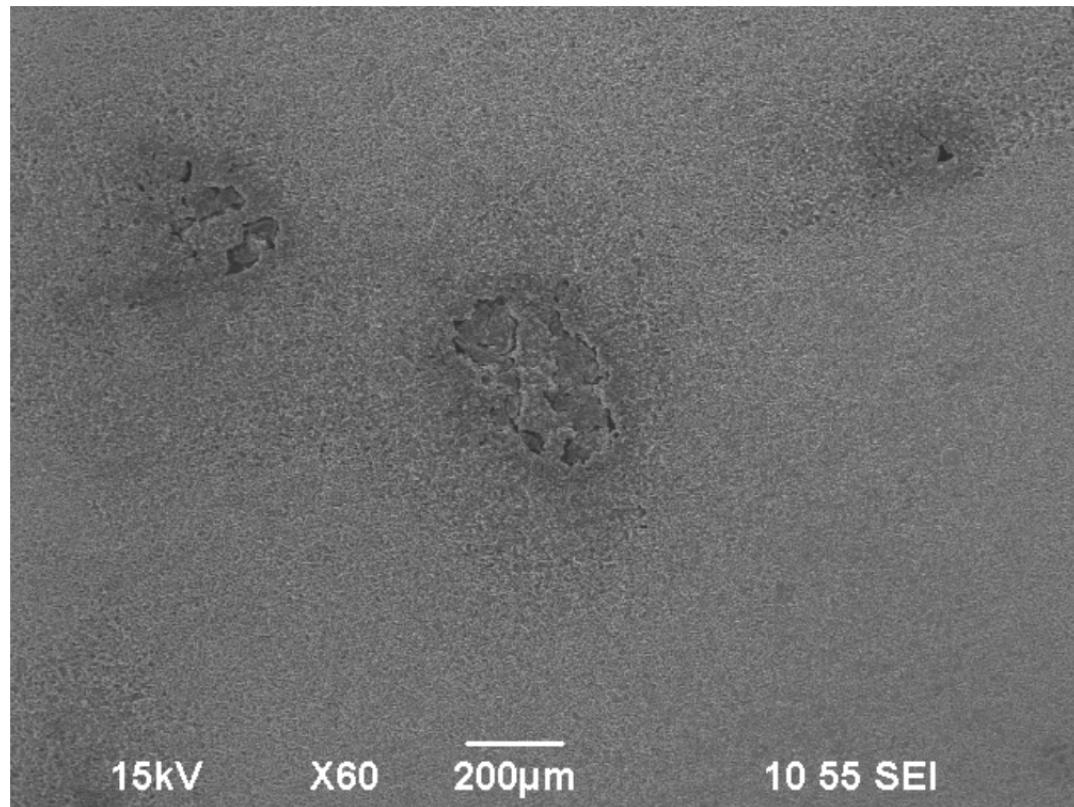
Figure 5.29 SEM of steel surface after 144 hours exposure at test conditions 25°C, 1 wt% NaCl solution, pH 5.0, steel surface is partially covered by sand particles, corrosion product removed.

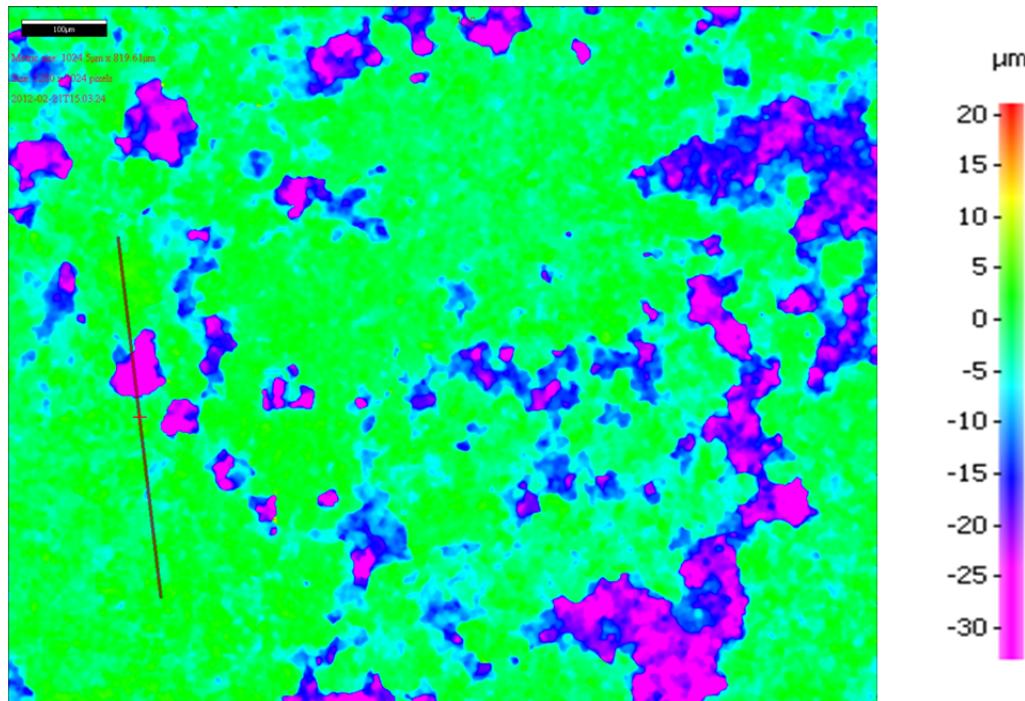
Figure 5.30 Infinite focusing microscopy scanning of steel surface after 144 hours exposure at test conditions 25°C, 1 wt% NaCl solution, pH 5.0, steel surface is partially covered by sand particles and corrosion product removed.

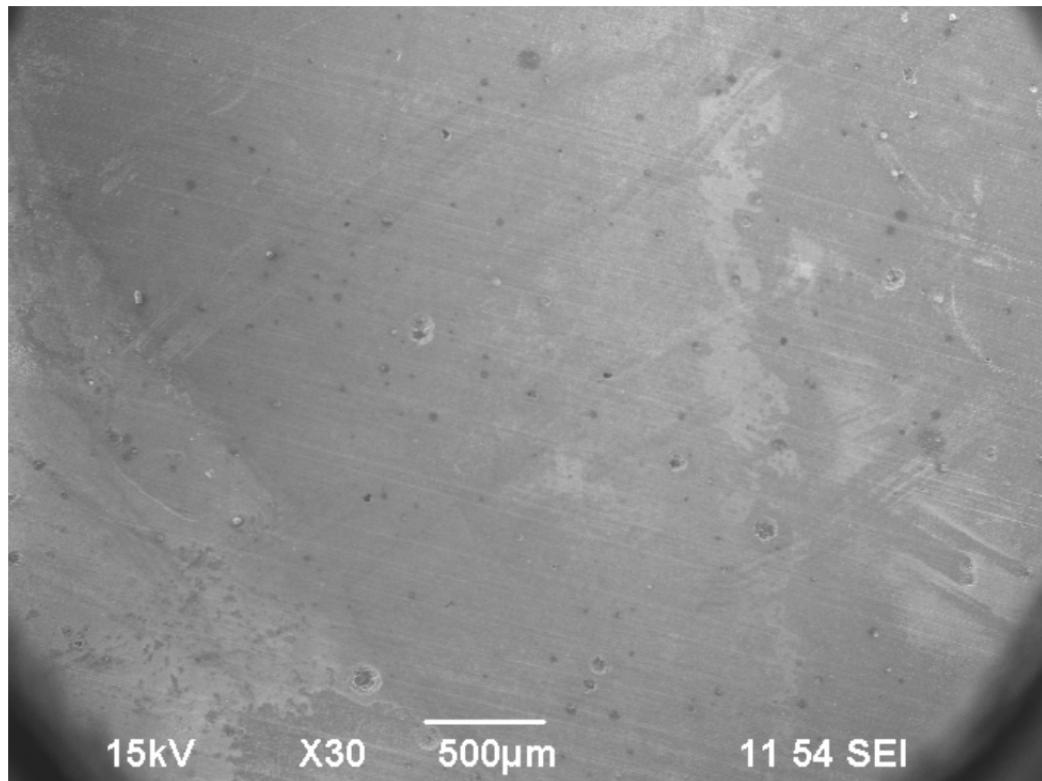
Figure 5.31 SEM image of the steel surface after 160 hours exposure at test conditions 25°C, 1 wt% NaCl solution, 5.0, 2 mm sand deposit present after 70 ppm K1 addition.

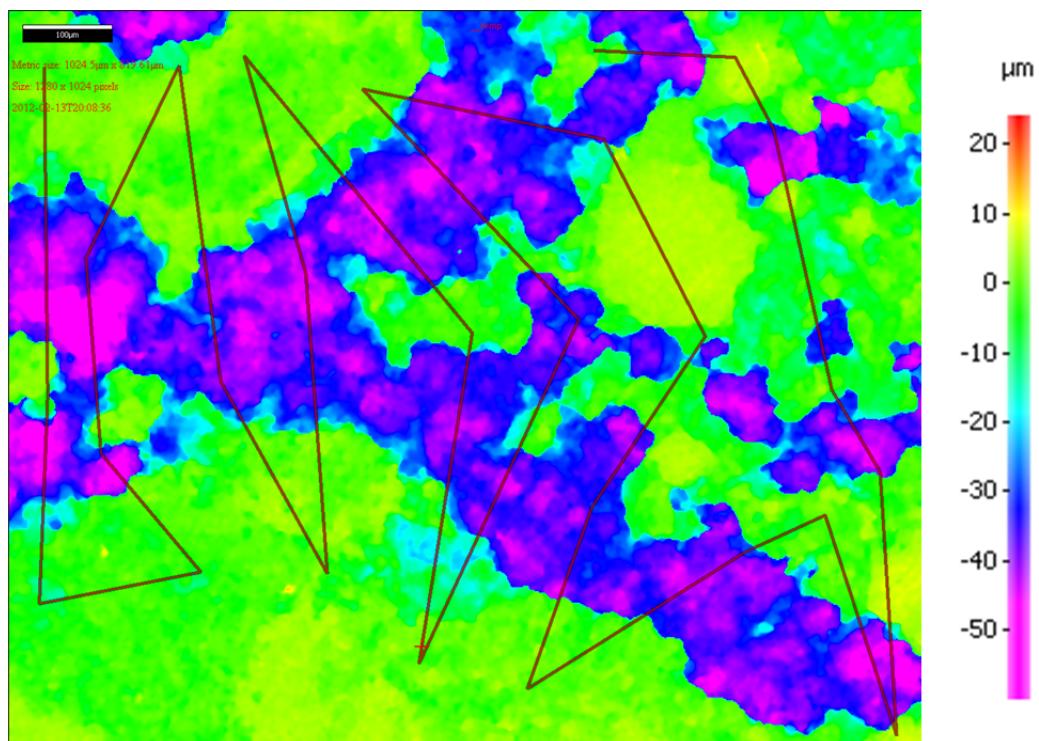
Figure 5.32 IFM scanning of the steel surface after 160 hours exposure at conditions 25°C, 1 wt% NaCl solution, pH 5.0, 2 mm sand deposit present after 70 ppm K1 addition.

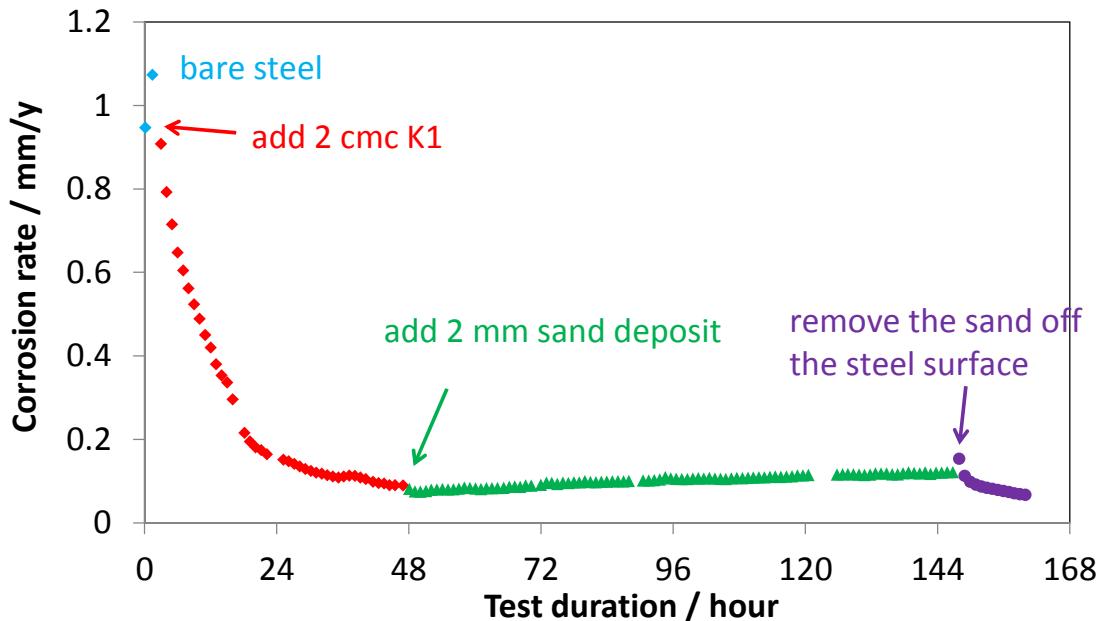
Figure 5.33 LPR corrosion rate over time at test conditions 25°C, 1 wt% NaCl solution, pH 5.0, 2 mm sand deposit present after 70 ppm K1 addition.

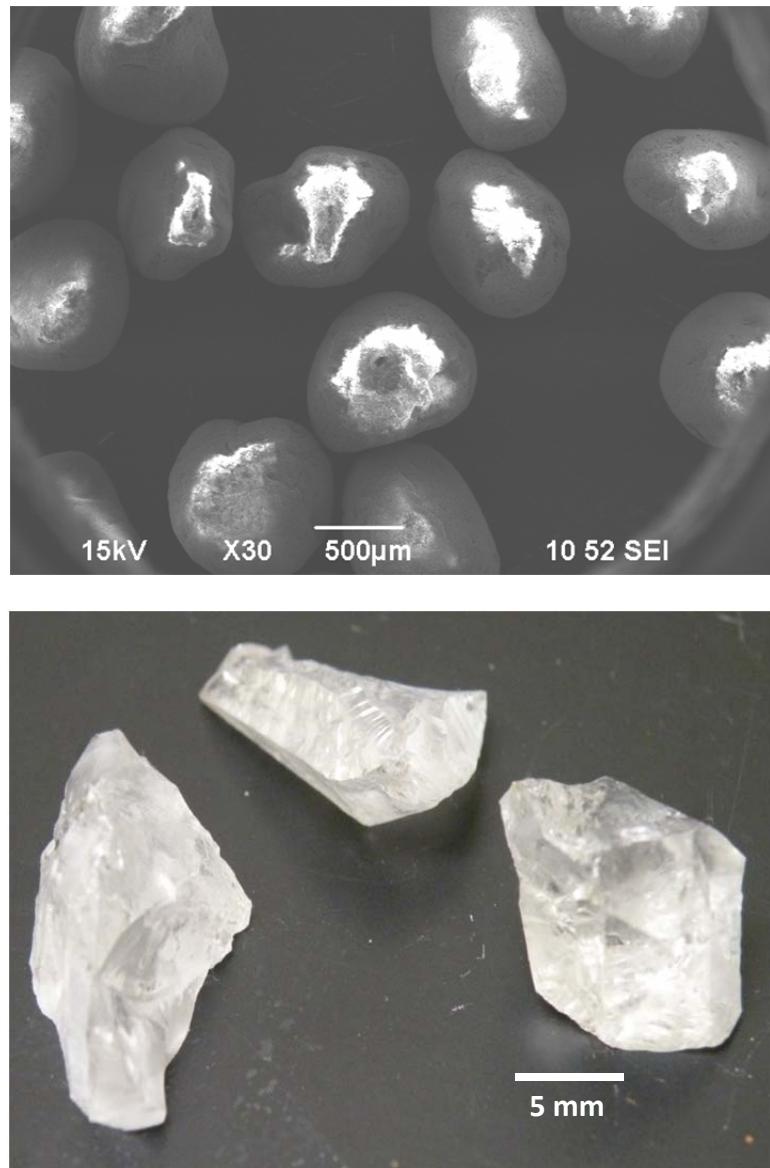
Figure 6.1 Deposit used for localized corrosion experiments: silica sand particles (750 μm), silica crystals (5 mm).

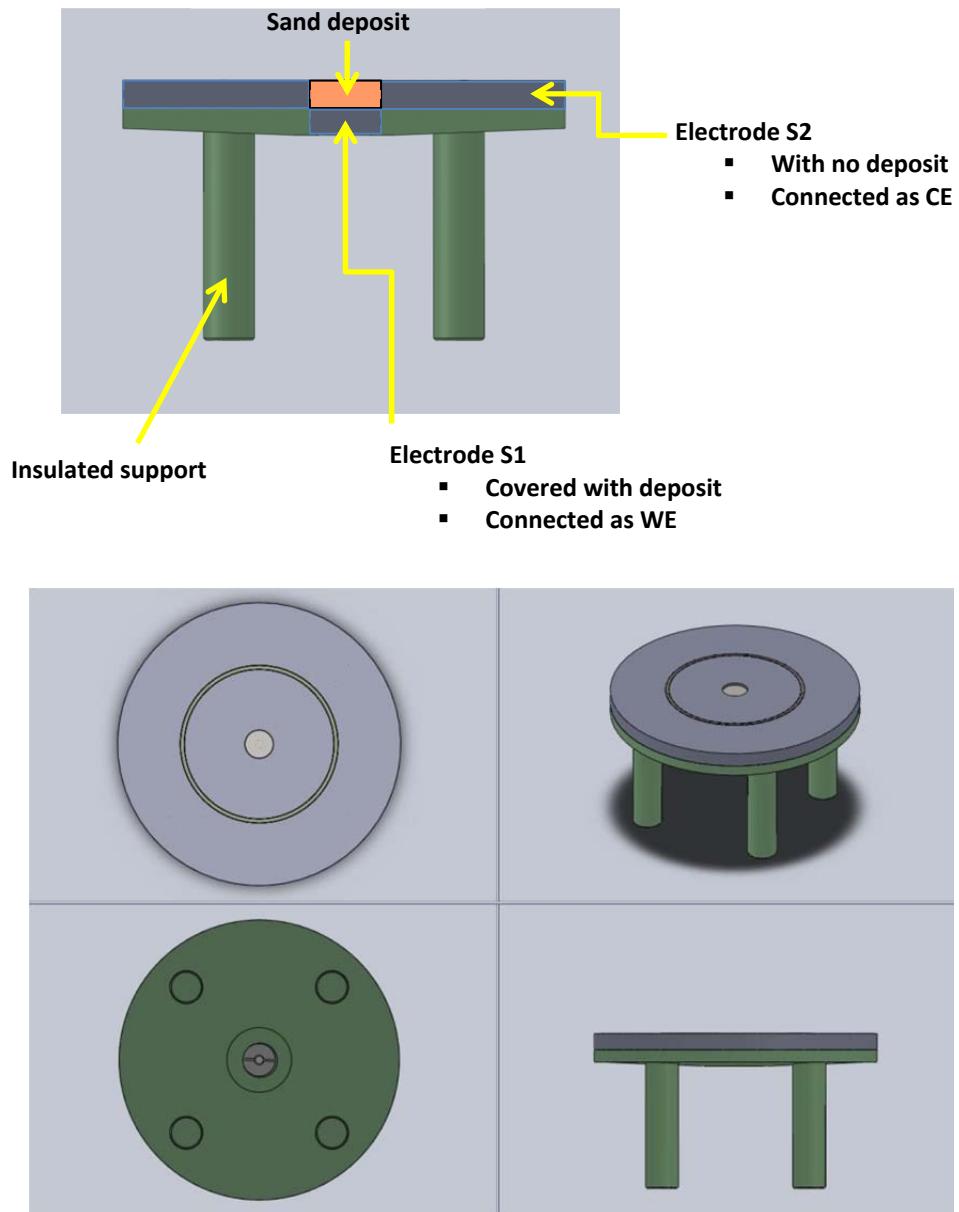
Figure 6.2 Galvanic-couple working electrode. The surface area ratio of the surrounding ring electrode to the central disc electrode is 60:1.

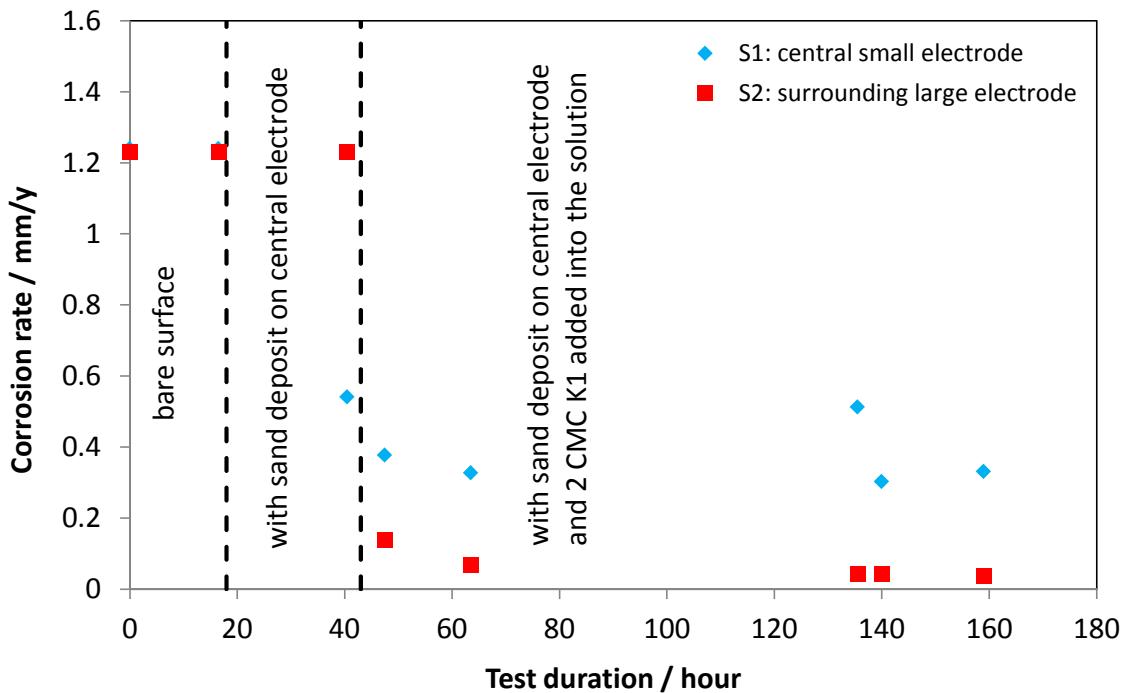
Figure 6.3 LPR corrosion rate (uncoupled) over time at test conditions 25°C, 1 wt% NaCl, pH 5.0. 2 mm sand deposit present only on the central small electrode S1 prior to 70 ppm K1 addition.

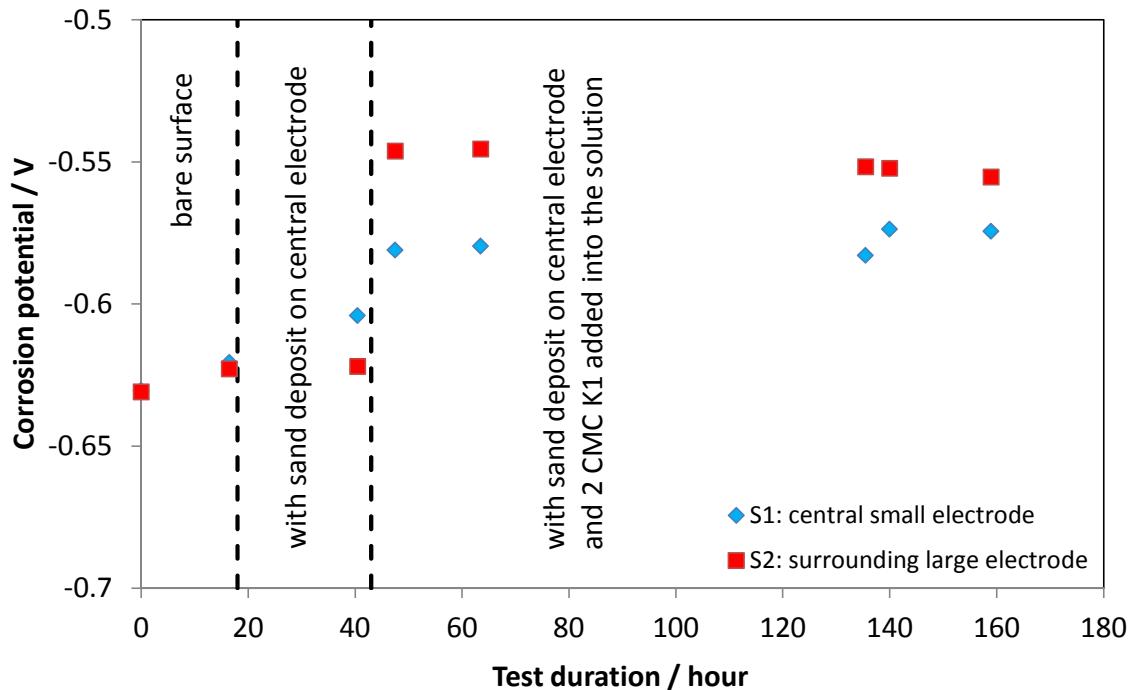
Figure 6.4 Corrosion potential vs. Ag/AgCl reference electrode (uncoupled) over time at test conditions 25°C, 1 wt% NaCl, pH 5.0. 2 mm sand deposit present only on the central small electrode S1 prior to 70 ppm K1 addition.

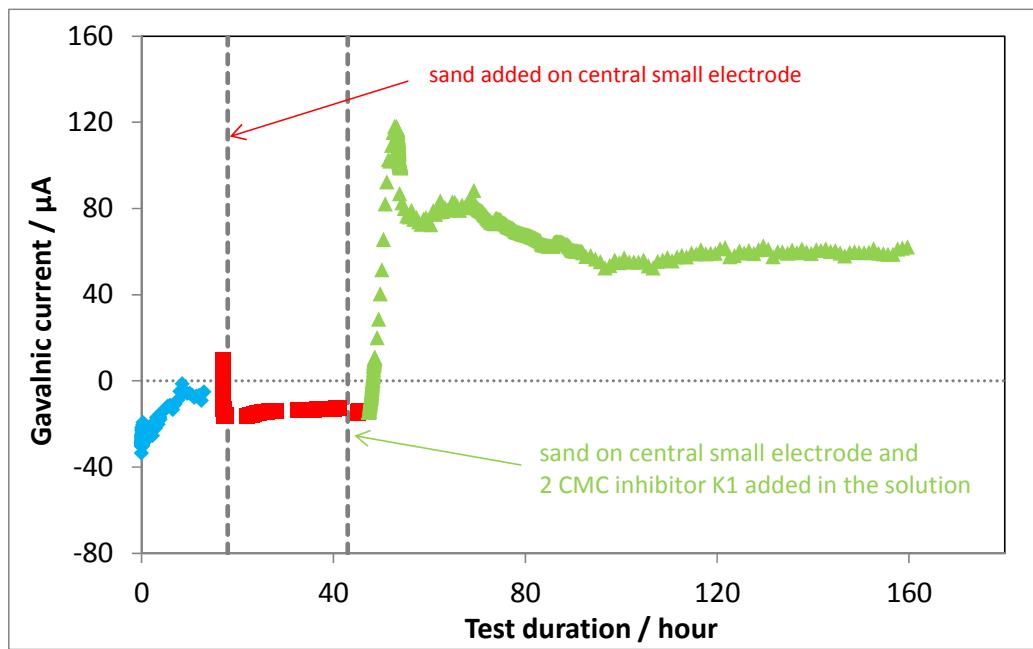
Figure 6.6 Galvanic current between the two electrodes coupled together over time at test conditions 25°C, 1 wt% NaCl, pH 5.0. A 2 mm sand deposit is present only on the central small electrode, S1, prior to 70 ppm K1 addition.

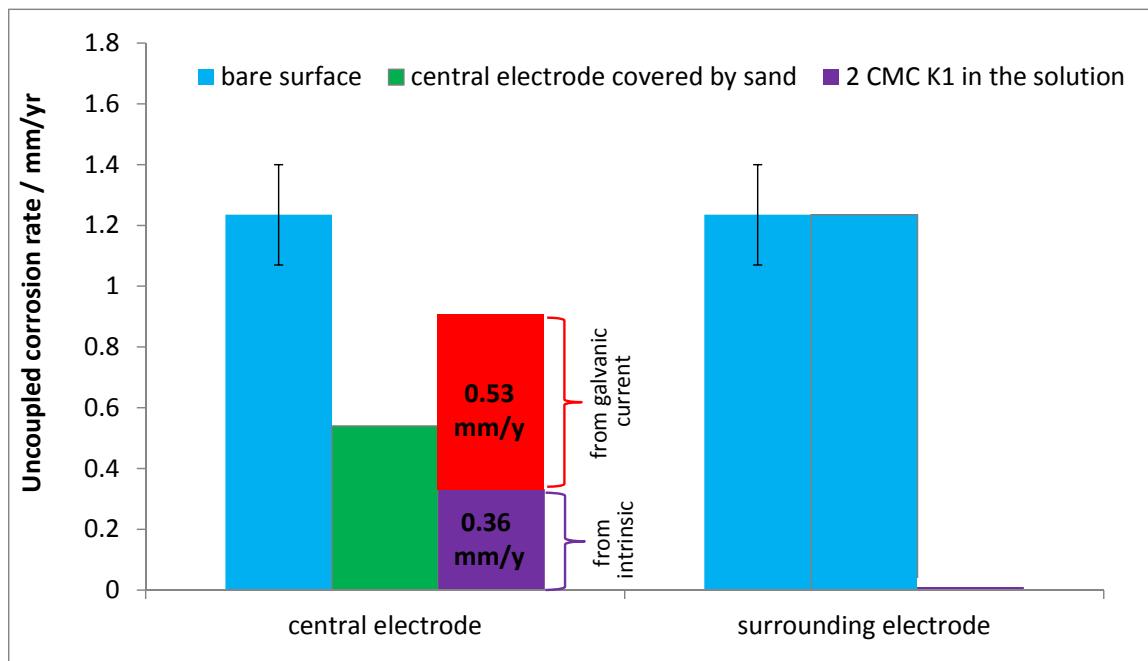
Figure 6.7 Galvanic effect on corrosion rate at test conditions 25°C, 1 wt% NaCl, pH 5.0.

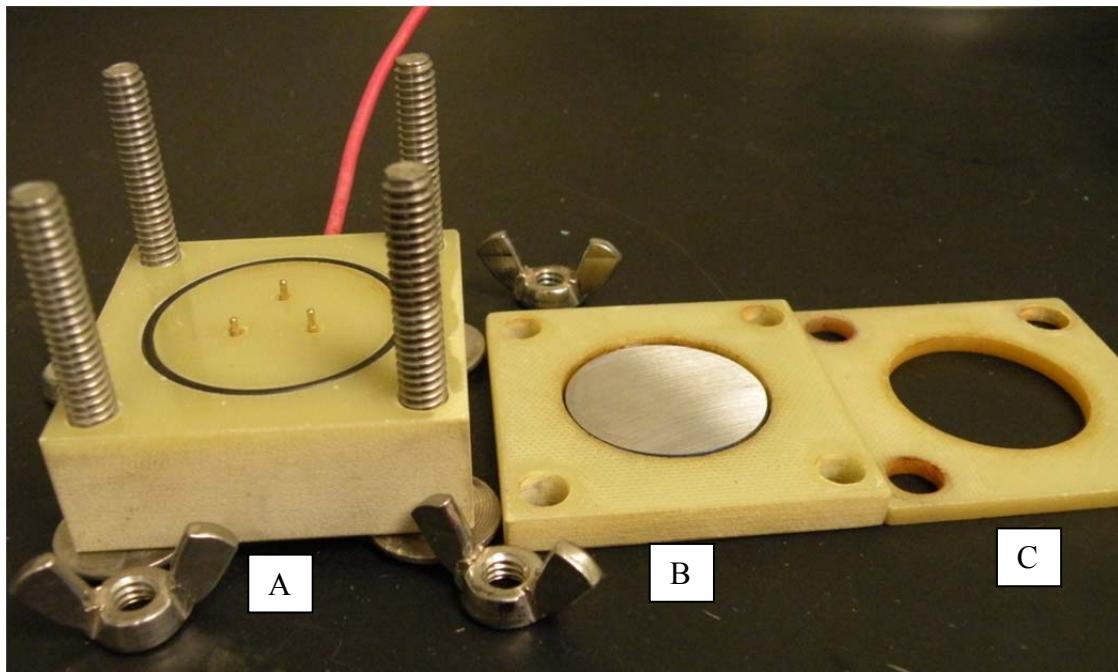
Figure 6.8 API 5L X65 mild steel specimen holder: (A) base, with three gold contacts to connect the steel specimen and wire for electrochemical measurement; (B) steel sample holder, where steel specimen is installed; (C) sand holder, fill up to 2 mm sand deposit.

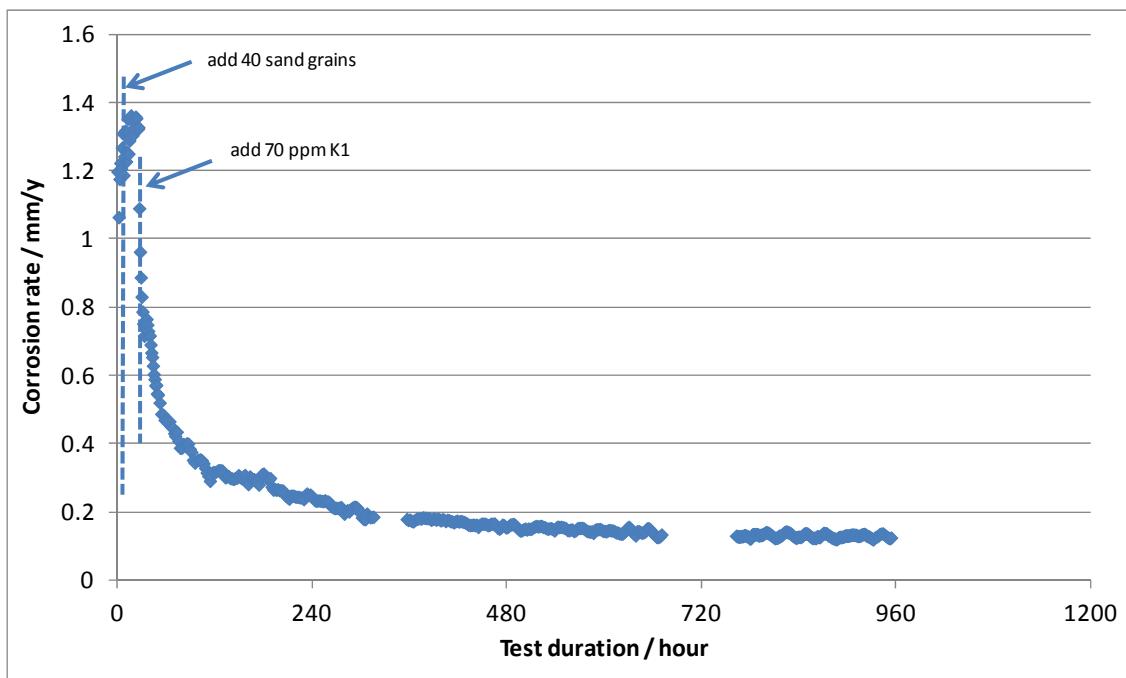
Figure 6.9 LPR corrosion rate over time at test conditions 25°C, pH 5, 1 wt% NaCl solution saturated with CO₂. About 40 grains of sand particles present prior to 70 ppm K1 addition.

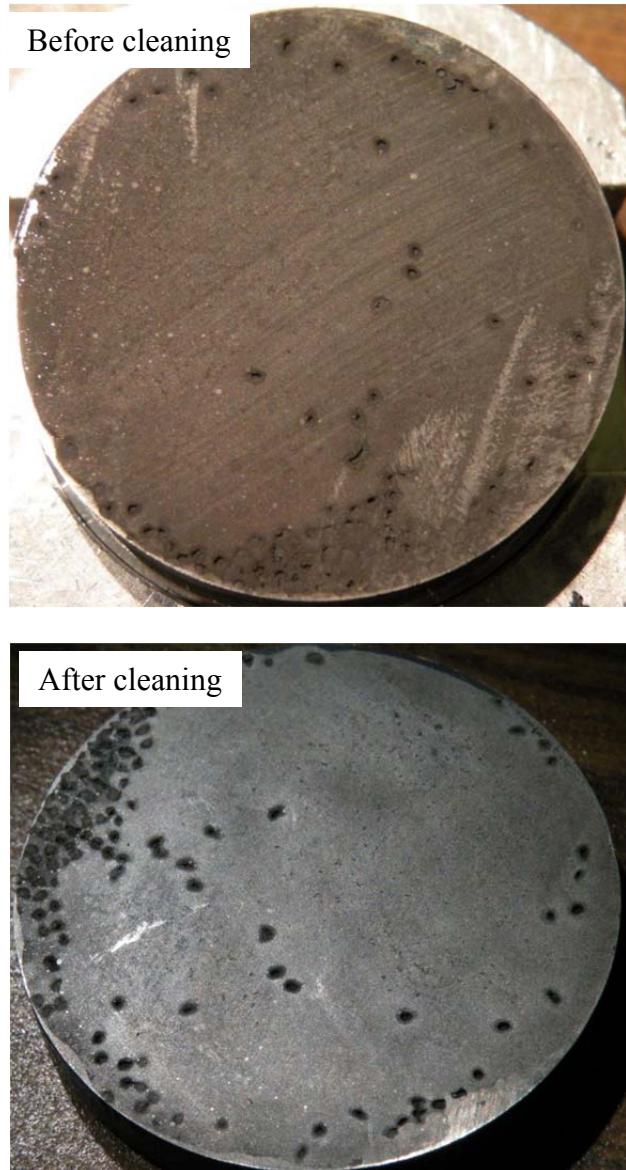
Figure 6.10 View of the steel surface showing a lot of pits after 40 days exposure at conditions 25°C, pH 5, 1 wt% NaCl solution saturated with CO₂.

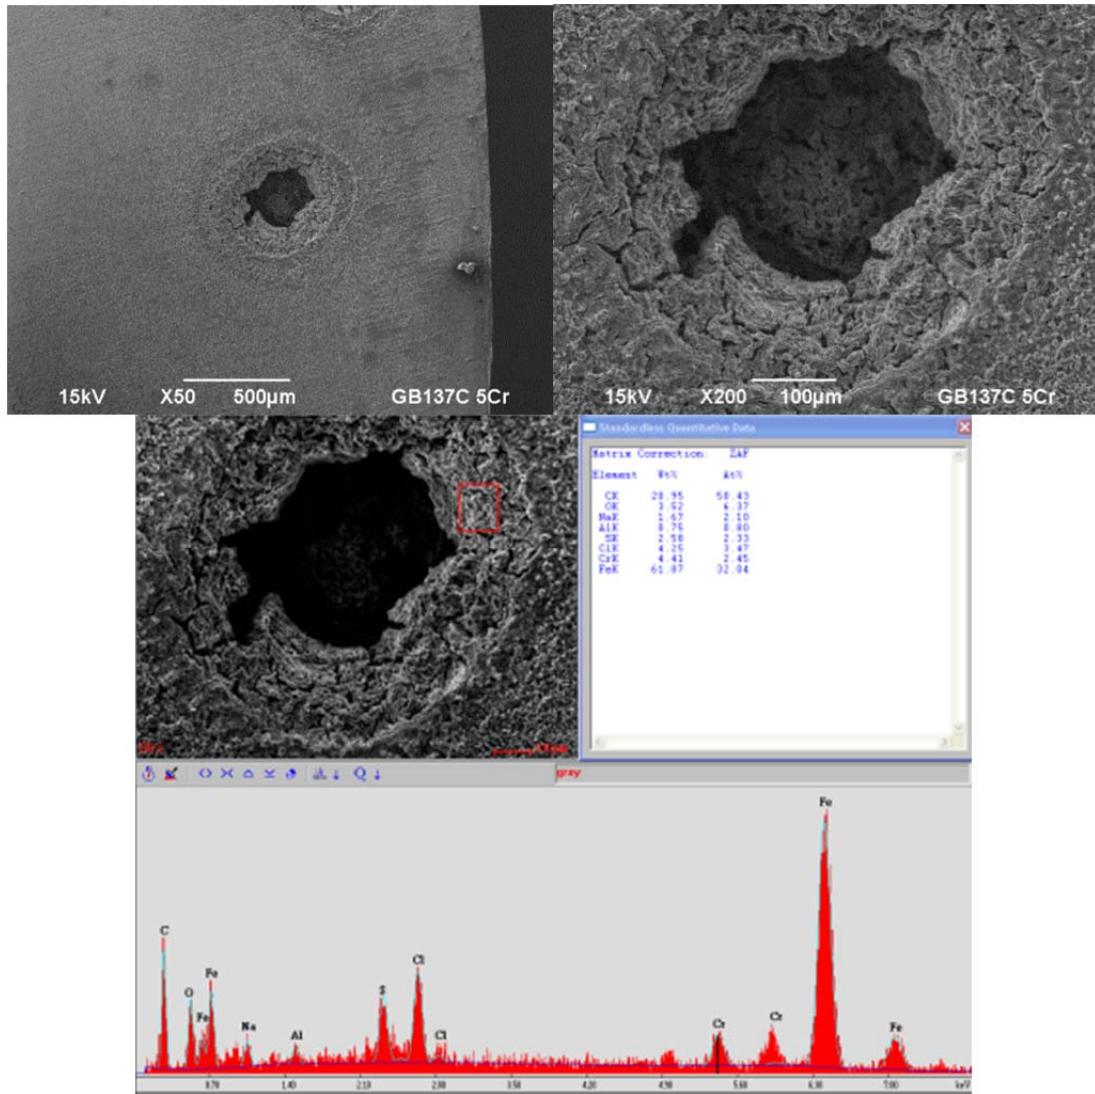
Figure 6.11 SEM and EDS images of the steel surface with corrosion product layers after 40 days exposure at conditions 25°C, pH 5, 1 wt% NaCl solution saturated with CO₂.

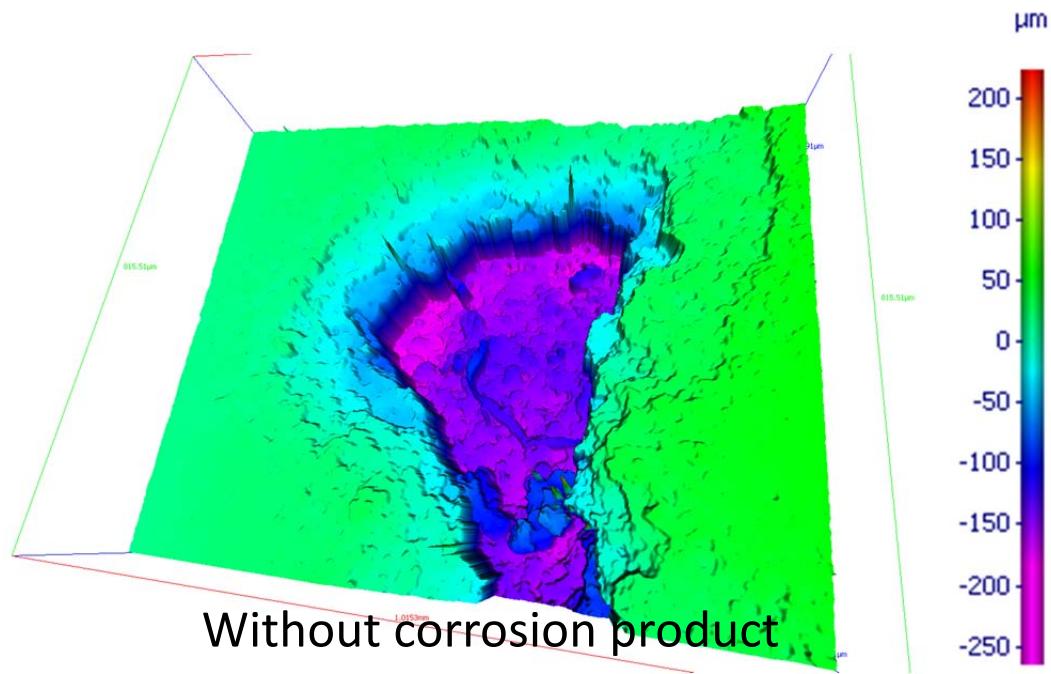
Figure 6.12 Prolifometer image of one of the pits found on the steel surface after 40 days exposure at conditions 25°C, pH 5, 1 wt% NaCl solution saturated with CO₂.

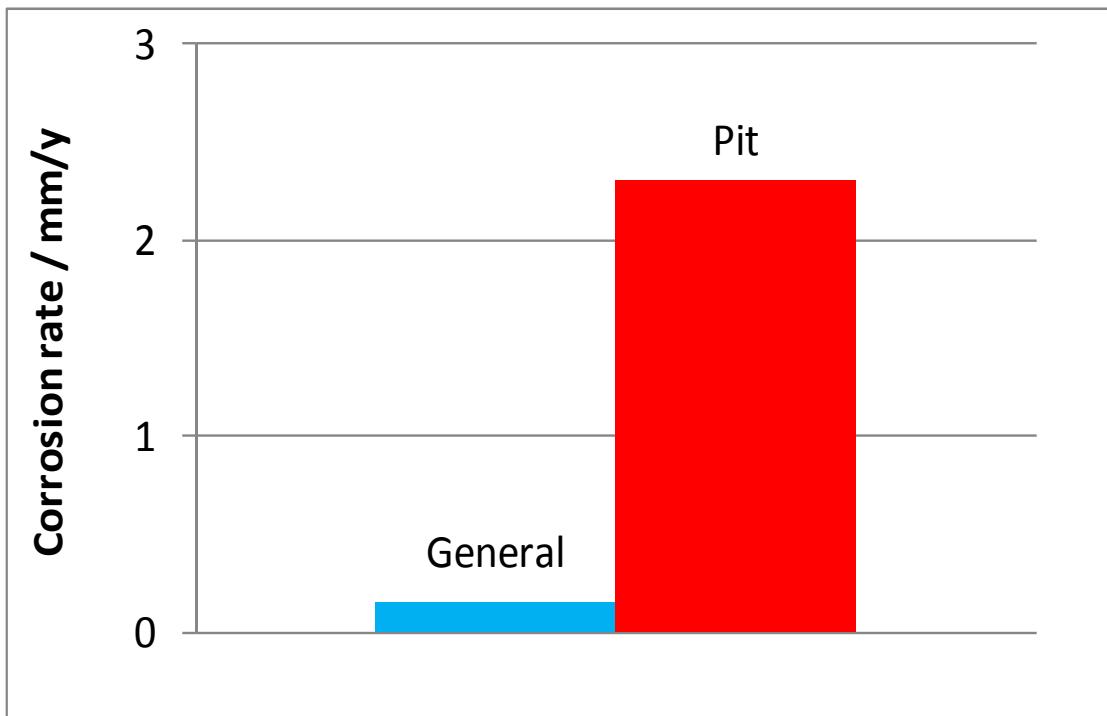
Figure 6.13 Comparison of pitting rate and surface averaged corrosion rate obtained from LPR after 40 days exposure at conditions 25°C, pH 5, 1 wt% NaCl solution saturated with CO₂.

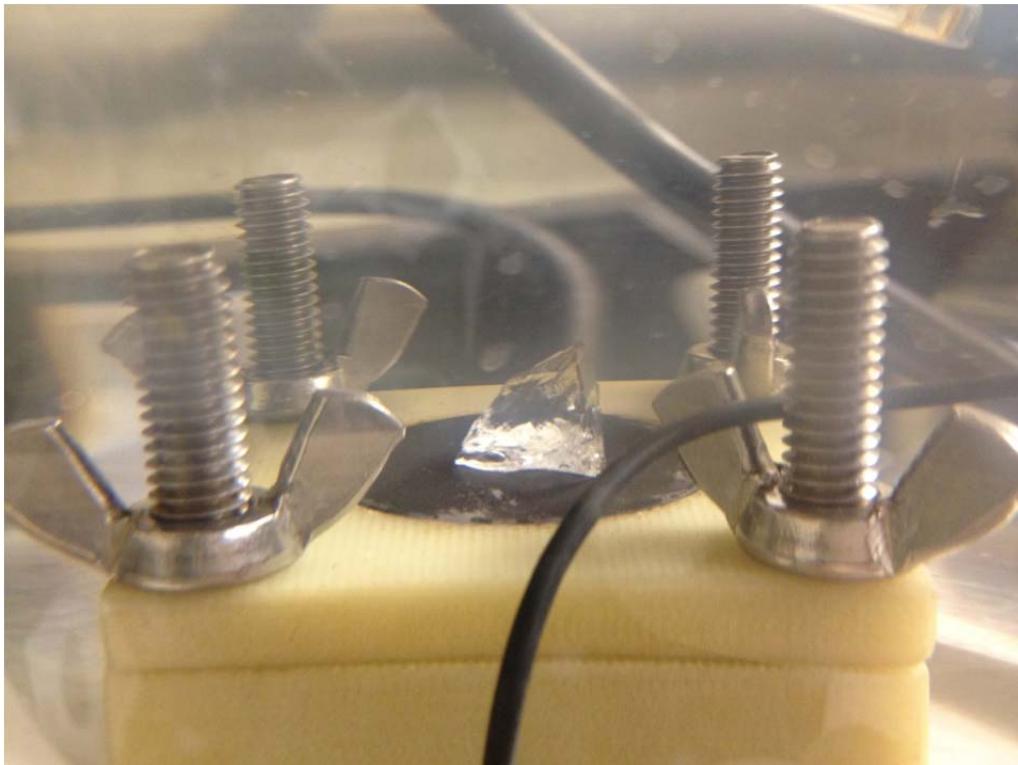
Figure 6.14 View of one big crystal sitting on the steel surface at test conditions 25°C,
pH 5, 1 wt% NaCl solution saturated with CO₂.

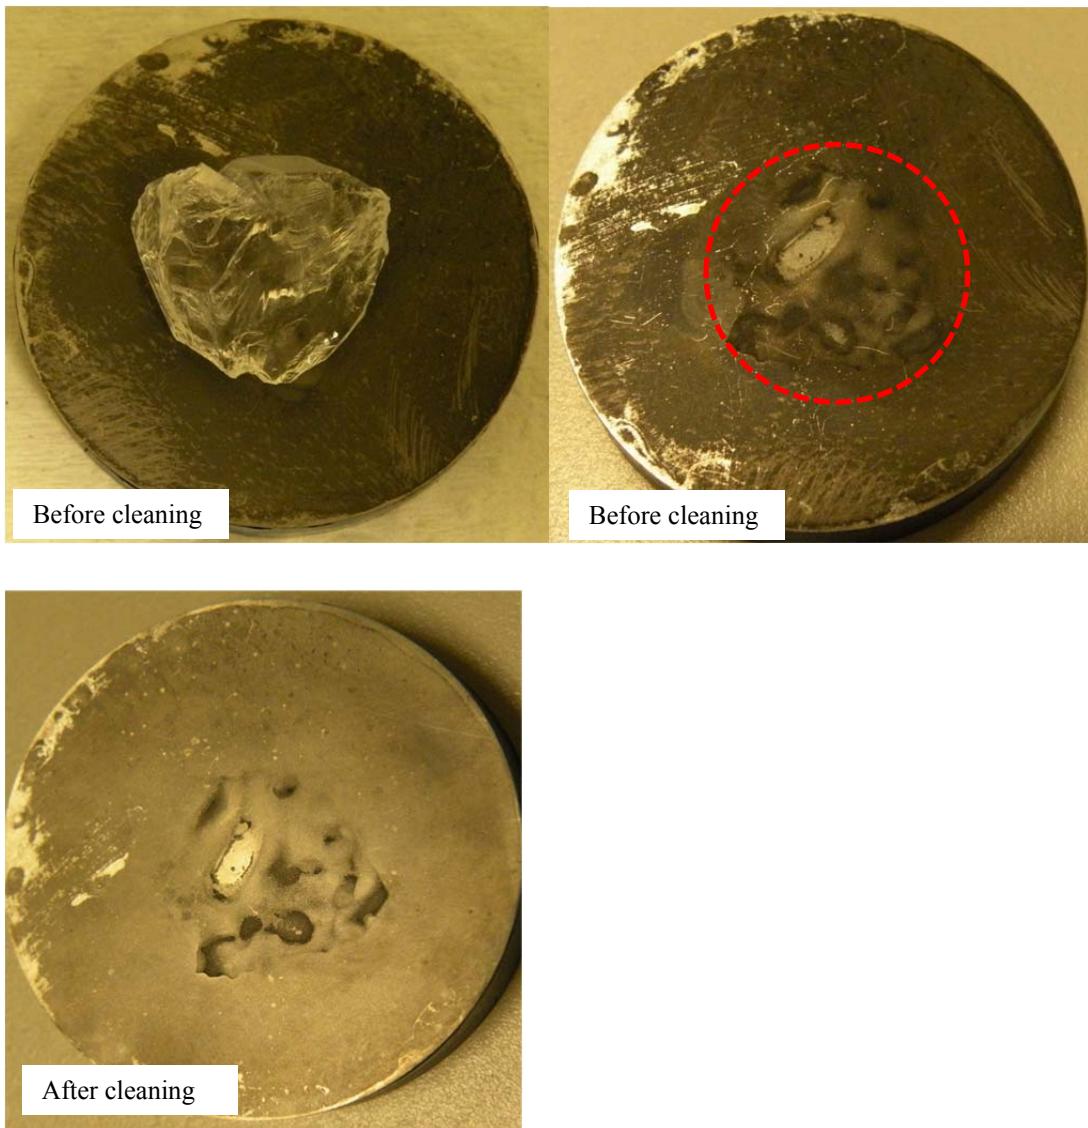
Figure 6.15 View of the steel surface after 9 days exposure at test conditions 25°C, pH 5,

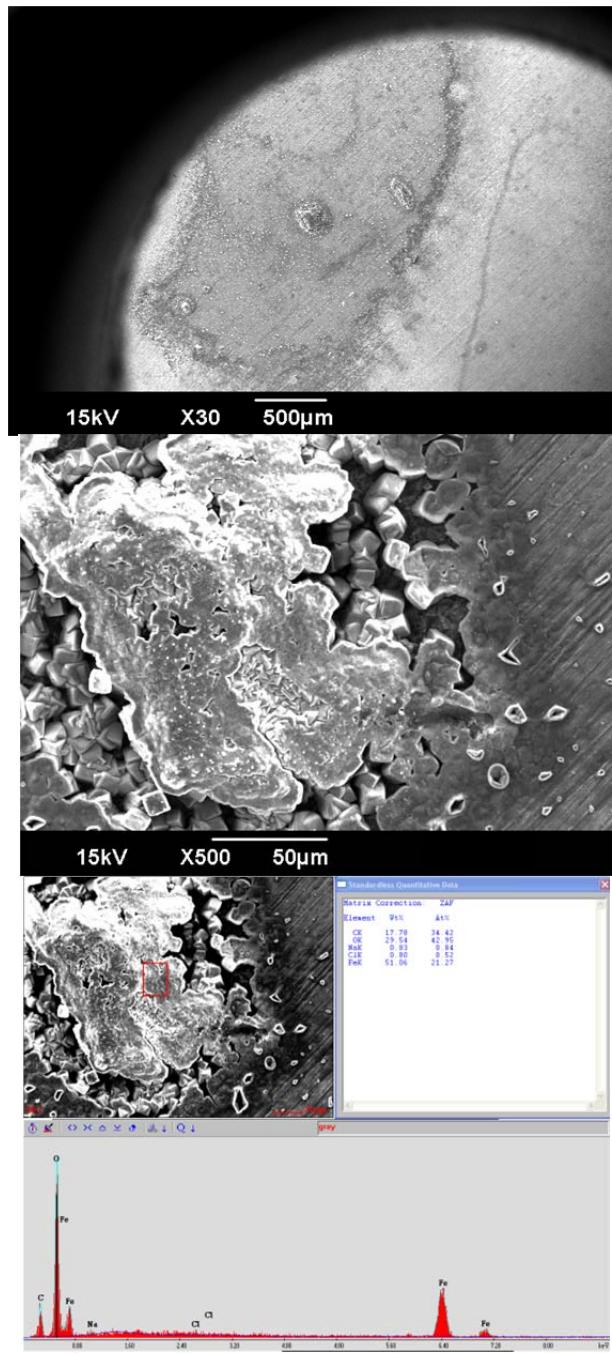
Figure 6.16 SEM and EDX images of the steel surface with corrosion product layers after 9 days exposure at test conditions 25°C, pH 5, 1 wt% NaCl solution saturated with CO₂.

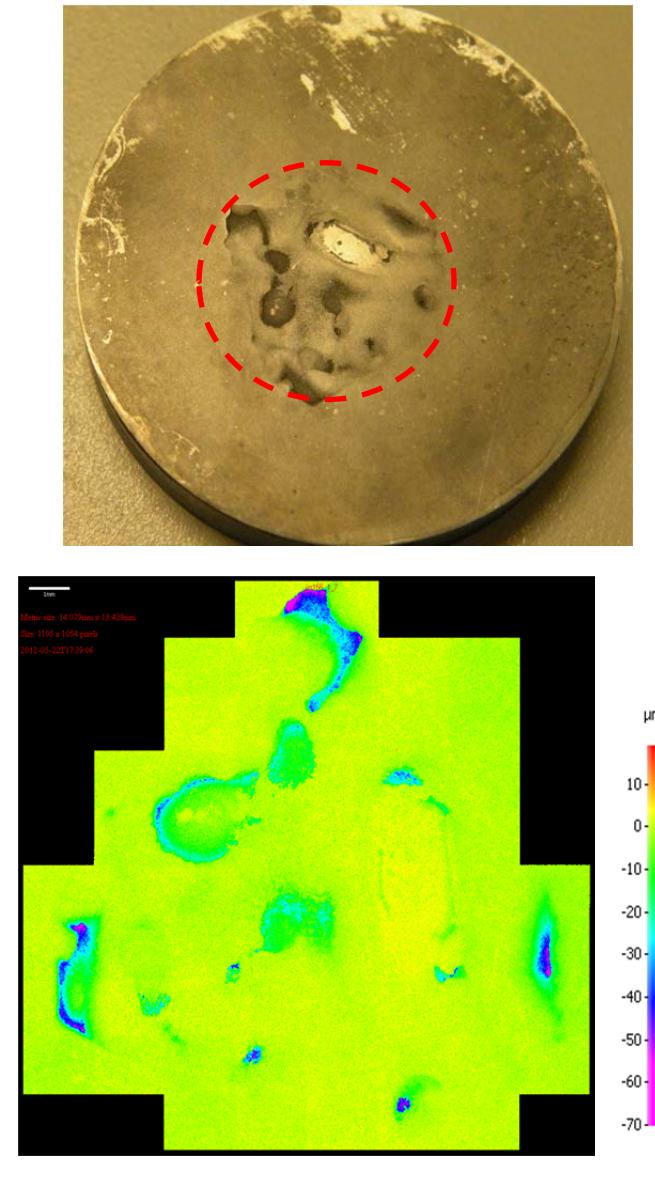
Figure 6.17 Infinite focusing microscopy Image of the steel surface after 9 days exposure and corrosion product layer removed at test conditions: 25°C, pH 5, 1 wt% NaCl solution saturated with CO₂.

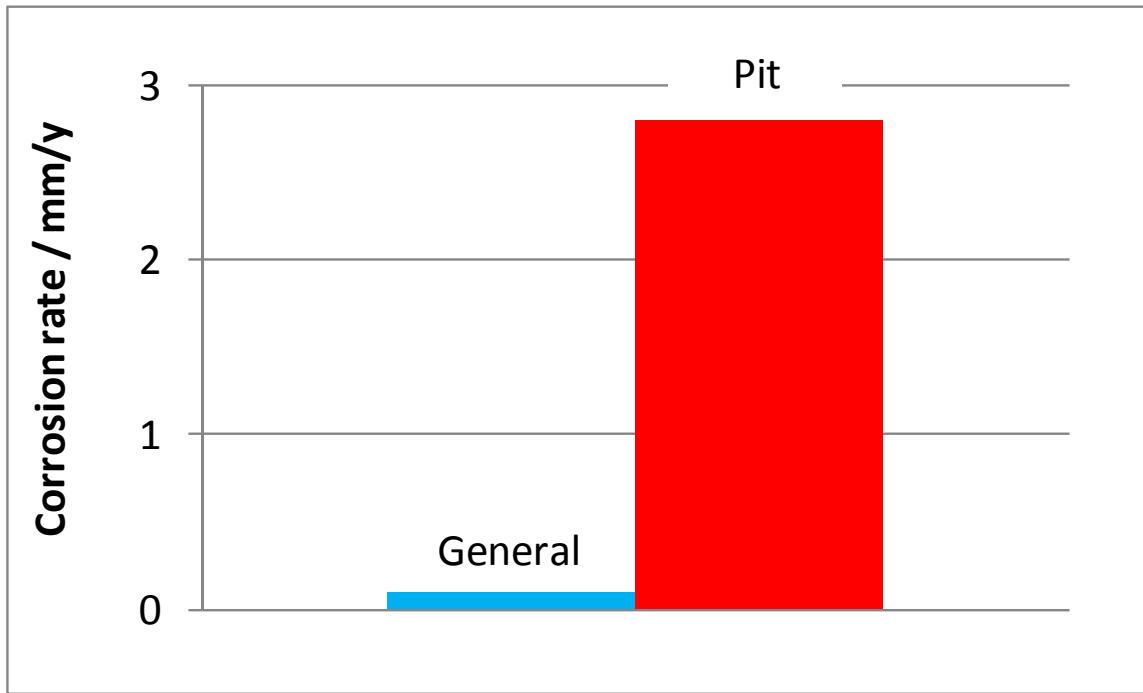
Figure 6.18 Comparison of the pitting rate and surface averaged corrosion rate obtained from weight loss after 9 days exposure at test conditions 25°C, pH 5, 1 wt% NaCl solution saturated with CO₂.

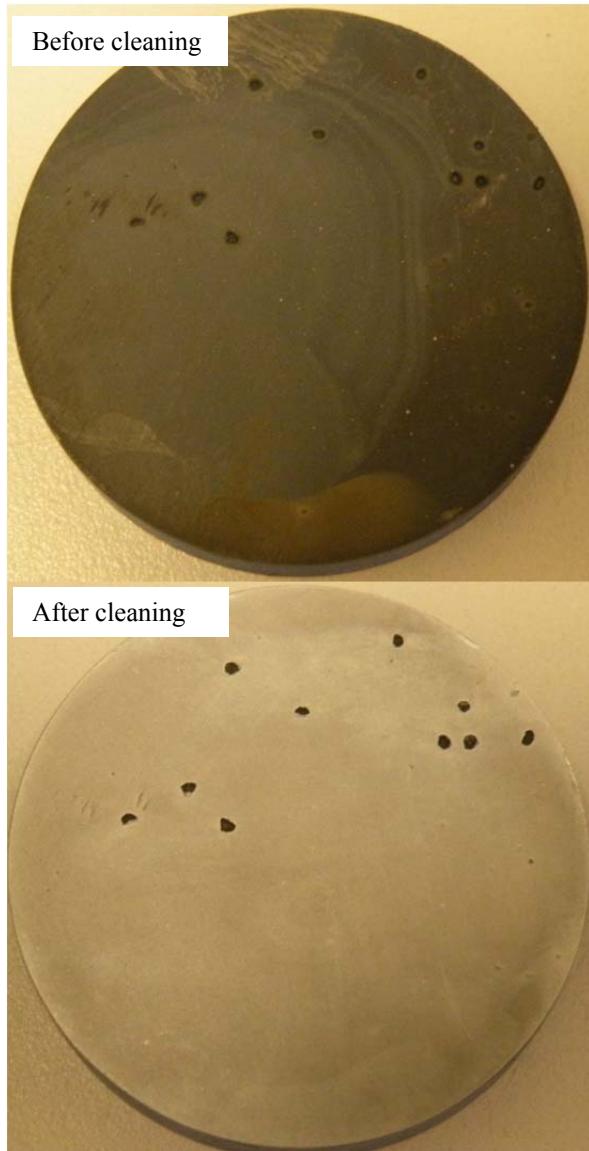
Figure 6.19 View of the experiment sample #1 after 25 days exposure with corrosion product layers and without corrosion product layers at test conditions 25°C, pH 5, 1 wt% NaCl solution saturated with CO₂.

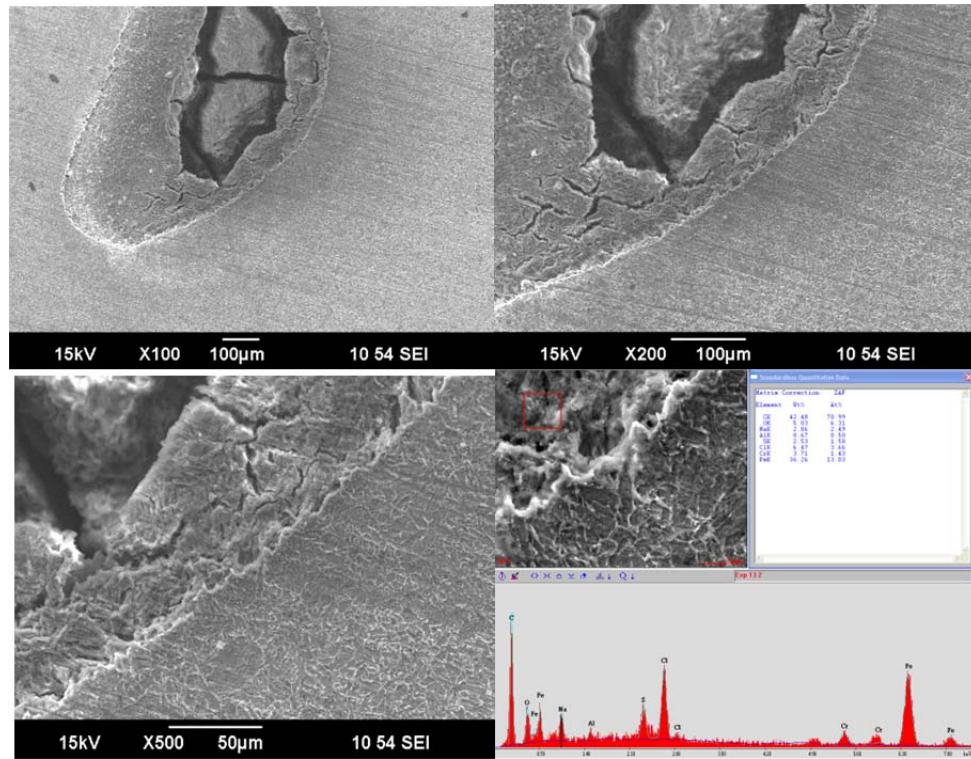
Figure 6.20 SEM and EDS images of the experiment sample #1 with corrosion product layers after 25 days exposure at test conditions 25°C, pH 5, 1 wt% NaCl solution saturated with CO₂.
