Mechanistic Study of Under Deposit Corrosion of Mild Steel in Aqueous Carbon Dioxide
Solution

A dissertation presented to
the faculty of
the Russ College of Engineering and Technology of Ohio University

In partial fulfillment
of the requirements for the degree
Doctor of Philosophy

Jin Huang

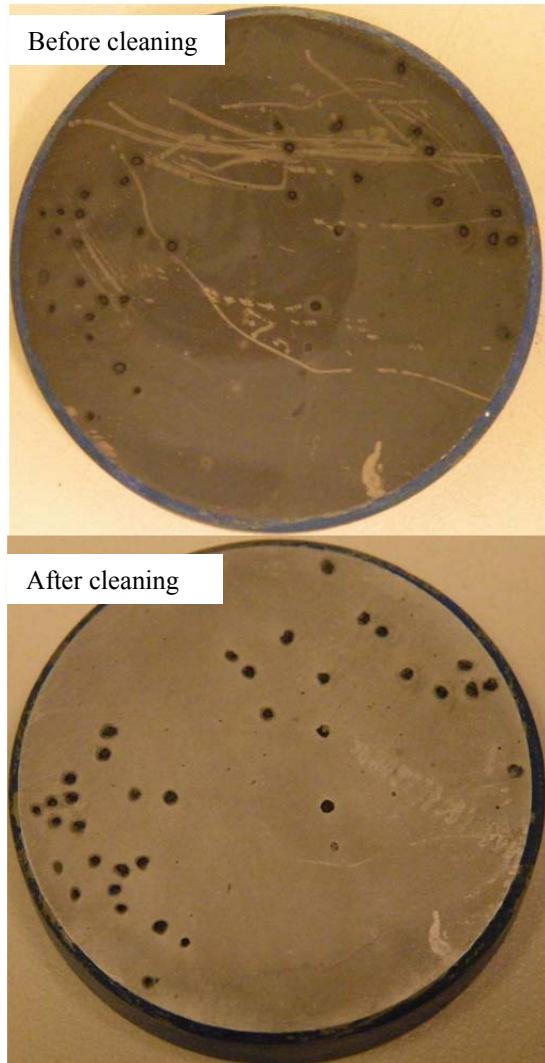
Figure 6.24 Views of the experiment sample #2 after 34 days exposure with corrosion product layers (left) and without corrosion product layers (right) at test conditions 25°C, pH 5, 1 wt% NaCl solution saturated with CO₂.

Figure 6.24 shows the view of specimen #2 which was left in the corrosion cell for 9 more days than specimen #1 with the sand particles removed from it. Pits can also be observed on the steel surface as expected. The SEM image of the pits before corrosion product removal is shown in Figure 6.25. No significant difference of the pit morphology can be distinguished between specimen #1 and #2. The deepest part of the pit was measured at $210 \mu\text{m} \pm 30 \mu\text{m}$ (Figure 6.26), corresponding to a pit penetration rate of $2.3 \pm 0.3 \text{ mm/yr}$. As compared to the uniform corrosion rate of 0.09 mm/yr , the localized corrosion is 25 times greater (Figure 6.27).

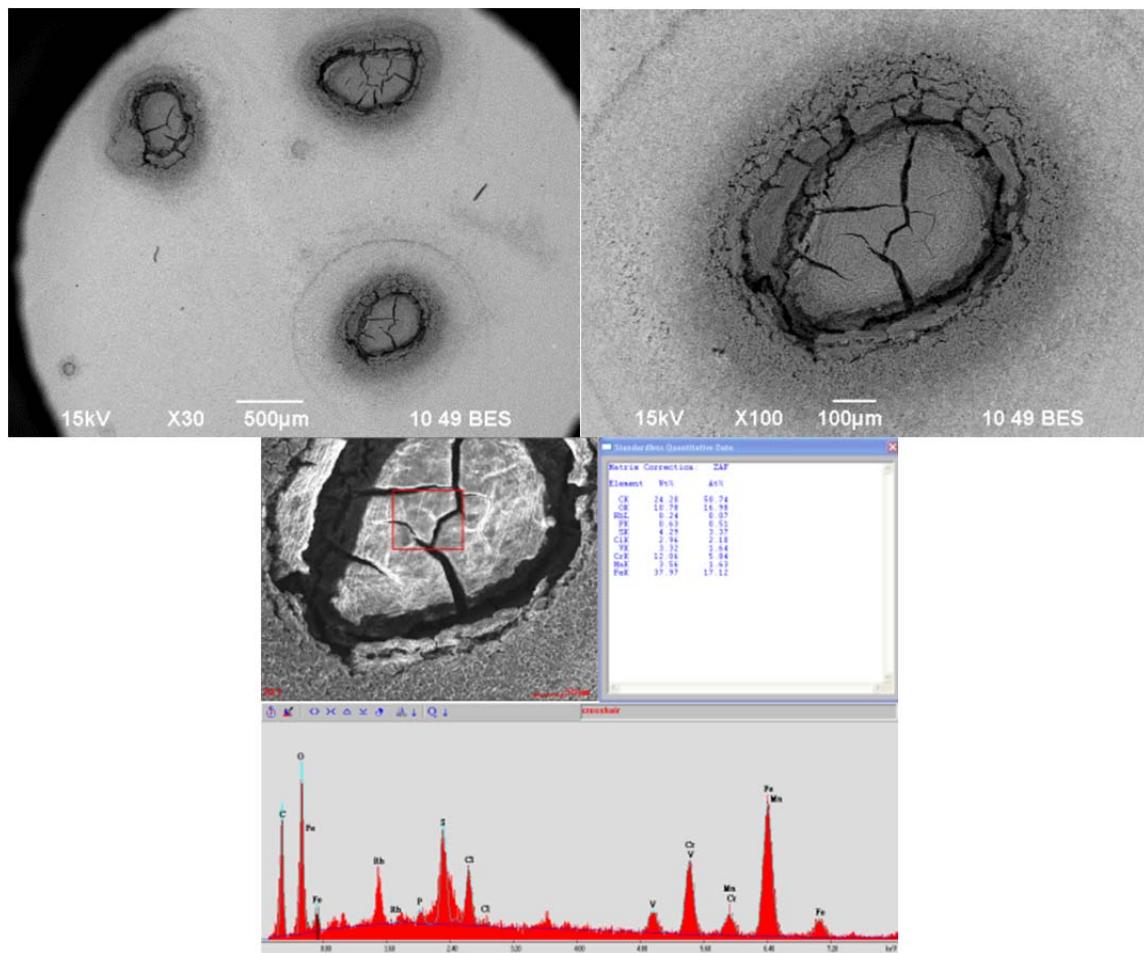
Figure 6.25. SEM and EDS images Pictures of the experiment sample #2 after 34 days exposure with corrosion product layers at test conditions 25°C, pH 5, 1 wt% NaCl solution saturated with CO₂.

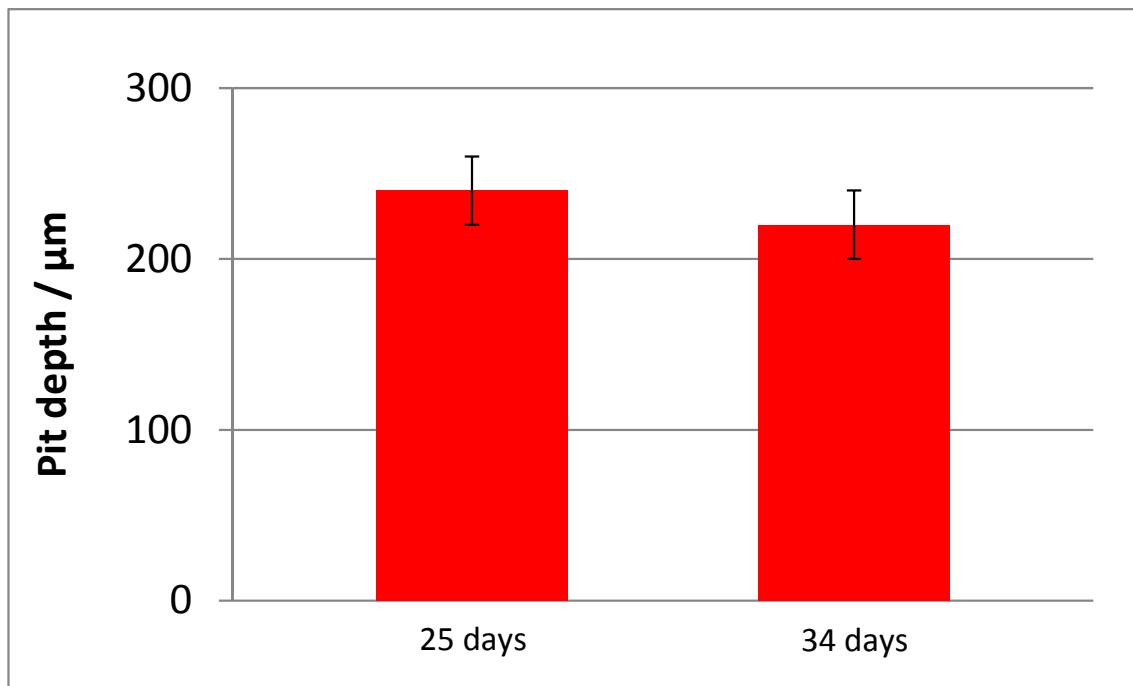
Figure 6.28 Comparison of the pit depth of sample #1 and #2. Test conditions are as described in 6.23, except that for sample #2 it corroded 9 more days with sand particles removed.

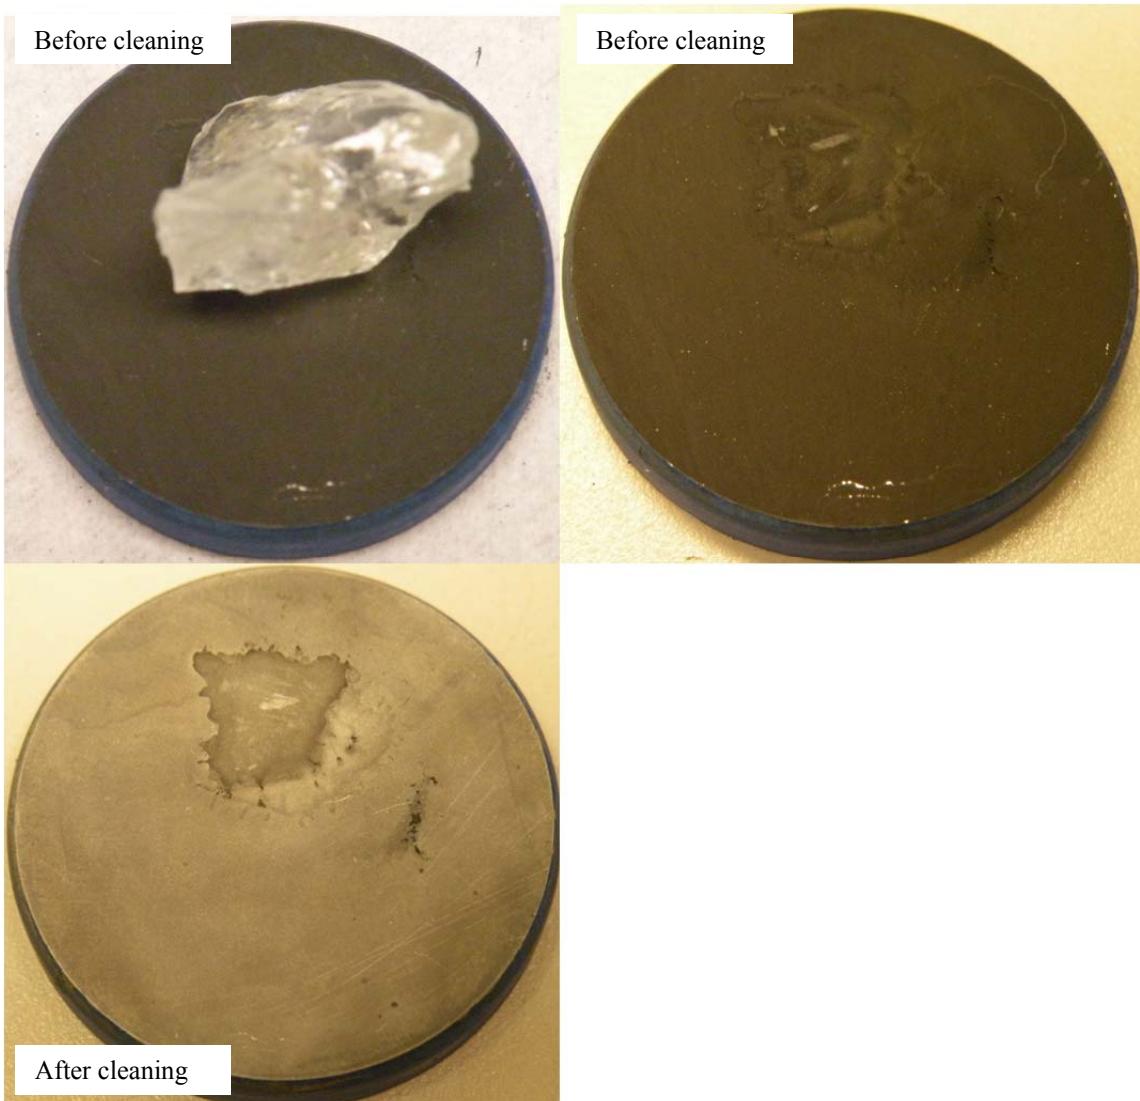
Figure 6.29 Views of the experiment sample #1 after 17 days exposure at test conditions

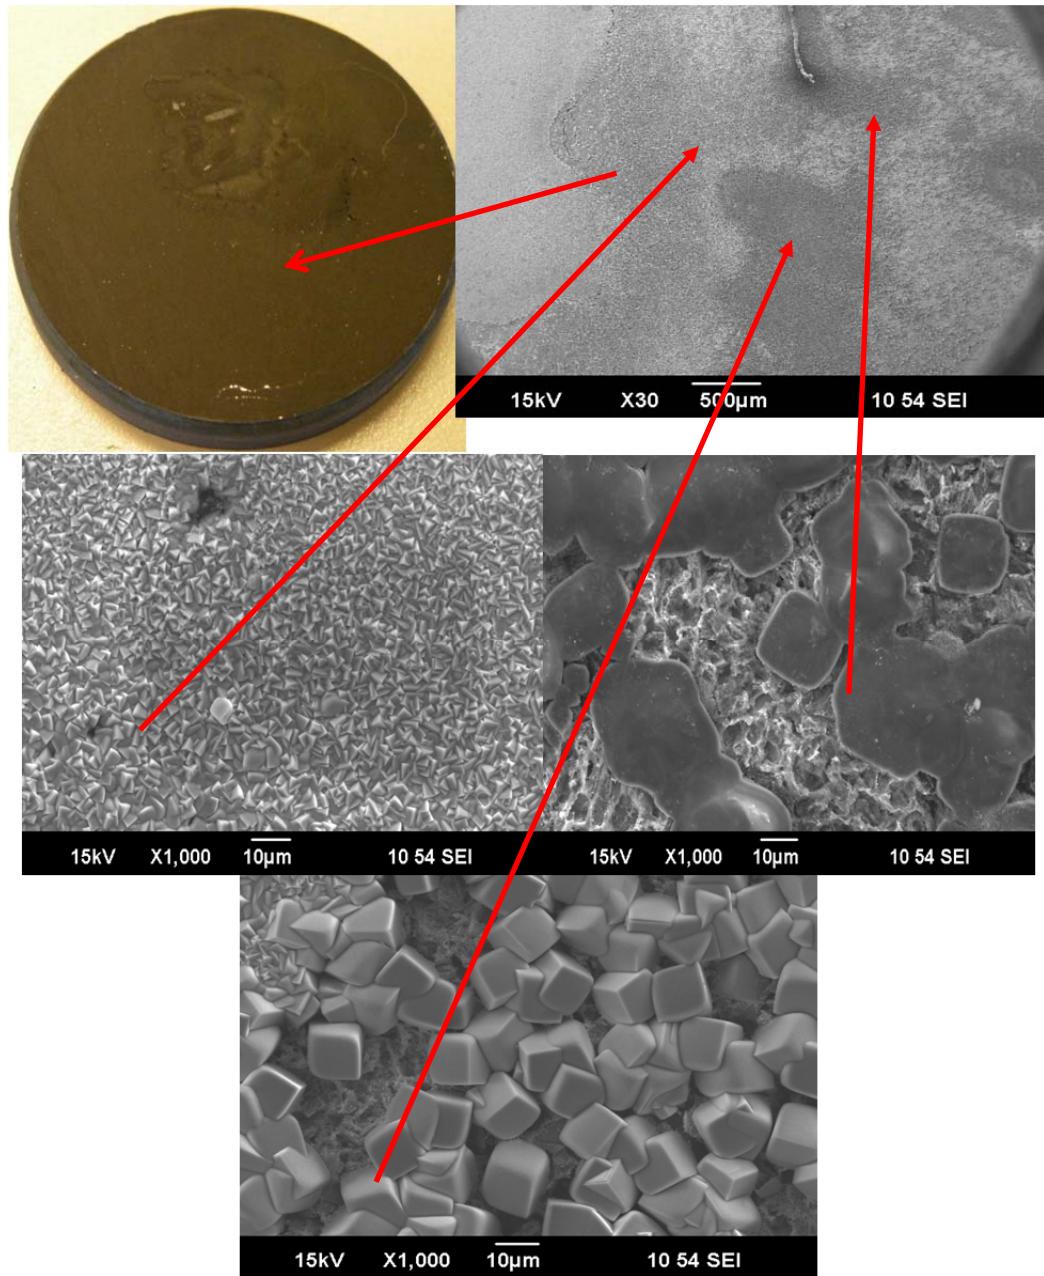
Figure 6.30 SEM images of the experiment sample #1 with corrosion product layers after 17 days exposure at test conditions 25°C, pH 5, 1 wt% NaCl solution saturated with CO₂.

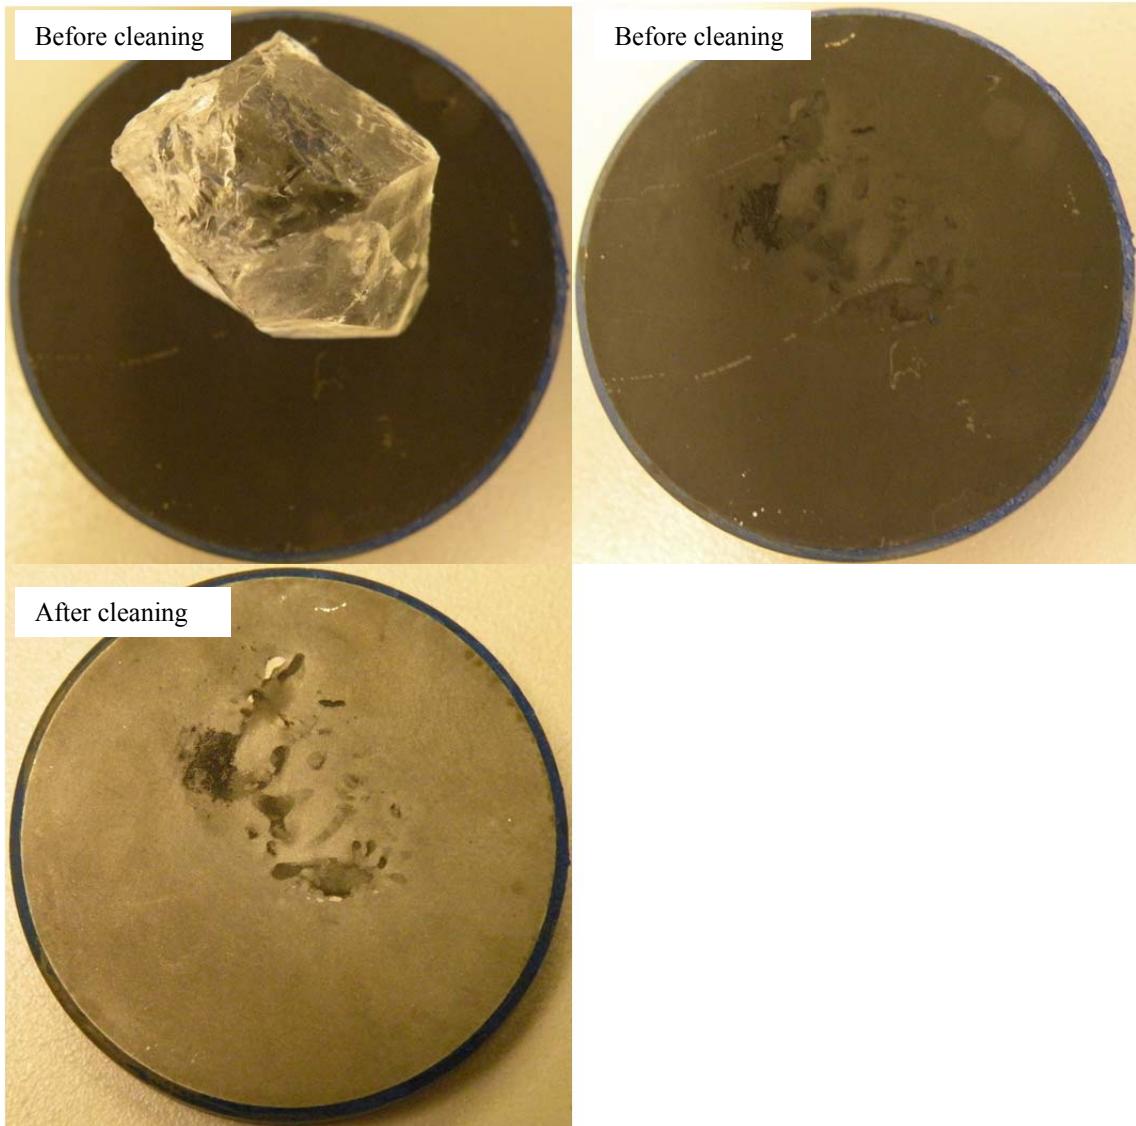
Figure 6.34 Views of the experiment sample #2 after 26 days exposure. For this sample, the first 17 days, it was under exactly the same condition as sample #1 as described in Figure 29, but the last 9 days, the sand particles were removed from the steel surface.

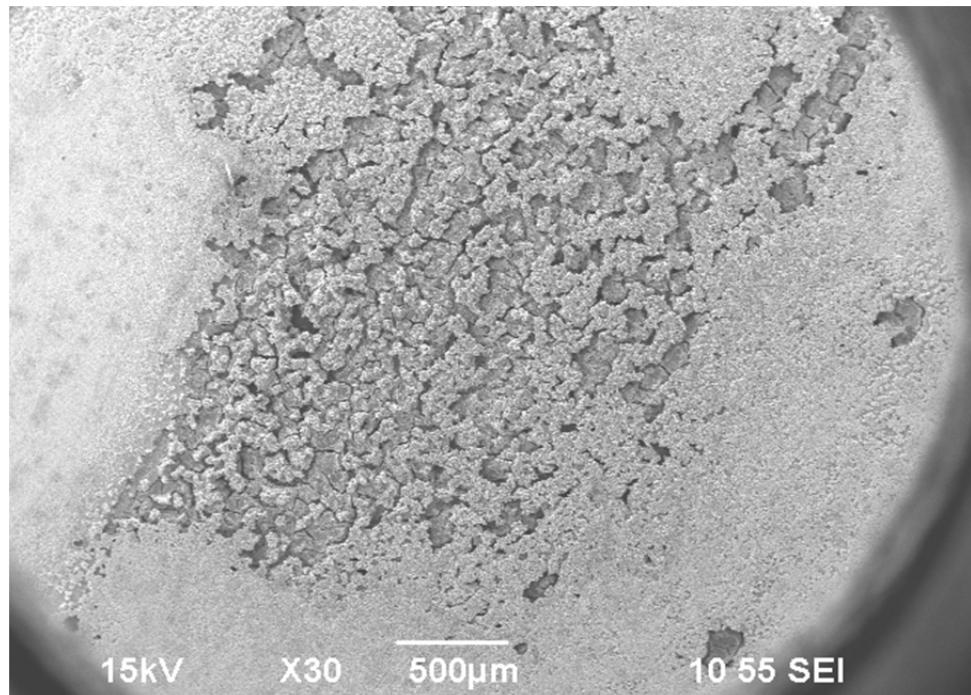
Figure 6.35 SEM images of the experiment sample #2 with corrosion product layers at test conditions 25°C, pH 5, 1 wt% NaCl solution saturated with CO_2 .

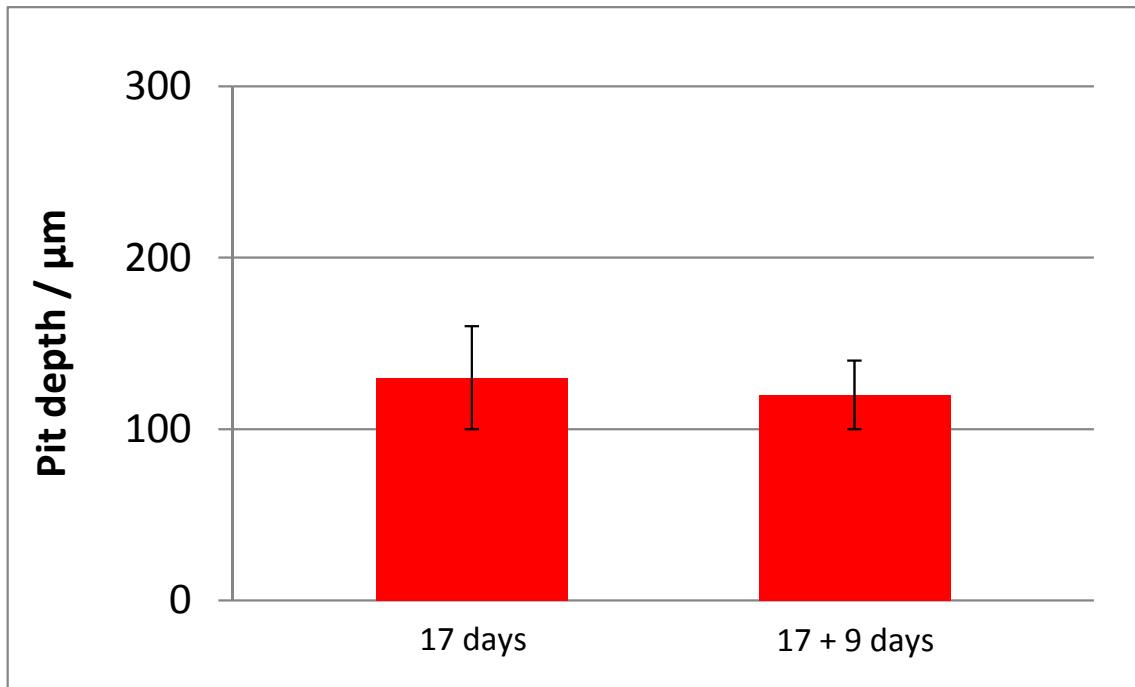
Figure 6.38 Comparison of the pit depth of sample #1 and #2 at test conditions 25°C, pH 5, 1 wt% NaCl solution saturated with CO₂.

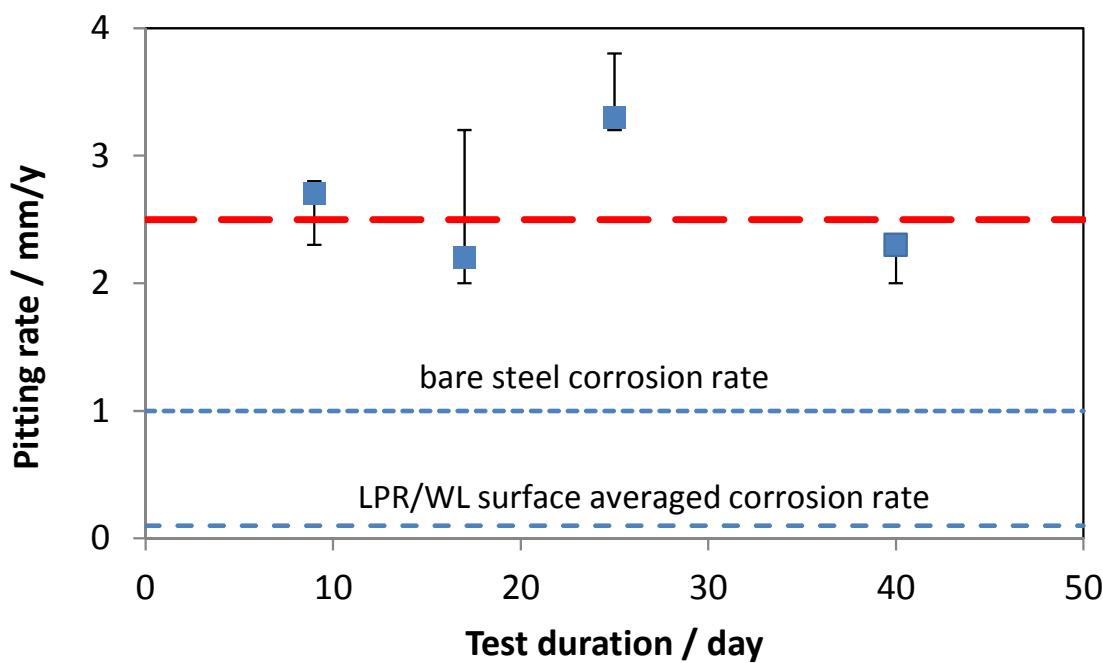
Figure 6.39 Comparison of pitting rate with bare steel corrosion rate and surface averaged corrosion rate from LPR/WL at test conditions 25°C, pH 5, 1 wt% NaCl solution saturated with CO₂.

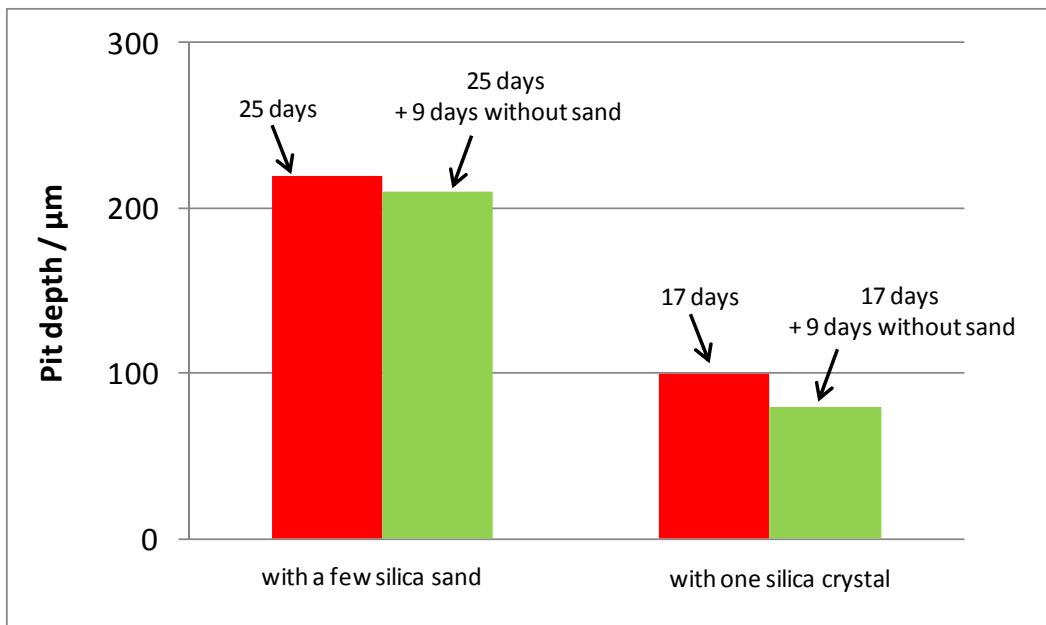
Figure 6.40 Change of pitting depth after silica sand or silica crystal was removed from the steel surface for experiments conducted at 25°C, pH 5, in a 1 wt% NaCl solution saturated with CO₂.

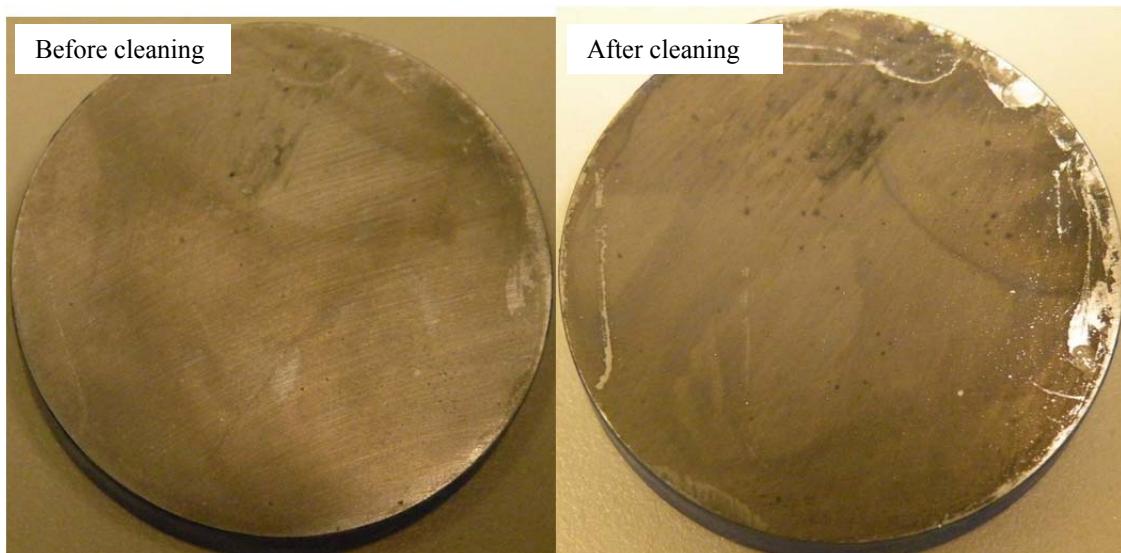
Figure 6.41 View of the experiment specimen after 14 days exposure at test conditions:
 25°C , pH 5, 1 wt% NaCl solution saturated with CO_2 .

for another 24 hours. Then sand particles were added to the specimens. The ferrous ion (Fe^{2+}) concentration was measured and recorded during the experiment for the average corrosion rate. Figure 6.41 shows the view of one of the specimens after removal from the glass cell, before and after removing the corrosion product. The trace of sand particles can still be seen on the sample surface. SEM scanning indicated local corrosion occurred only at the sand particle locations (Figure 6.42). After the corrosion product was removed, the steel surface was analyzed by infinite focusing microscopy which clearly shows that there were pits formed underneath the sand particles. The depths of those pits were $15 \pm 3 \mu\text{m}$ (Figure 6.43), which corresponded to a pit penetration rate of 0.2 mm/yr. This penetration rate value seems low, but it is 15 times greater than the 0.013 mm/yr uniform corrosion rate measured from weight loss, therefore it is still considered as localized corrosion.

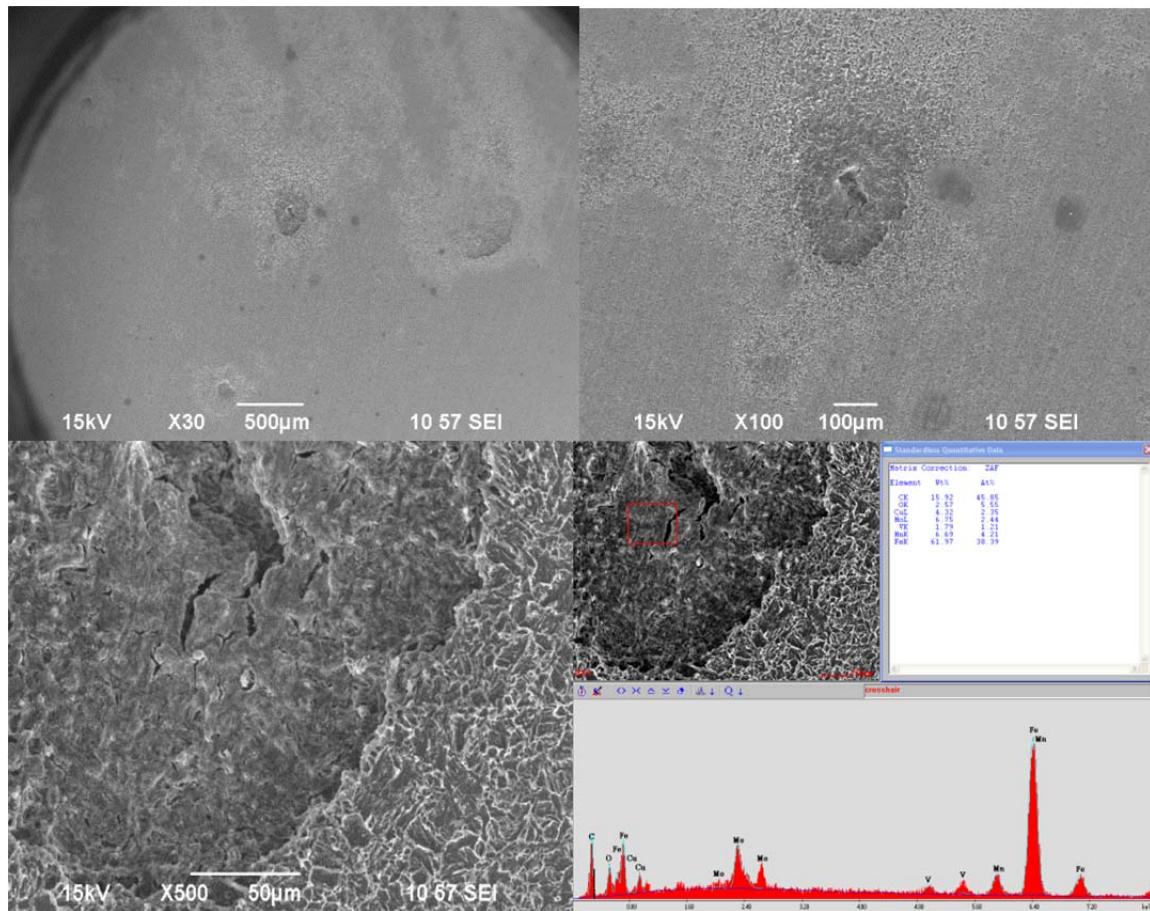
Figure 6.42 SEM and EDX images of the experiment sample #1 with corrosion product layers. Test conditions: 25°C, pH 5, 1 wt% NaCl solution saturated with CO₂.

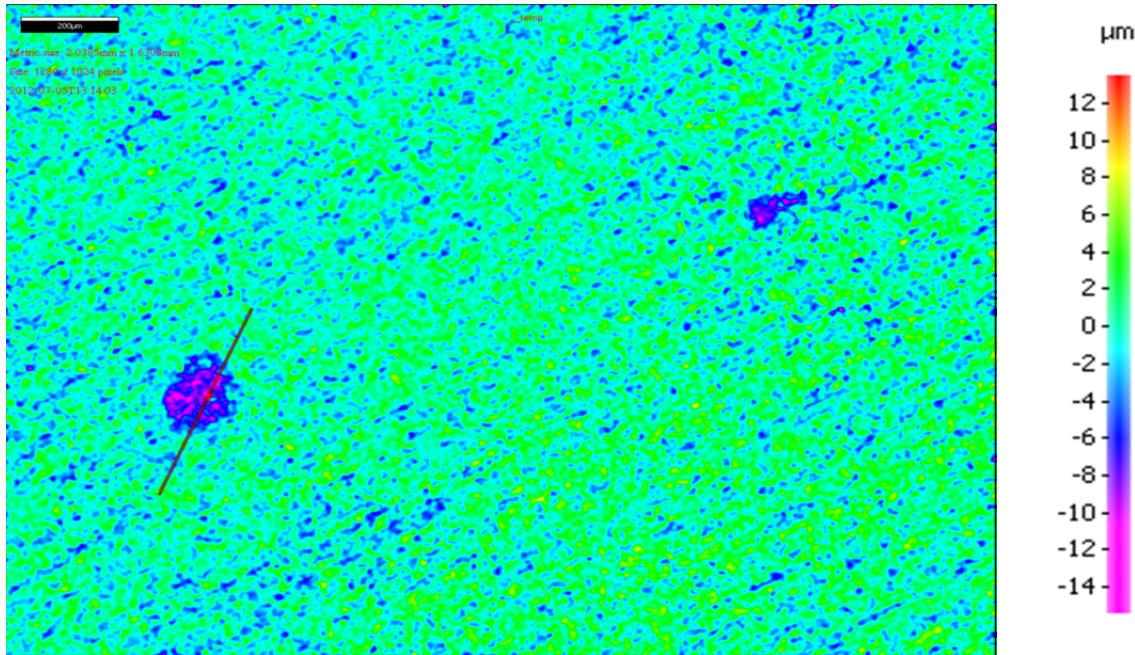
Figure 6.43 A infinite focusing microscopy image of the experiment sample #1 without corrosion product layers. Test conditions: 25°C, pH 5, 1 wt% NaCl solution saturated with CO₂.

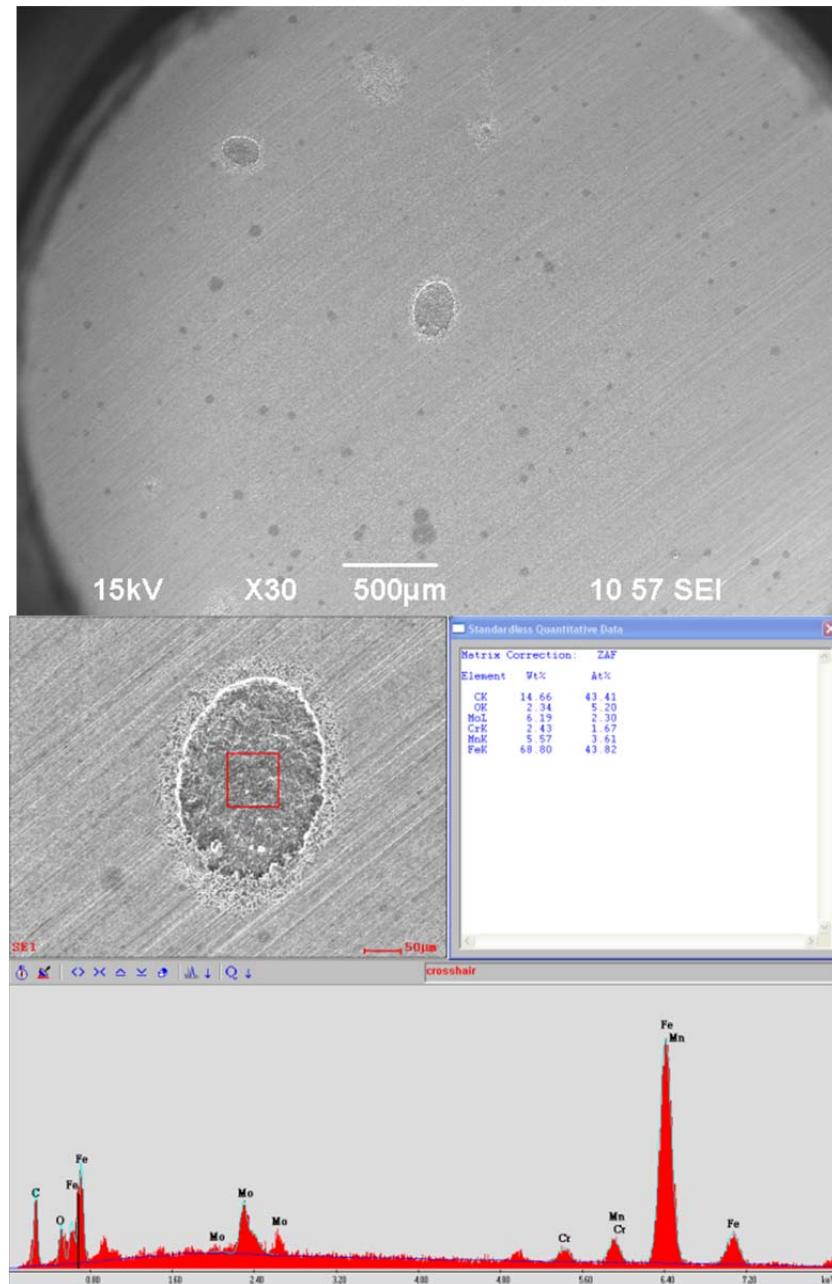
Figure 6.45 SEM and EDS images of the experiment sample #2 with corrosion product layers. Test conditions: 25°C, pH 5, 1 wt% NaCl solution saturated with CO₂.

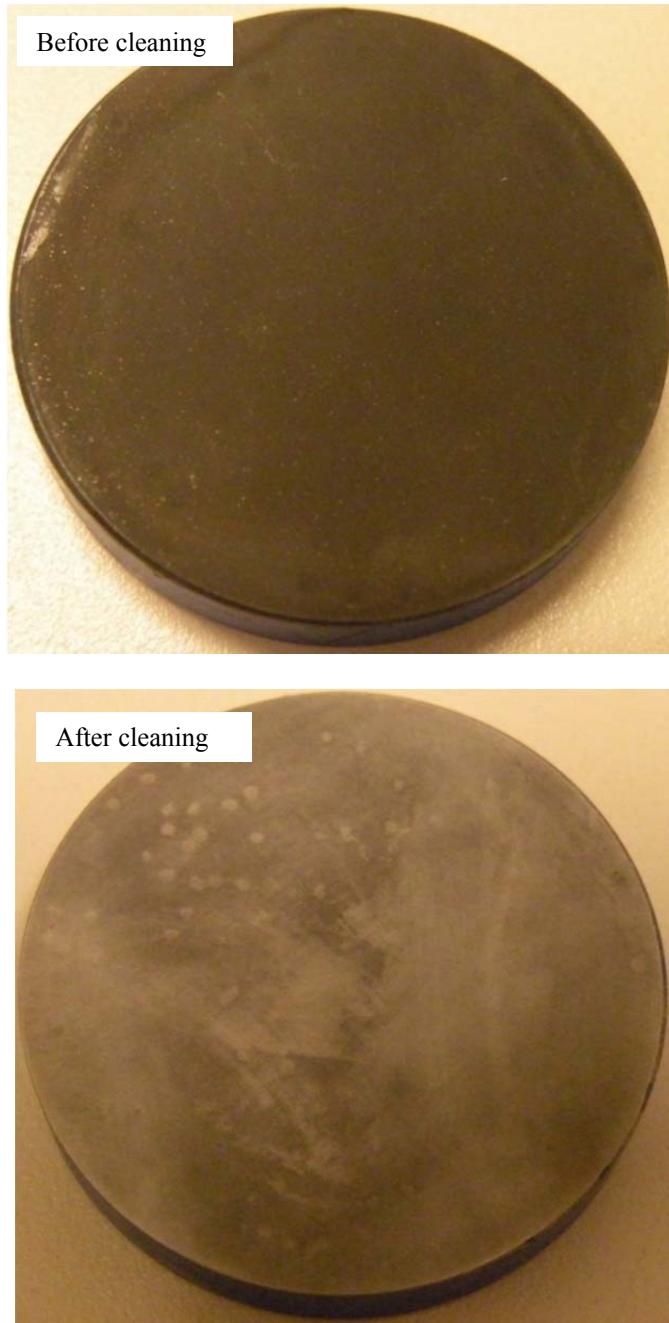
Figure 6.49 View of the experiment specimen #1 after 14 days exposure at test condition:
25°C, pH 5, 1 wt% NaCl solution saturated with CO₂.

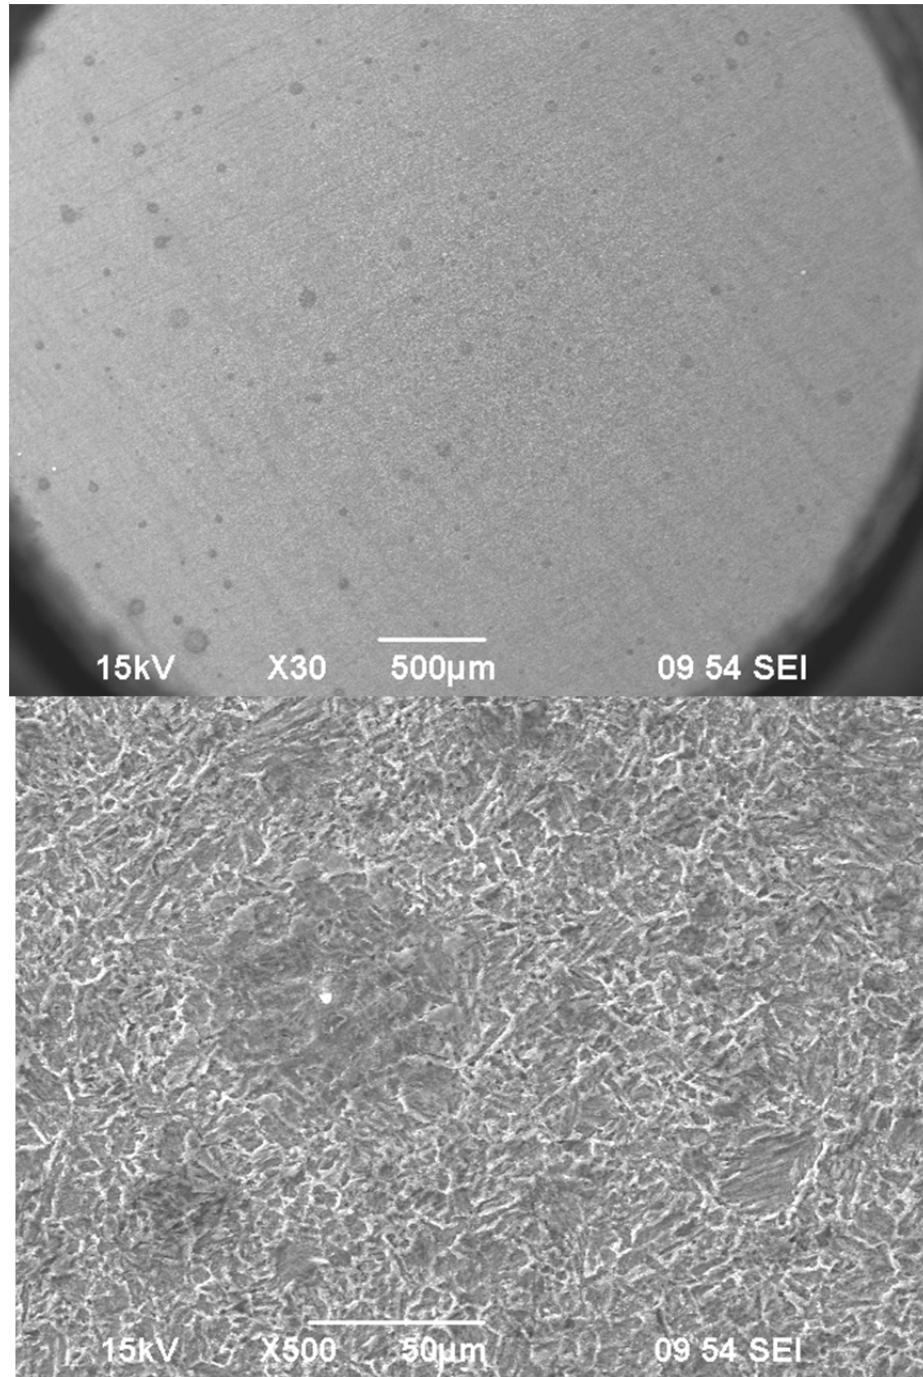
Figure 6.50 SEM images of the experiment sample #1 with corrosion product layers at test condition: 25°C, pH 5, 1 wt% NaCl solution saturated with CO₂.

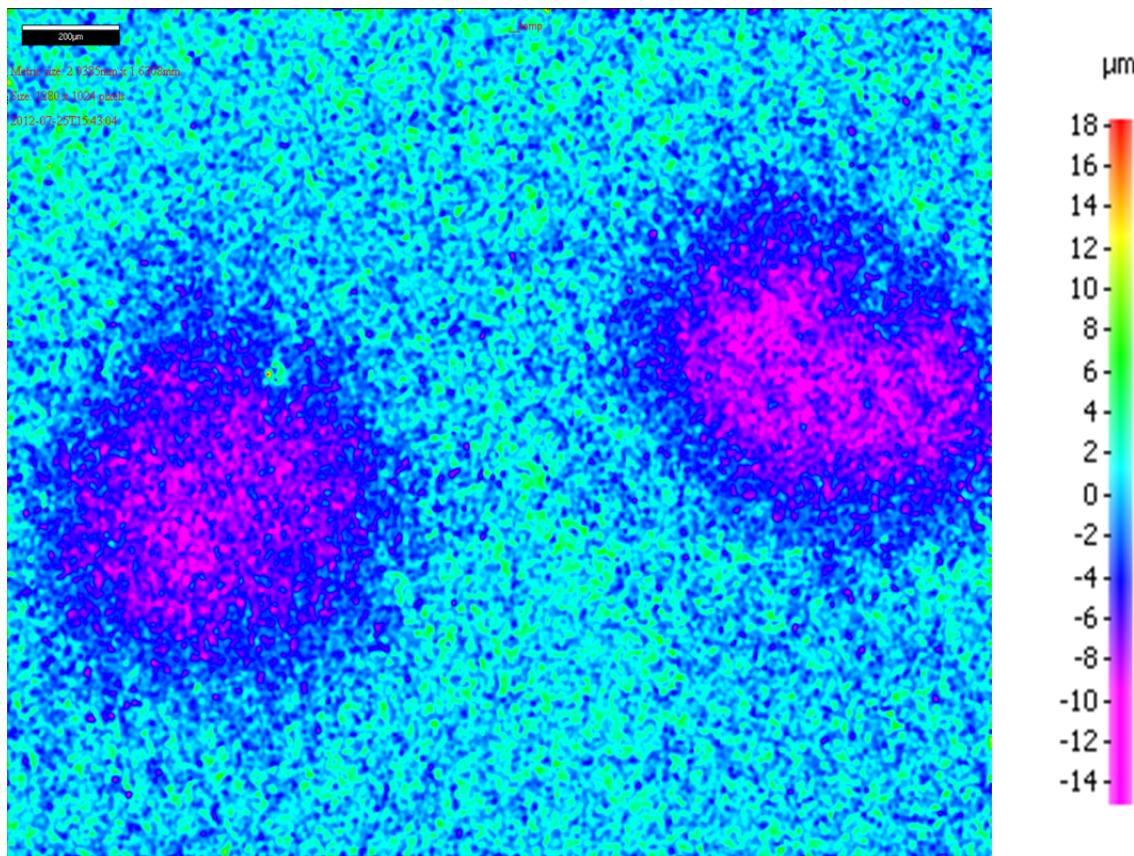
Figure 6.51 A infinite focusing microscopy image of experiment sample #1 after 14 days

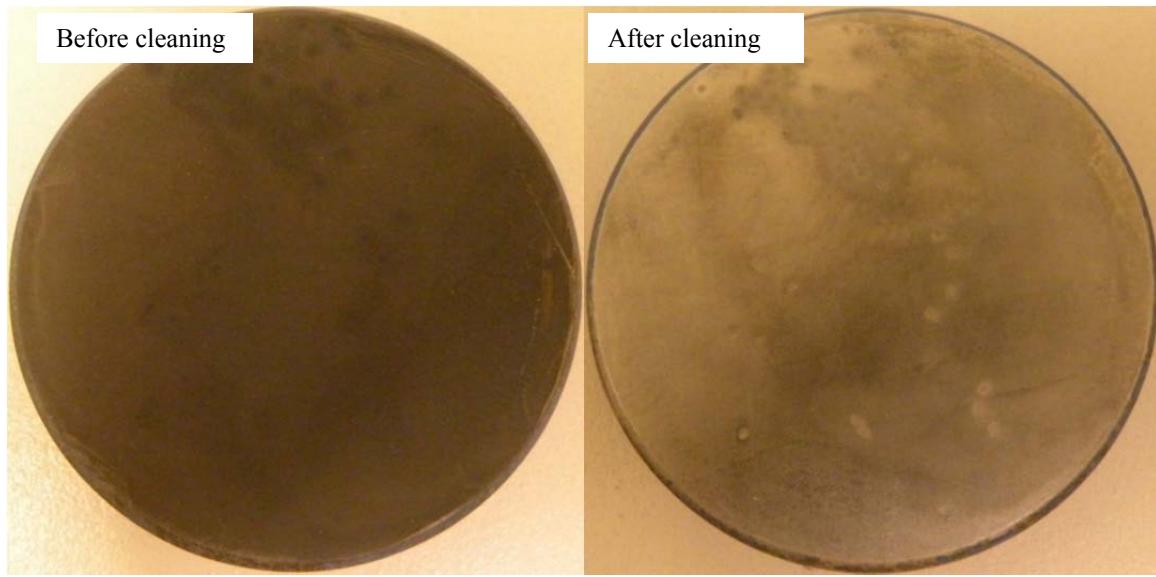
Figure 6.52 View of the experiment specimen #2 after 14 days exposure at test condition:
 25°C , pH 5, 1 wt% NaCl solution saturated with CO₂.

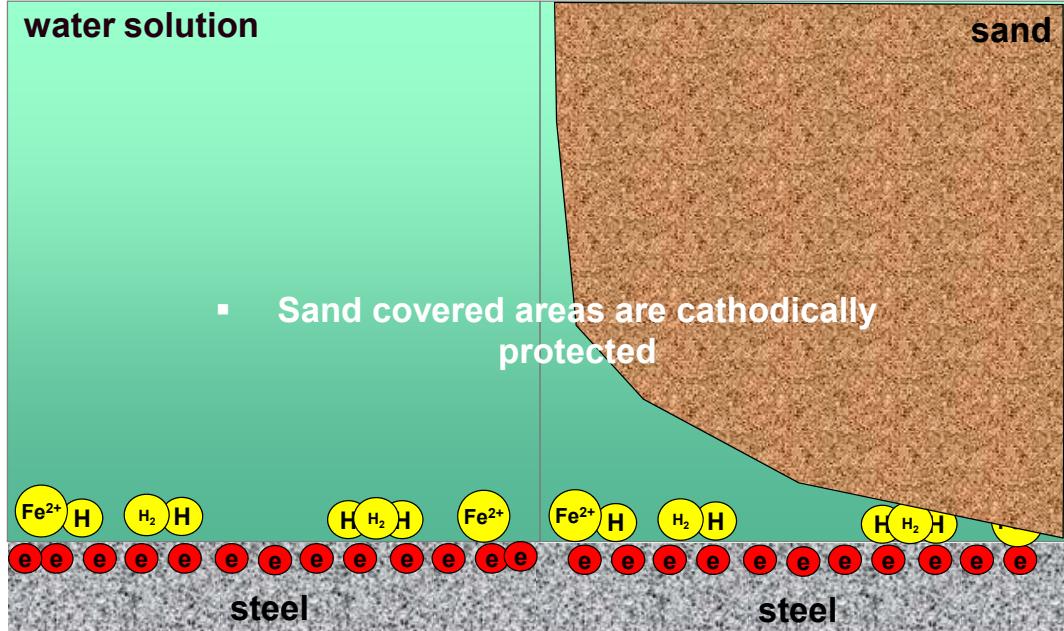
Figure 6.57 Description of the corrosion process in under deposit corrosion in inhibitor-free environment. (Sketches are not drawn to scale)
