The Influence of Sulfides on Localized Corrosion of Mild Steel

A dissertation presented to
the faculty of
the Russ College of Engineering and Technology of Ohio University

In partial fulfillment
of the requirements for the degree
Doctor of Philosophy

Bruce N. Brown

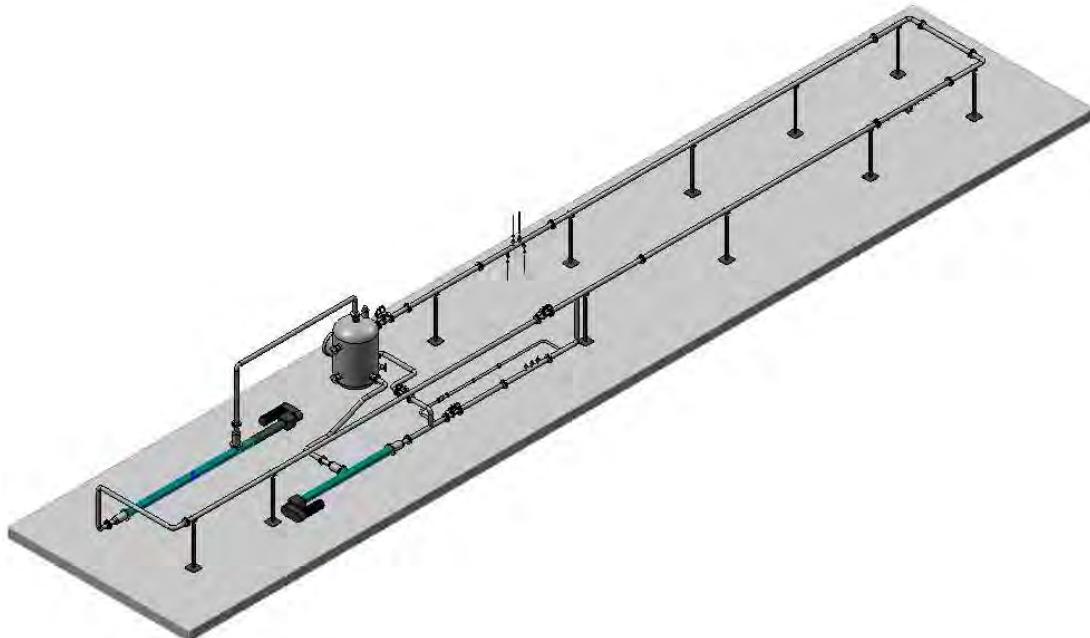
Figure 5. Schematic of the Hydrogen Sulfide large scale flow loop. Full dimensions are 29 m (95 ft) in length and 3.6 m (12 ft) in width.

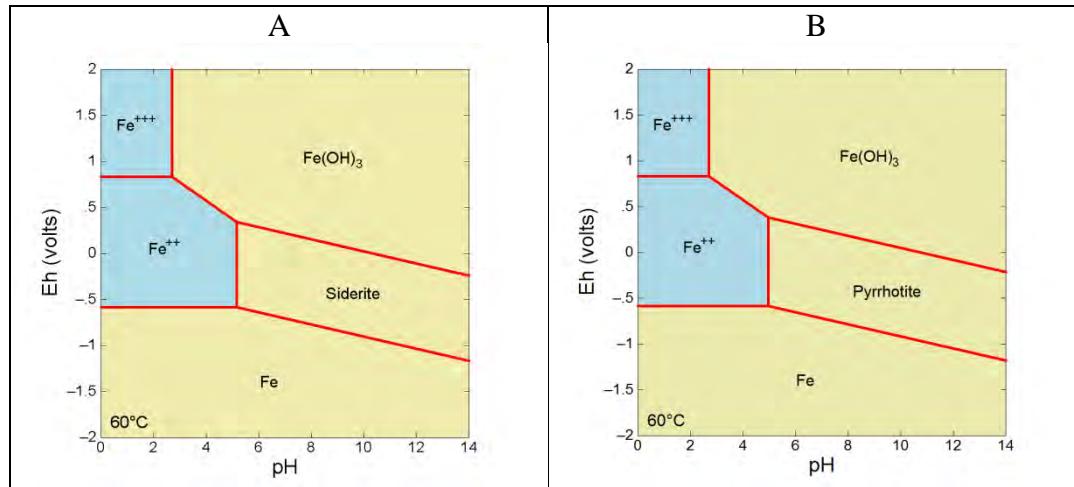
Figure 8. Pourbaix diagrams representing corrosion products formed at near saturation conditions for both iron carbonate and iron sulfide at (A) 1 mbar and (B) 5 mbar pH_2S , respectively (60°C , 7.7 bar pCO_2 , pH 6, 1 ppm $[\text{Fe}^{2+}]$). (Eh-pH diagrams from GWB³⁶)

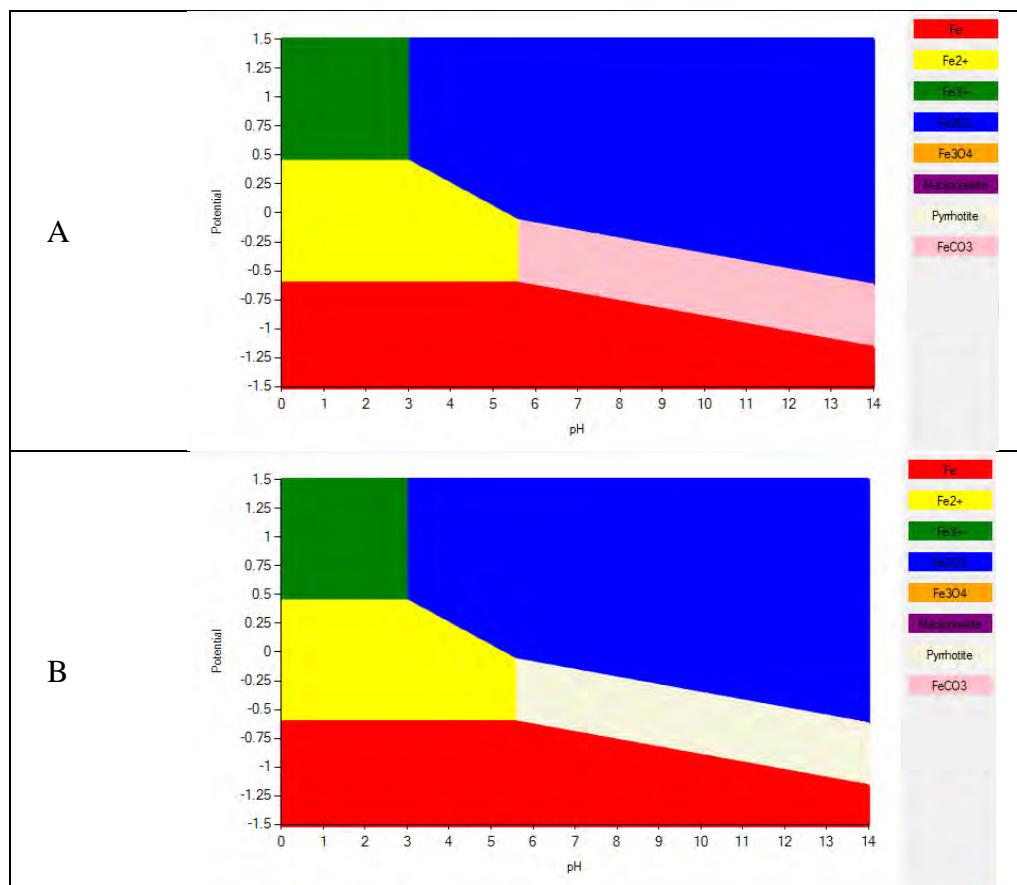
Figure 10. Pourbaix diagrams calculated from potential/pH program (VB version) showing that an increase in pH₂S from 0.1 mbar (A) to 1.0 mbar (B) will change the favored corrosion product from FeCO₃ (pink color) to pyrrhotite (white color). (60°C, 8 bar pCO₂, 1 ppm Fe⁺⁺)

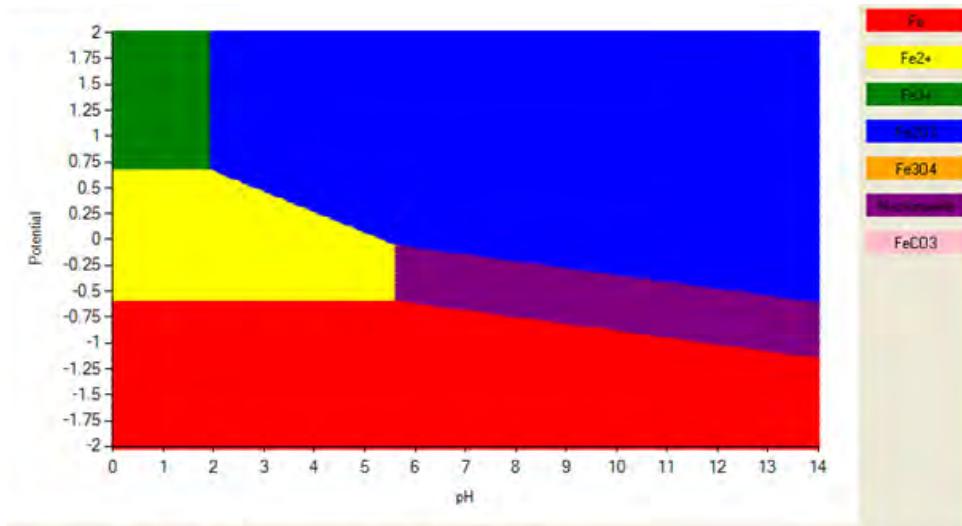
Figure 11. Pourbaix diagram calculated from potential/pH program (VB version) showing that an increase up to 24 mbar pH₂S is needed to make mackinawite (purple color) the favored corrosion product over FeCO₃. (60°C, 8 bar pCO₂, 1 ppm Fe⁺⁺)

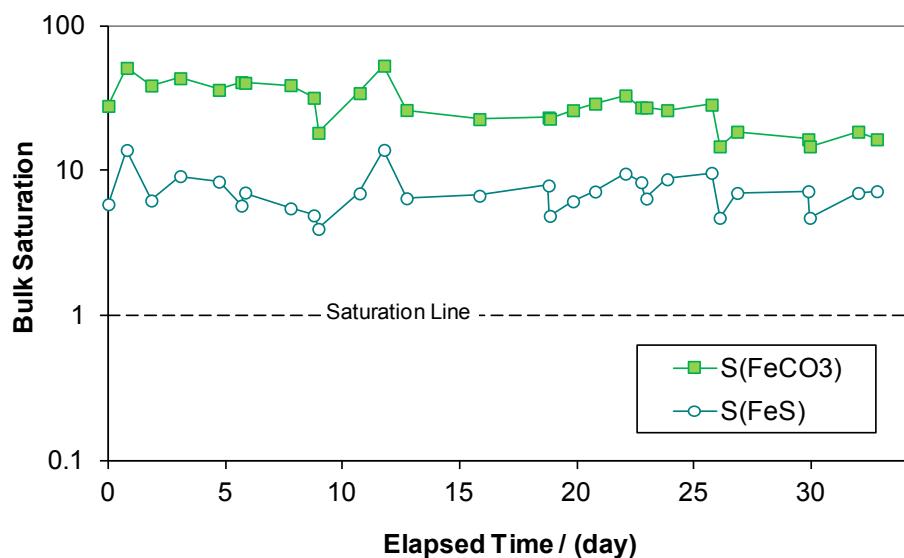
Figure 14. Calculated values of iron sulfide and iron carbonate saturation. (60°C, 0.77 MPa CO₂, pH 6, pH₂S = 0.00015 bar ± 0.00005 bar)

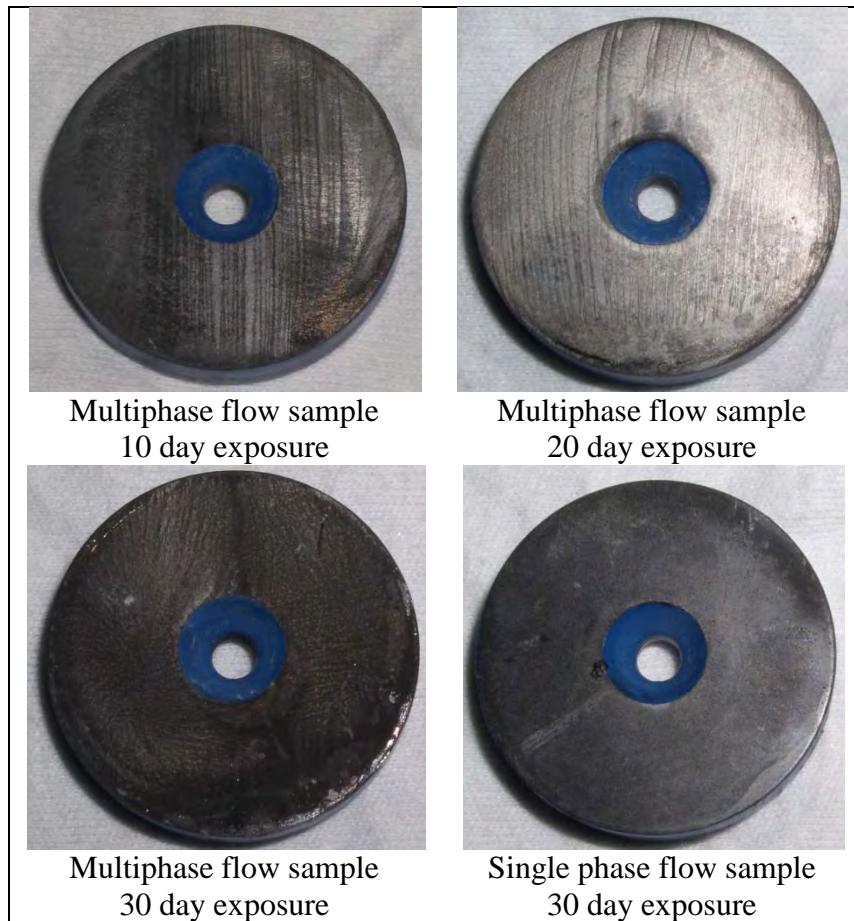
Figure 25. Visual examination of weight loss samples as removed from experiment.
(60°C , 0.77 MPa CO₂, pH 6, $\text{pH}_2\text{S} = 0.00012 \text{ bar} \pm 0.00004 \text{ bar}$)

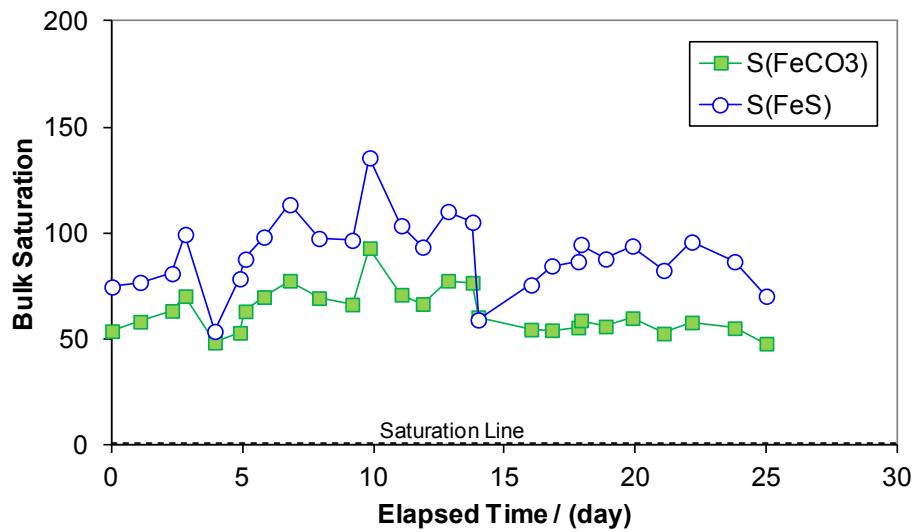
Figure 29. Saturation Values for Iron Carbonate and Iron Sulfide. (60°C, 0.77 MPa CO₂, pH 6, pH₂S = 1.2 mbar ± 0.1 mbar)

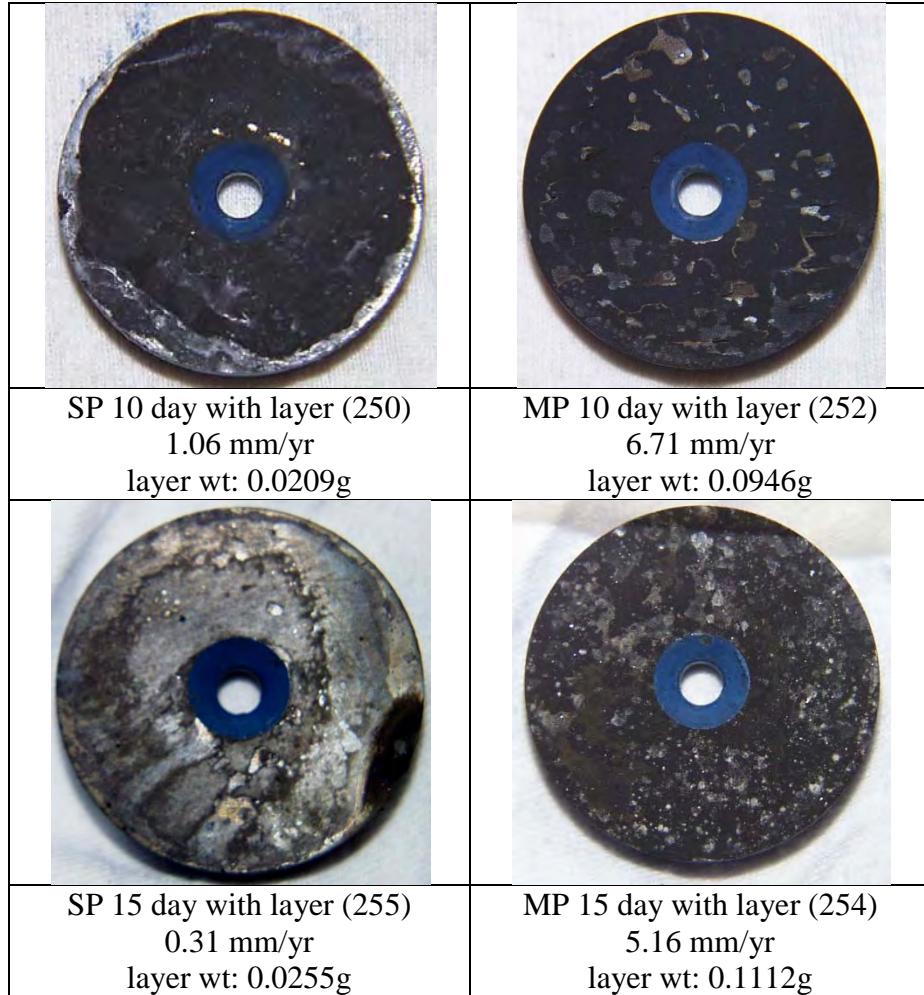
Figure 32. Visual examination of weight loss samples as removed from experiment for 10 day and 15 day exposure times. (60°C , 0.77 MPa CO_2 , pH 6, $\text{pH}_2\text{S} = 1.2 \text{ mbar} \pm 0.1 \text{ mbar}$).

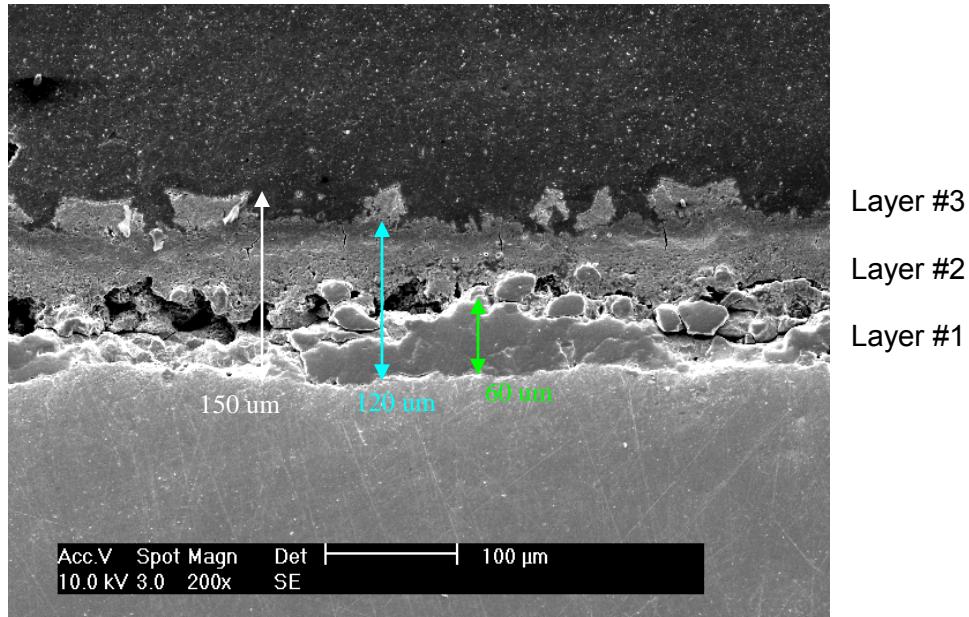
Figure 36. Experiment 3: Cross section of multiphase X65(2) coupon after 25 day exposure (60°C, 0.77 MPa CO₂, pH 6, pH₂S = 1.2 mbar ± 0.1 mbar, 25 day exposure). (next to metal surface) layer #1: 60 μm, layer #2: 60 μm, and layer #3: 30 μm. Layer #1 EDS is [32.4% Fe, 0.0% S, 13.4% C, 26.5% O], the interface between layer #1 and layer #2 EDS is [35.4% Fe, 12.9% S, 14.0% C, 9.5% O], and the EDS of layer #2 is [31.2% Fe, 15.0% S, 20.8% C, 11.2% O].

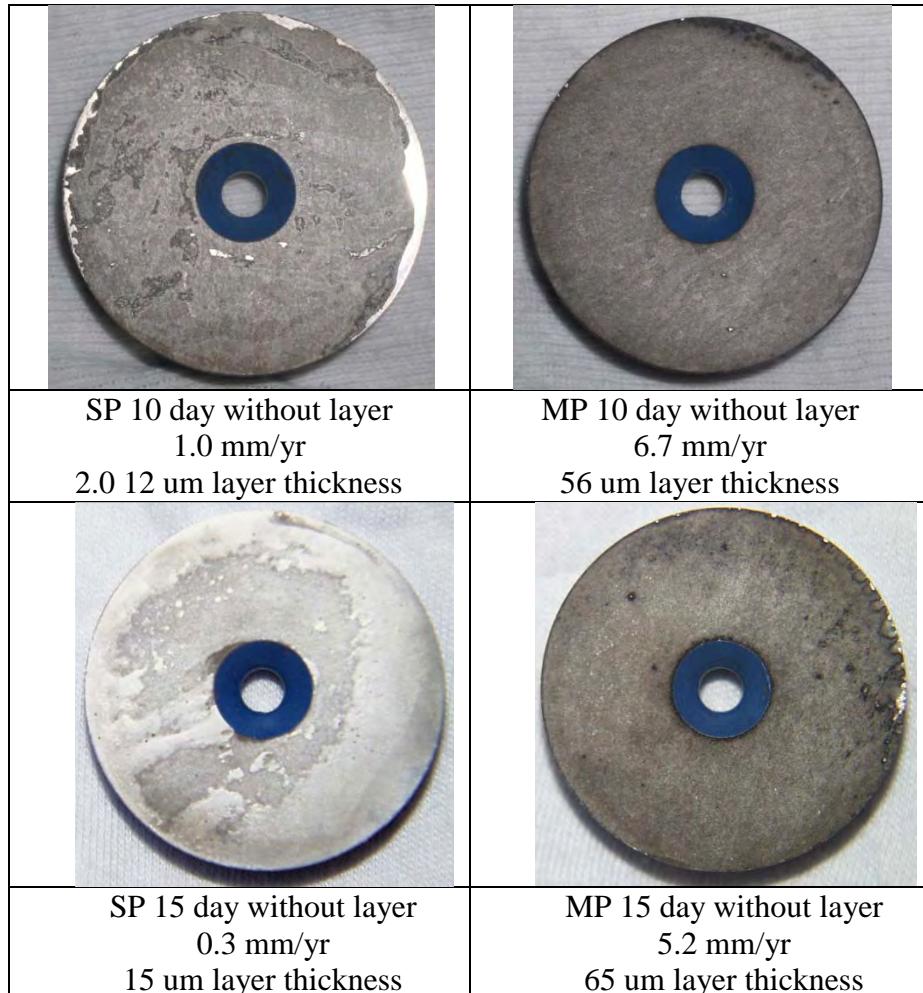
Figure 37. Visual examination of weight loss samples after Clarke solution procedures to remove the corrosion product layer; samples cut in half have undergone cross section analysis. (60°C, 0.77 MPa CO₂, pH 6, pH₂S = 1.2 mbar ± 0.1 mbar).

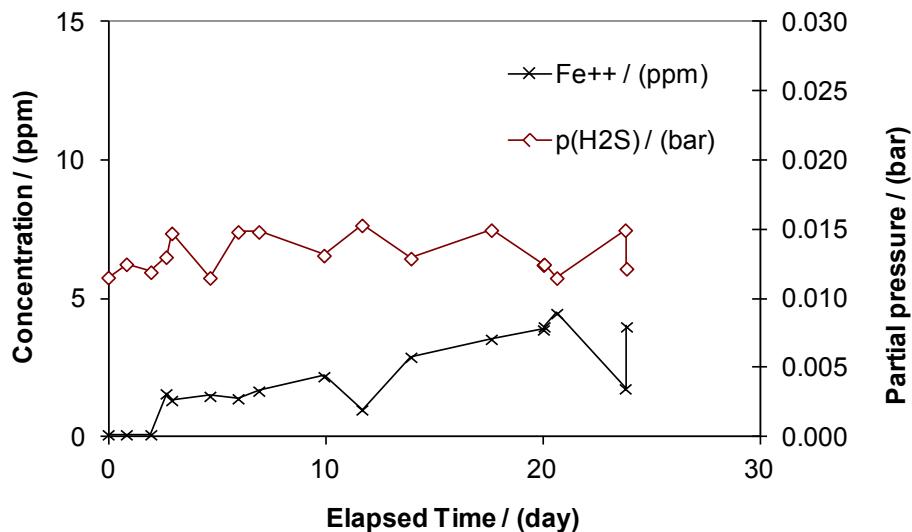
Figure 38. Variations of iron and hydrogen sulfide concentrations with time. (60°C , $P_{\text{total}} = 8 \text{ bar}$, $0.01 \text{ bar} \pm 0.001 \text{ bar pH}_2\text{S}$ [1000 ppm])

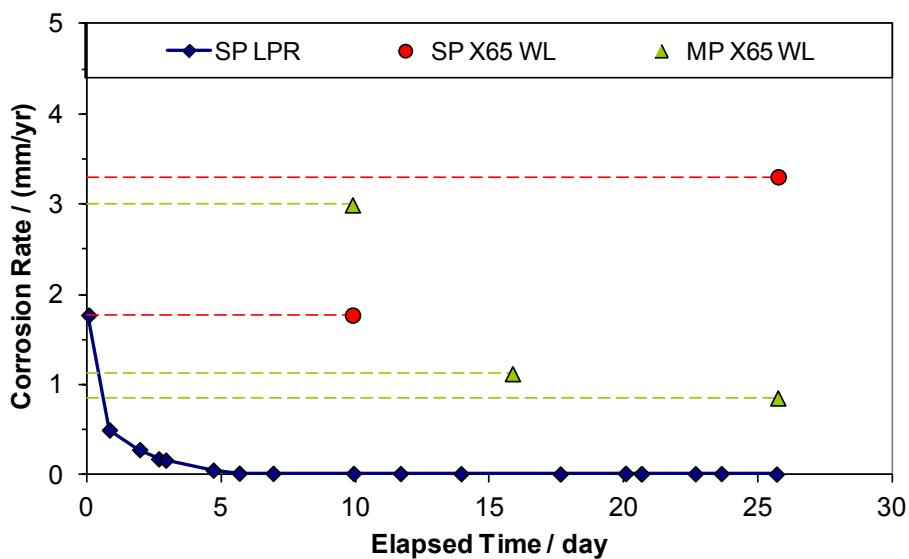
Figure 40. Comparison of Corrosion rates measured by linear polarization and weight loss coupons. SP – Single Phase, MP – Multiphase (60°C , $P_{\text{total}} = 8 \text{ bar}$, $0.01 \text{ bar} \pm 0.001 \text{ bar pH}_2\text{S}$ [1000 ppm], 1 wt% NaCl)

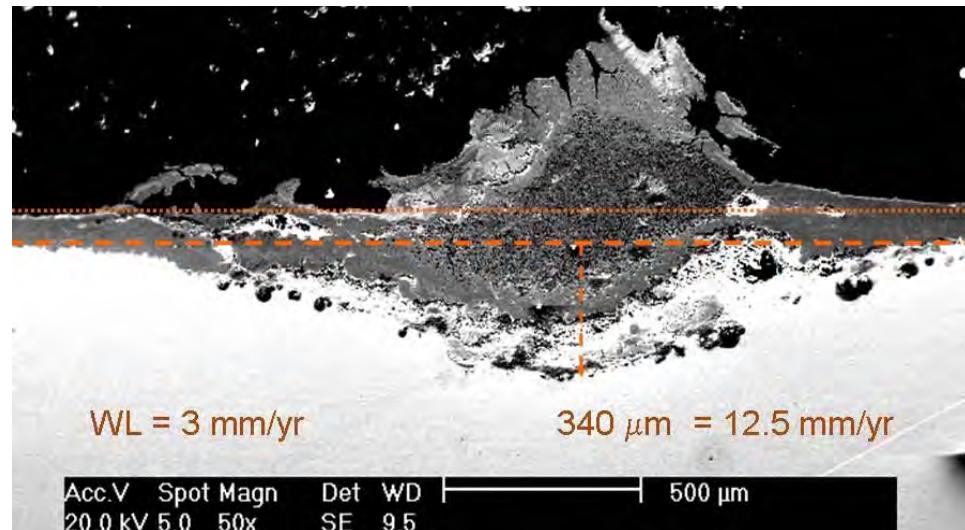
Figure 41. Cross section with calculation of general corrosion rate vs. localized corrosion rate for multiphase flow sample after 10 days exposure. (60°C , $P_{\text{total}} = 8 \text{ bar}$, $0.01 \text{ bar} \pm 0.001 \text{ bar pH}_2\text{S}$ [1000ppm], 1 wt% NaCl)

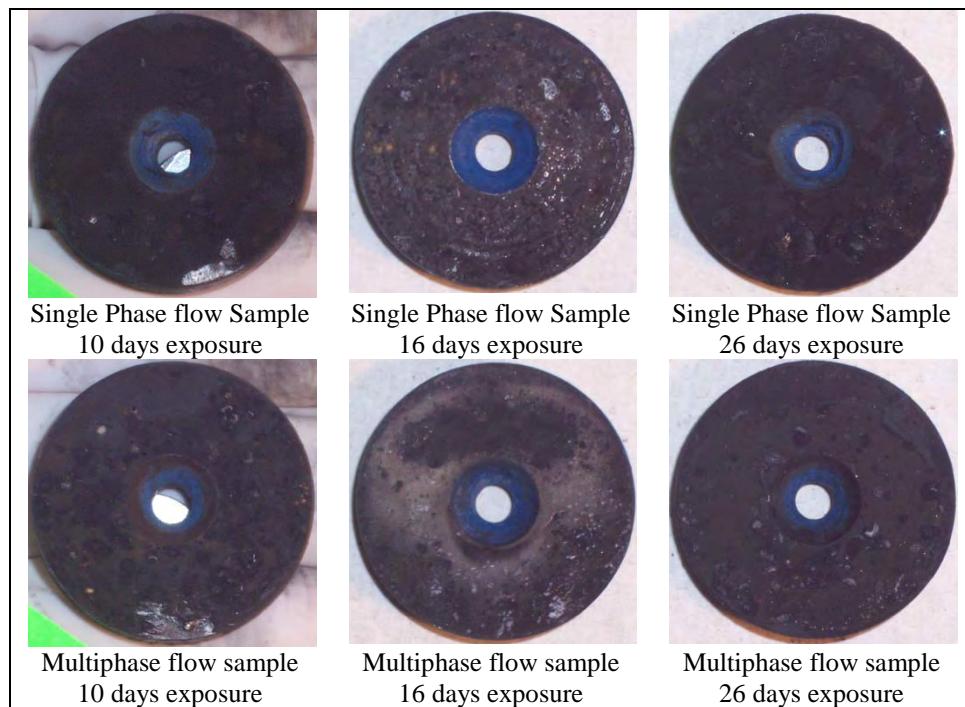
Figure 42. Visual examination of weight loss samples as removed from experiment. (60°C , $P_{\text{total}} = 8 \text{ bar}$, $0.01 \text{ bar} \pm 0.001 \text{ bar pH}_2\text{S}$ [1000ppm], 1 wt% NaCl)

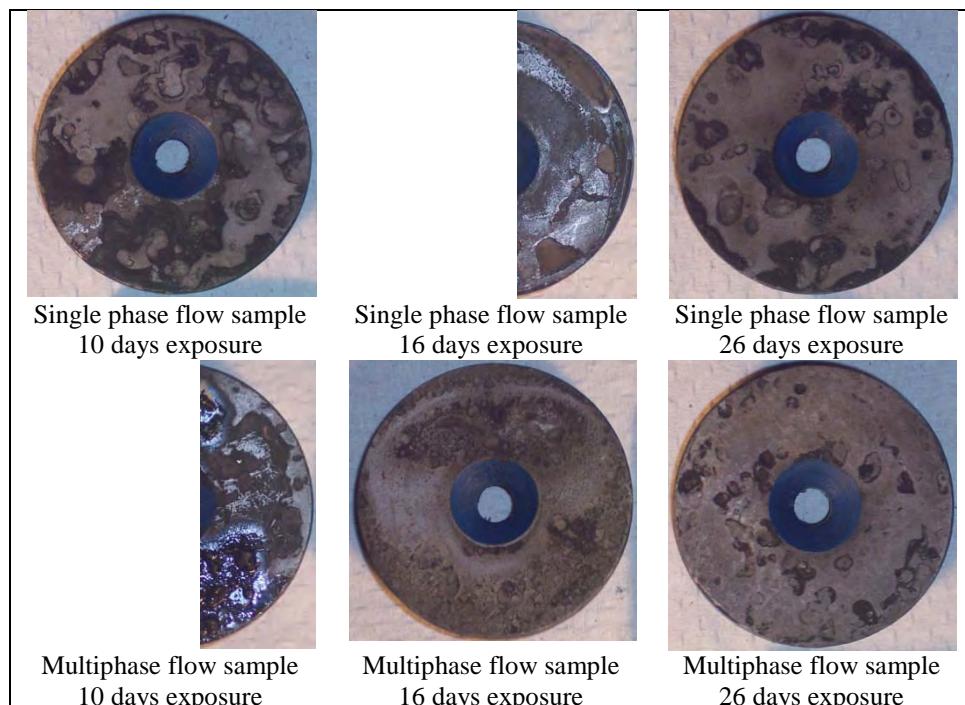
Figure 43. Visual examination of weight loss samples after Clarke solution procedures to remove the corrosion product layer; samples cut in half have undergone cross section analysis. (60°C , $P_{\text{total}} = 8$ bar, 0.01 bar ± 0.001 bar pH_2S [1000ppm], 1 wt% NaCl)

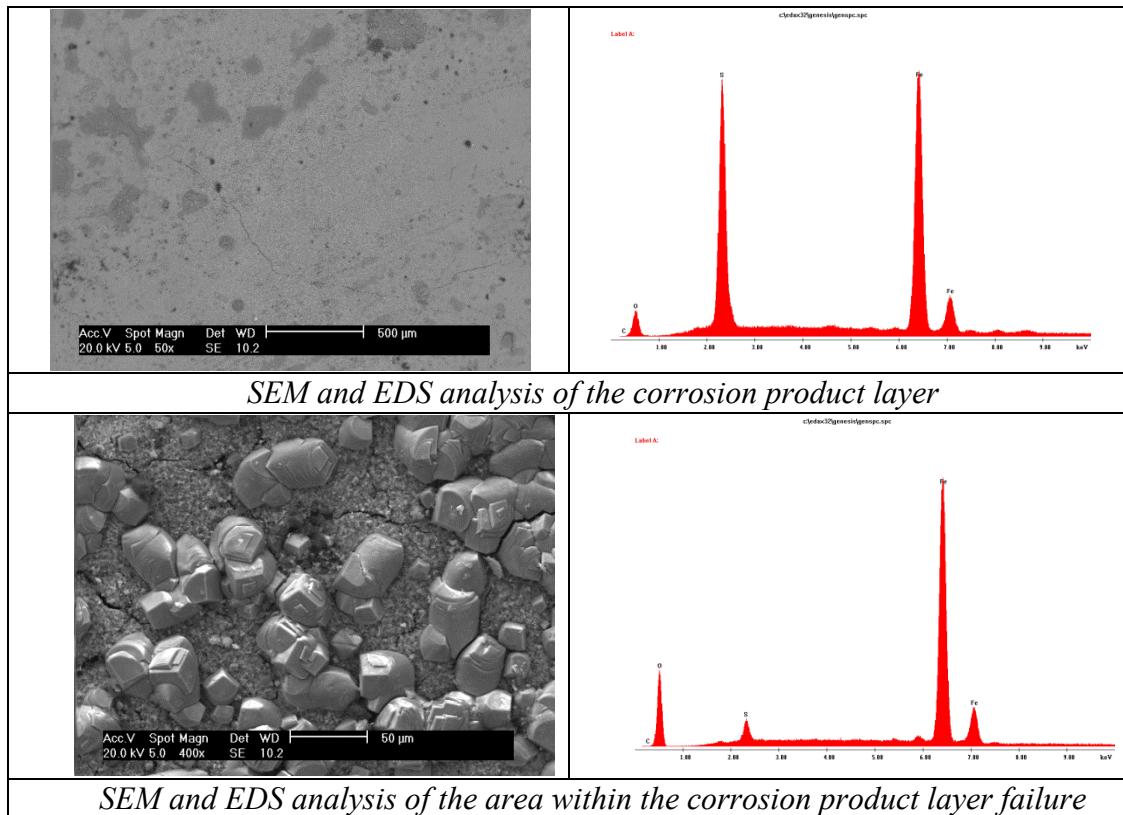
Figure 50. SEM and EDS analysis of the corrosion product layer outside and inside a surface layer failure from single phase flow after 16 days exposure. (60°C , $P_{\text{total}} = 8 \text{ bar}$, $0.01 \text{ bar} \pm 0.001 \text{ bar pH}_2\text{S}$ [1000ppm], 1 wt% NaCl)

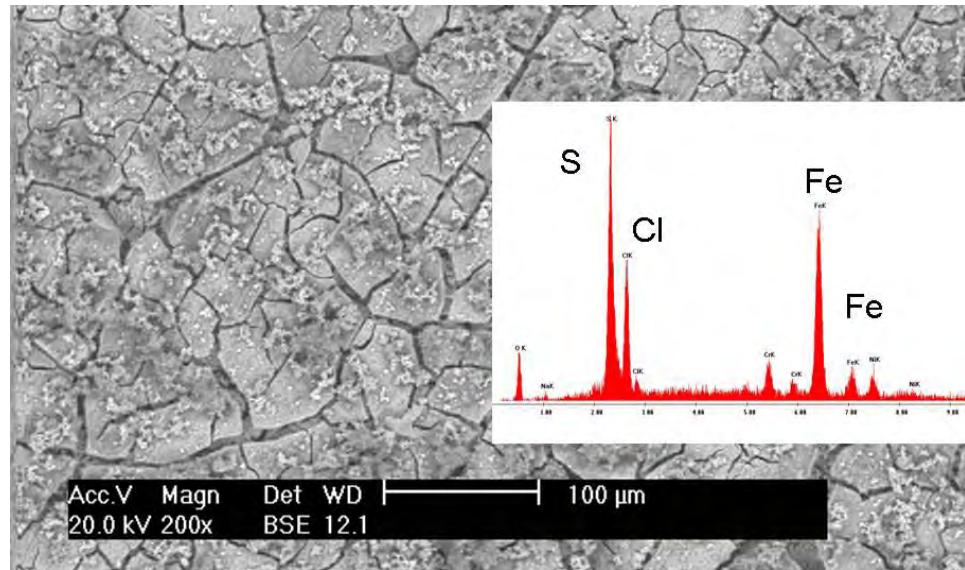
Figure 56. Experiment 5: Surface layer from influence of pH₂S and NaCl solution. (60°C, P_{total} = 8 bar, pH₂S = 0.001 bar [100 ppm], 10wt% NaCl).

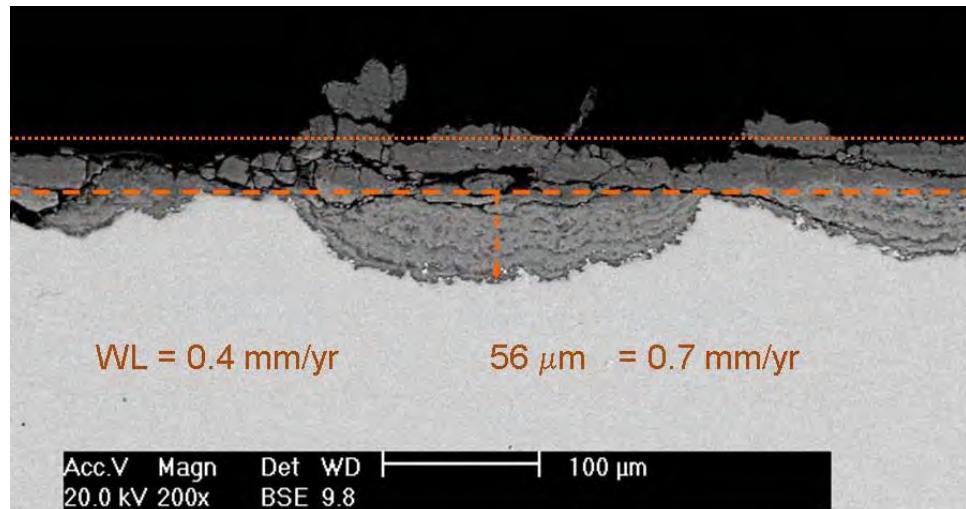
Figure 57. Experiment 5: Surface layer from influence of pH_2S and NaCl solution. (60°C , $P_{\text{total}} = 8$ bar, $\text{pH}_2\text{S} = 0.001$ bar [100ppm], 10wt% NaCl).

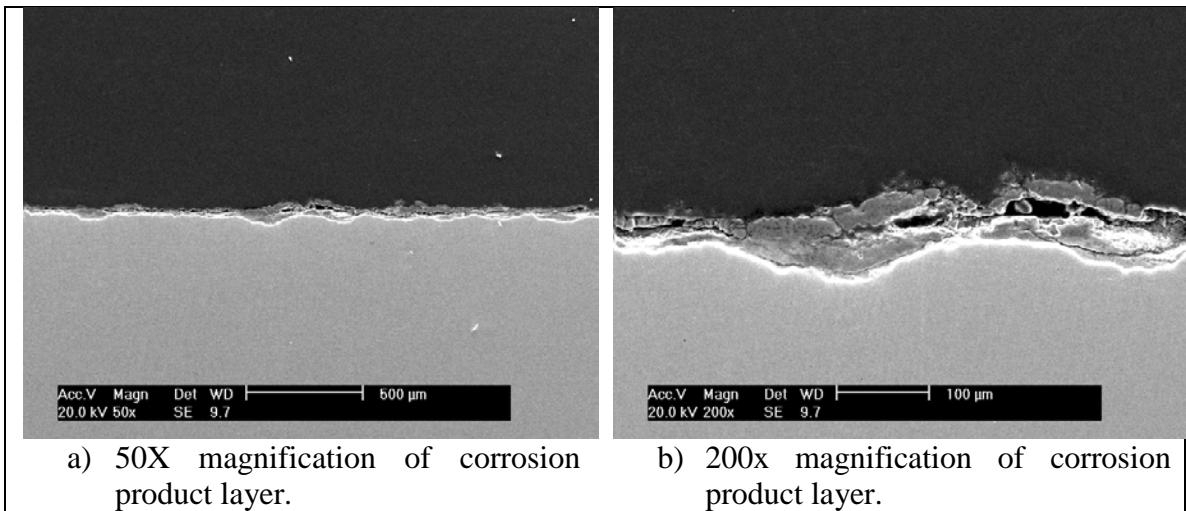
Figure 58. Surface features in cross sectional analysis of X65 sample from Single Phase flow after 31 day exposure to system conditions. (60°C , $P_{\text{total}} = 8$ bar, $\text{pH}_2\text{S} = 0.001$ bar [100ppm], 10wt% NaCl).

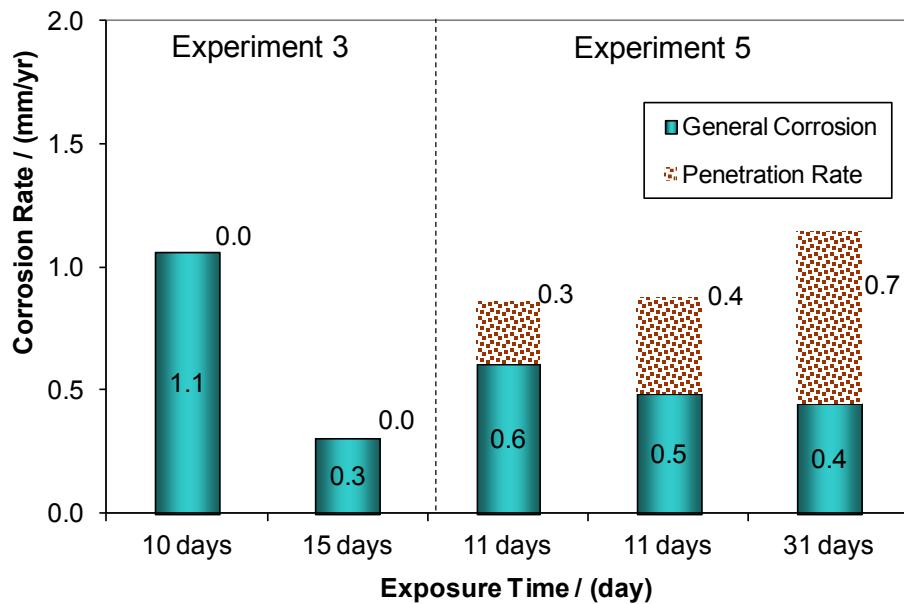
Figure 60. Bar chart comparison of WL general corrosion rate and IFM measured penetration rate for both sets of samples from Experiment 3 and Experiment 5. (60°C , $P_{\text{total}} = 8 \text{ bar}$, $p\text{H}_2\text{S} = 0.001 \text{ bar}$ [100ppm], 10wt% NaCl).

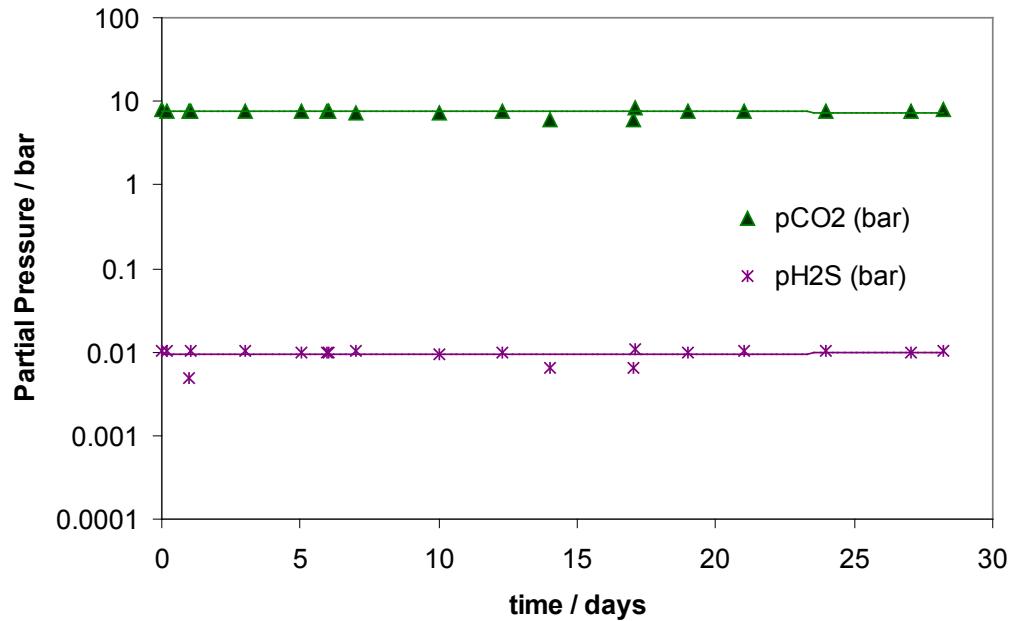
Figure 61. Experiment 6: partial pressures of CO₂ and H₂S vs. time.

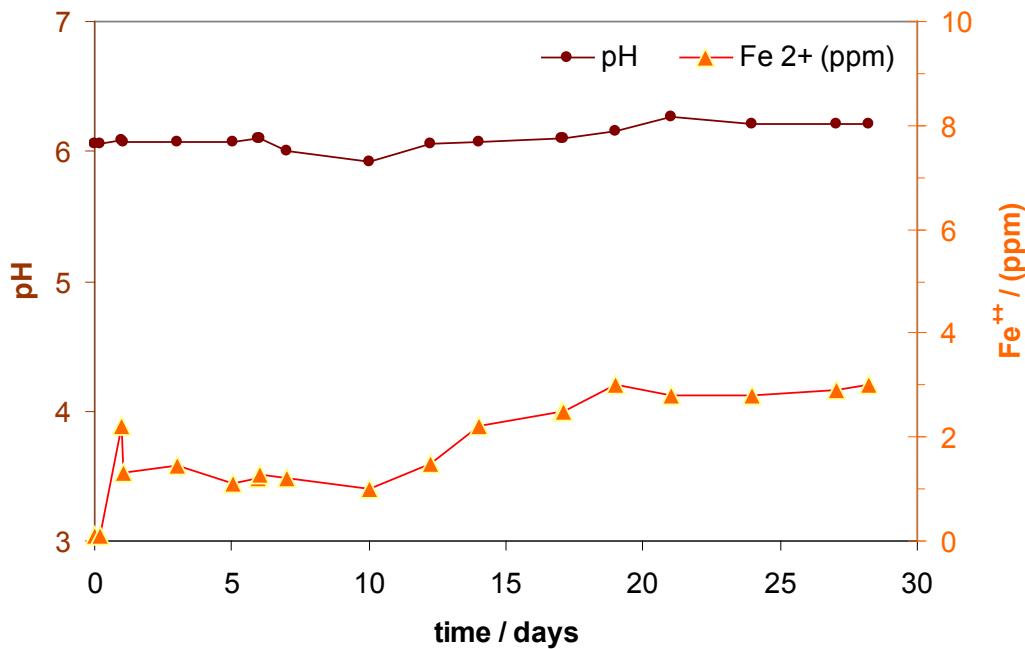
Figure 62. Experiment 6: pH and [Fe⁺⁺] vs. time

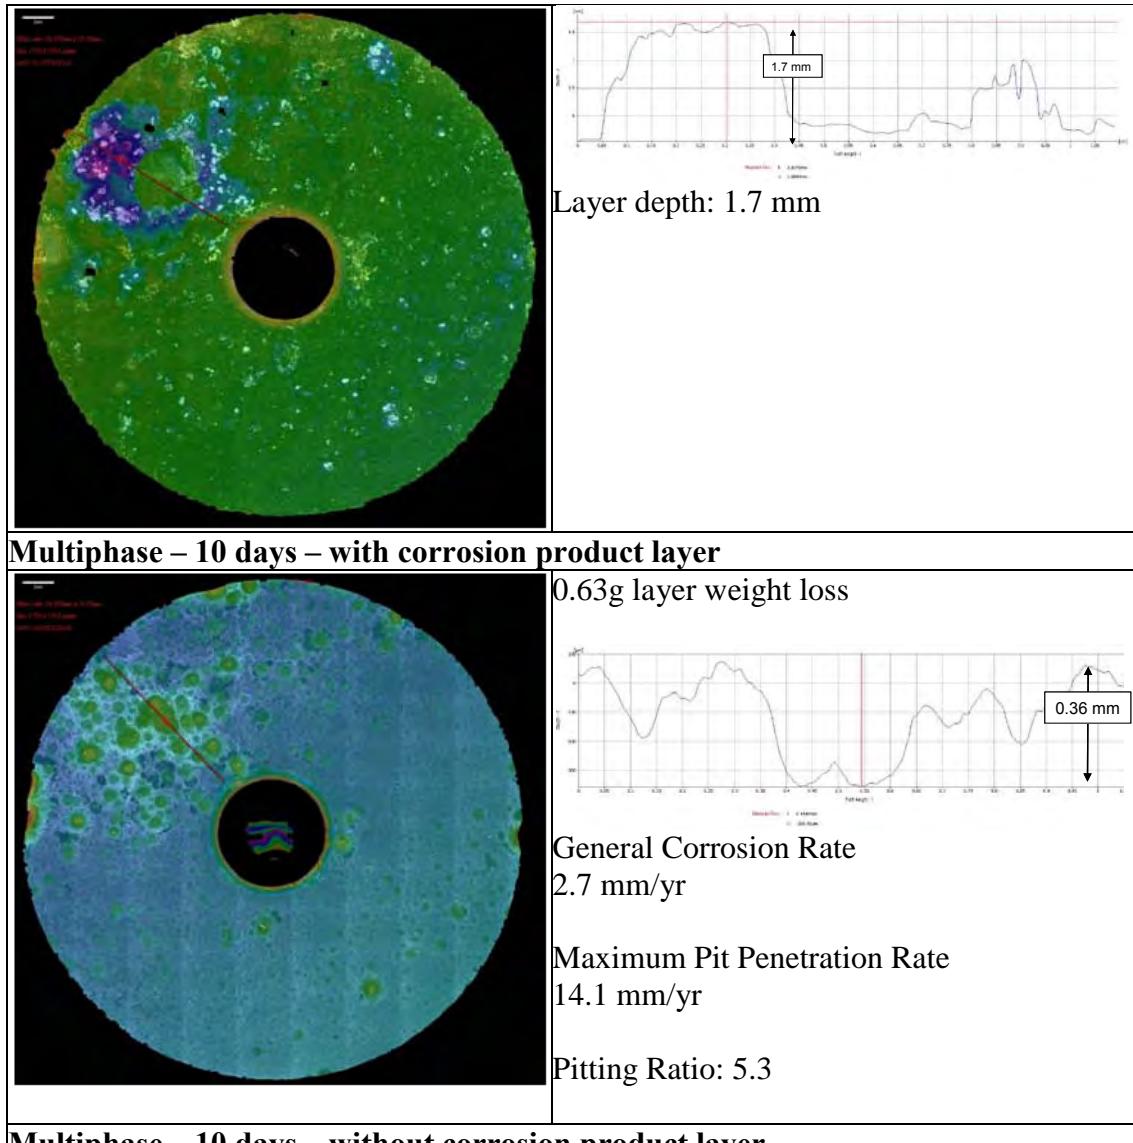
Figure 63. Experiment 6: Multiphase, 10 days, 60°C, $p\text{CO}_2 = 7.7$ bar, pH 6.0, 10 mbar H_2S , 10 wt% NaCl

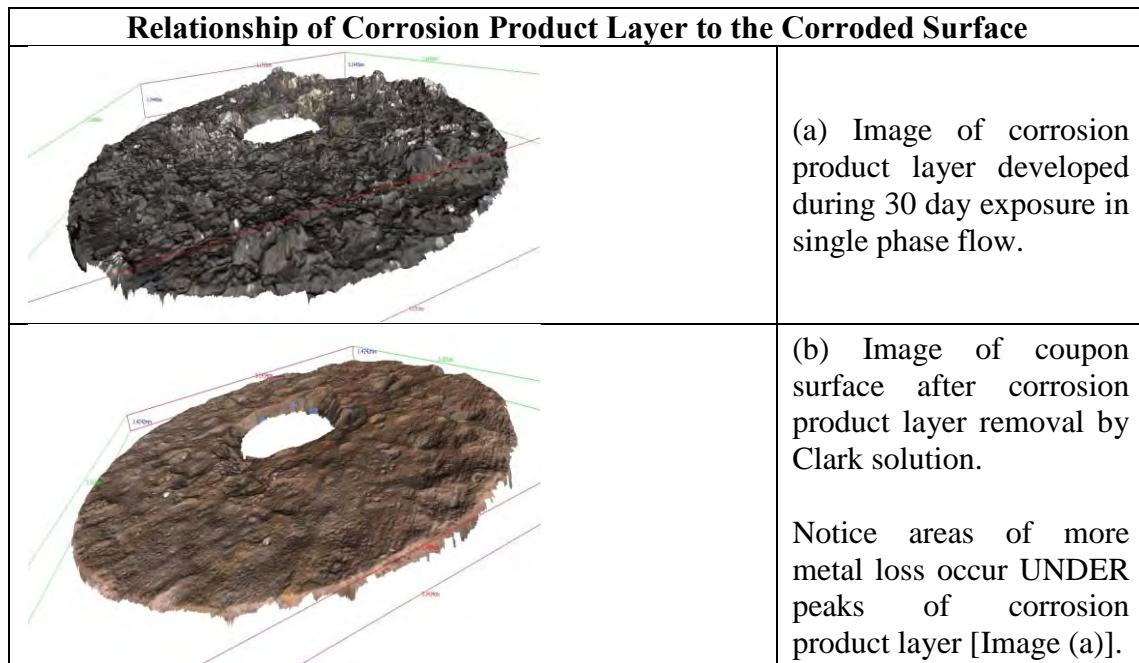
Figure 64. Experiment 6: IFM surface imaging of X65 coupon exposed for 30 days in single phase flow for conditions: 60°C, pCO₂ = 7.7 bar, pH 6.0, 1.0 mbar H₂S, 10 wt% NaCl.

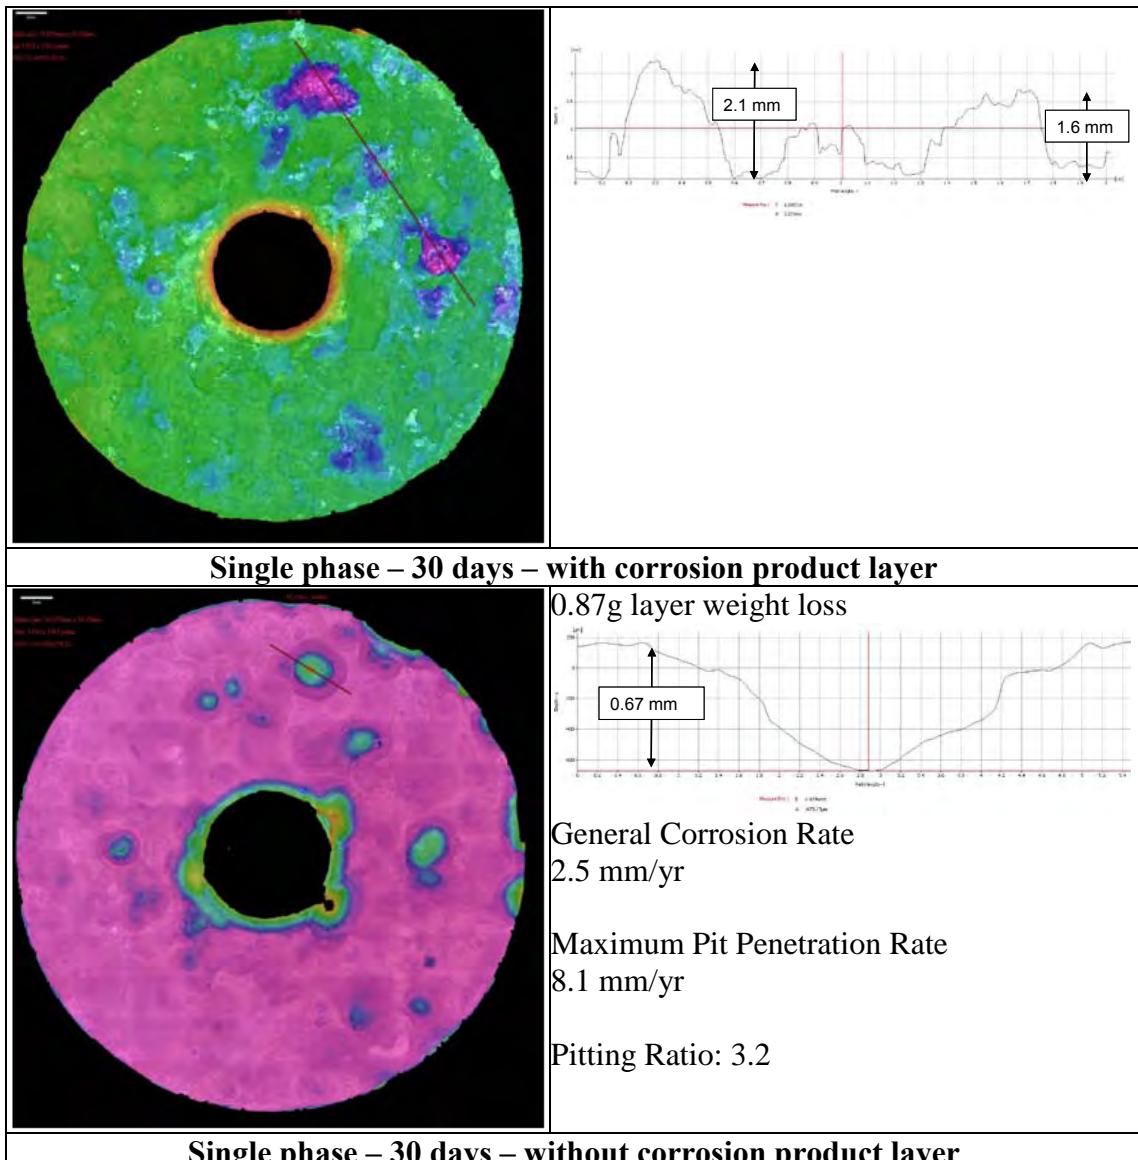
Figure 65. Experiment 6: IFM surface imaging of X65 coupon exposed for 30 days in single phase flow for conditions: 60°C, $p\text{CO}_2 = 7.7$ bar, pH 6.0, 1.0 mbar H_2S , 10 wt% NaCl

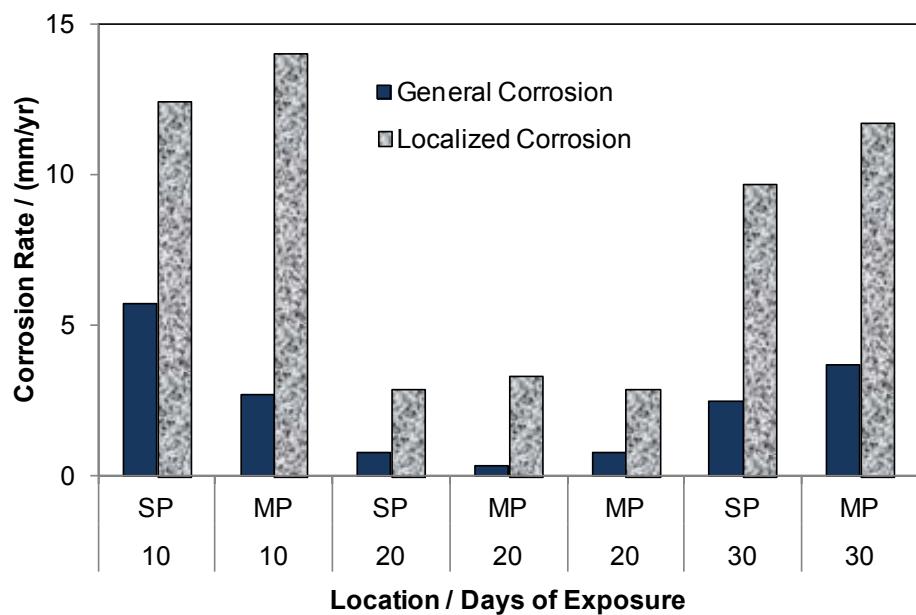
Figure 67. Corrosion rate vs location (SP – single phase, MP – multiphase), 60°C, $p\text{CO}_2 = 7.7$ bar, pH 6.0, 10.0 mbar H_2S , 10 wt% NaCl

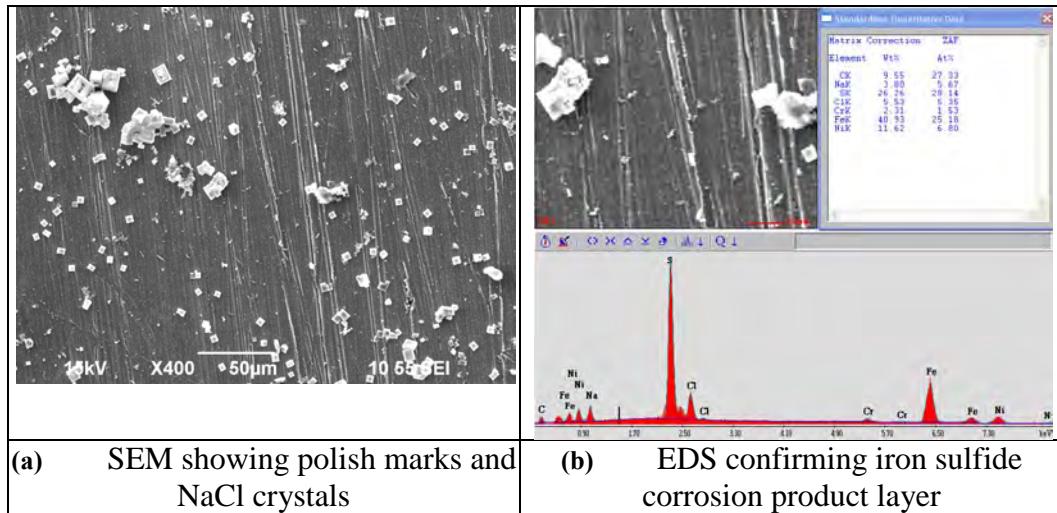
Figure 72. Exp 9. Multiphase weight loss sample taken from 60°C, pH 5, pCO₂ = 7.7 bar, pH₂S = 10 mbar, 10 wt% NaCl after 7 days' exposure.

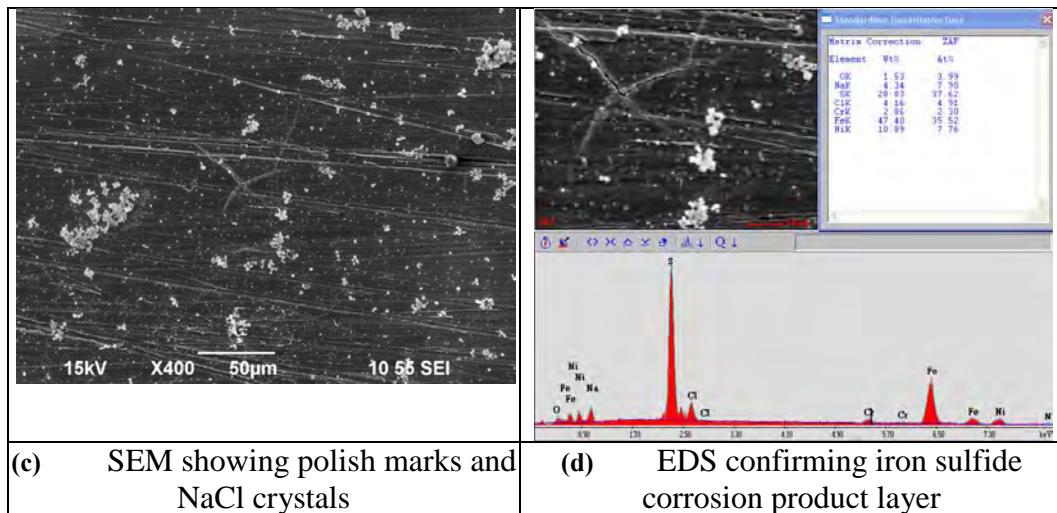
Figure 73. Exp 9. Multiphase weight loss sample taken from 60°C, pH 5, pCO₂ = 7.7 bar, pH₂S = 10 mbar, 10 wt% NaCl after 7 days' exposure.

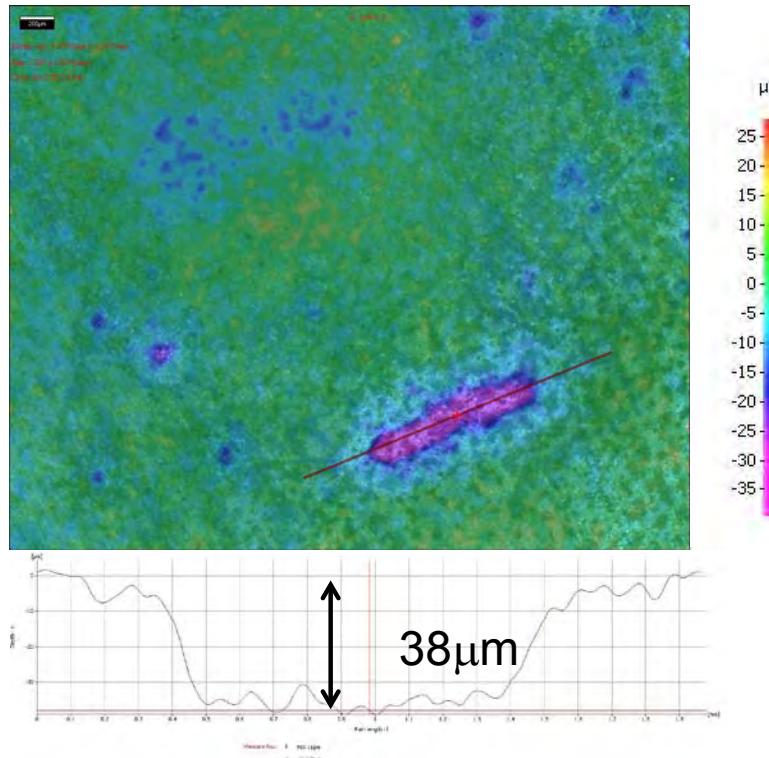
Figure 74. Exp 9. IFM analysis from multiphase flow sample showing the single localized corrosion location. Multiphase weight loss sample taken from 60°C, pH 5, $\text{pCO}_2 = 7.7$ bar, $\text{pH}_2\text{S} = 10$ mbar, 10 wt% NaCl after 7 days' exposure.

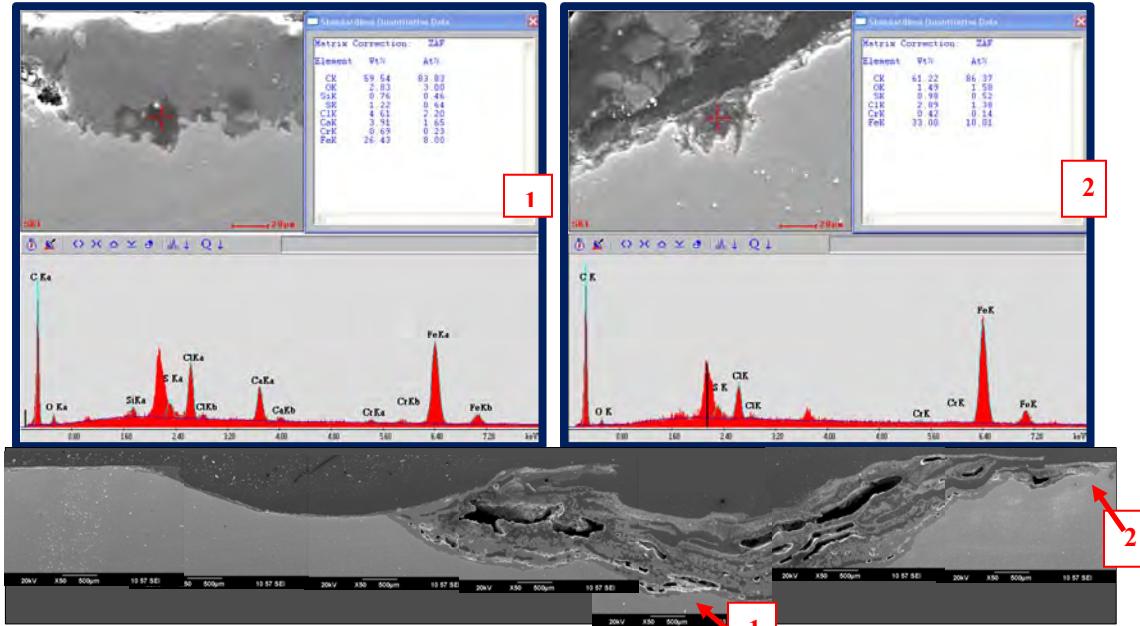
Figure 79. Exp 9. SEM composite image of Multiphase weight loss sample taken from 60°C, pH 5, $p\text{CO}_2 = 7.7$ bar, $\text{pH}_2\text{S} = 10$ mbar, 10 wt% NaCl. Arrow locations 1& 2 were analyzed by EDS. Both locations show a higher chloride content than was observed elsewhere on the same sample.
