The Influence of Sulfides on Localized Corrosion of Mild Steel

A dissertation presented to
the faculty of
the Russ College of Engineering and Technology of Ohio University

In partial fulfillment
of the requirements for the degree
Doctor of Philosophy

Bruce N. Brown

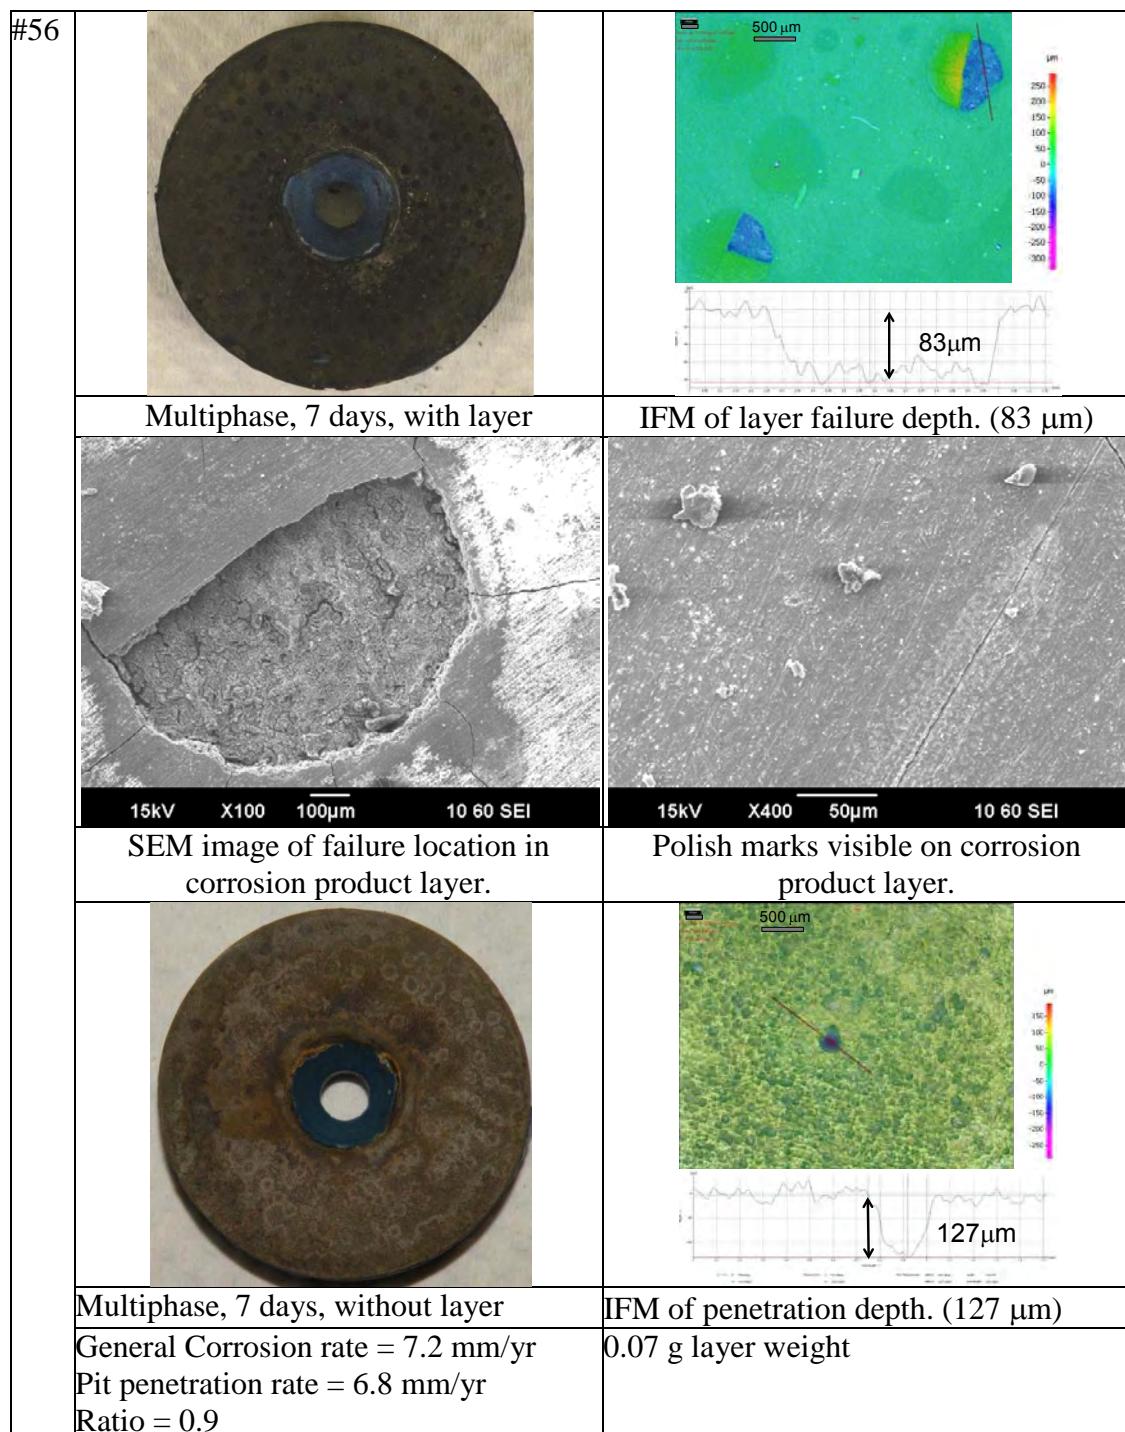
Figure 87. Exp 12. Analysis of WL sample exposed in 60°C, pCO₂ = 7.7 bar, pH₂S = 10 mbar, 10 wt% NaCl, multiphase flow, 7 days.

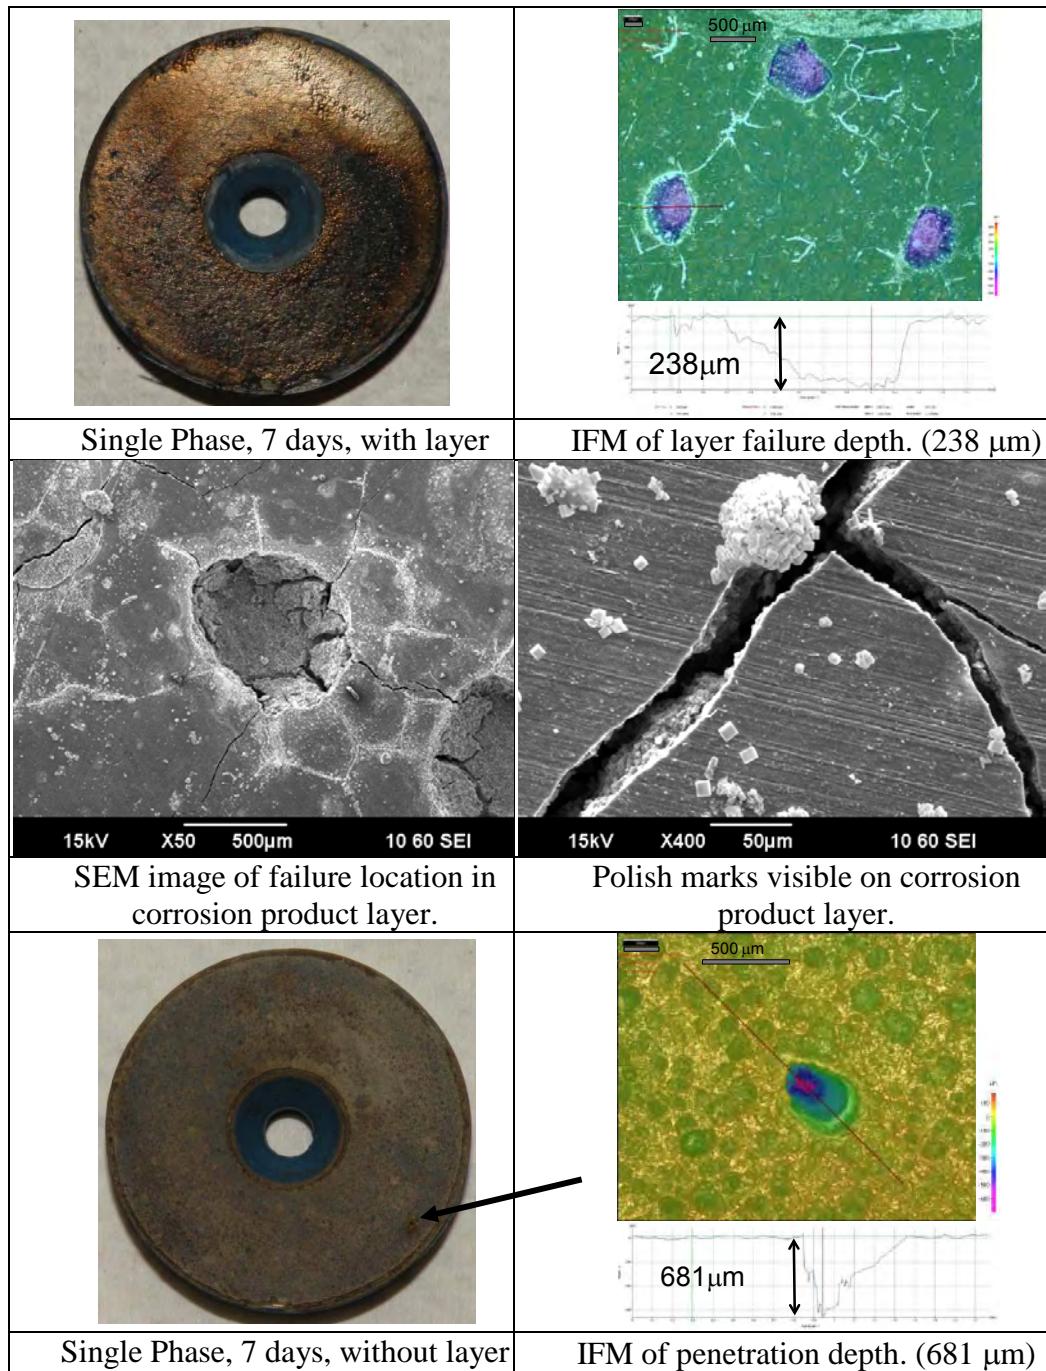
Figure 88. Exp 12. Sample #51. Analysis of WL sample exposed in 60°C, $\text{pCO}_2 = 7.7$ bar, $\text{pH}_2\text{S} = 10$ mbar, 10 wt% NaCl, single phase flow, for 7 days. pH 4.5. General Corrosion rate = 10.8 mm/yr; pit penetration rate = 36.3 mm/yr; Ratio = 3.4; Layer weight = 0.9 grams; multiple smaller pits of ~150 μm (8 mm/yr) were observed.

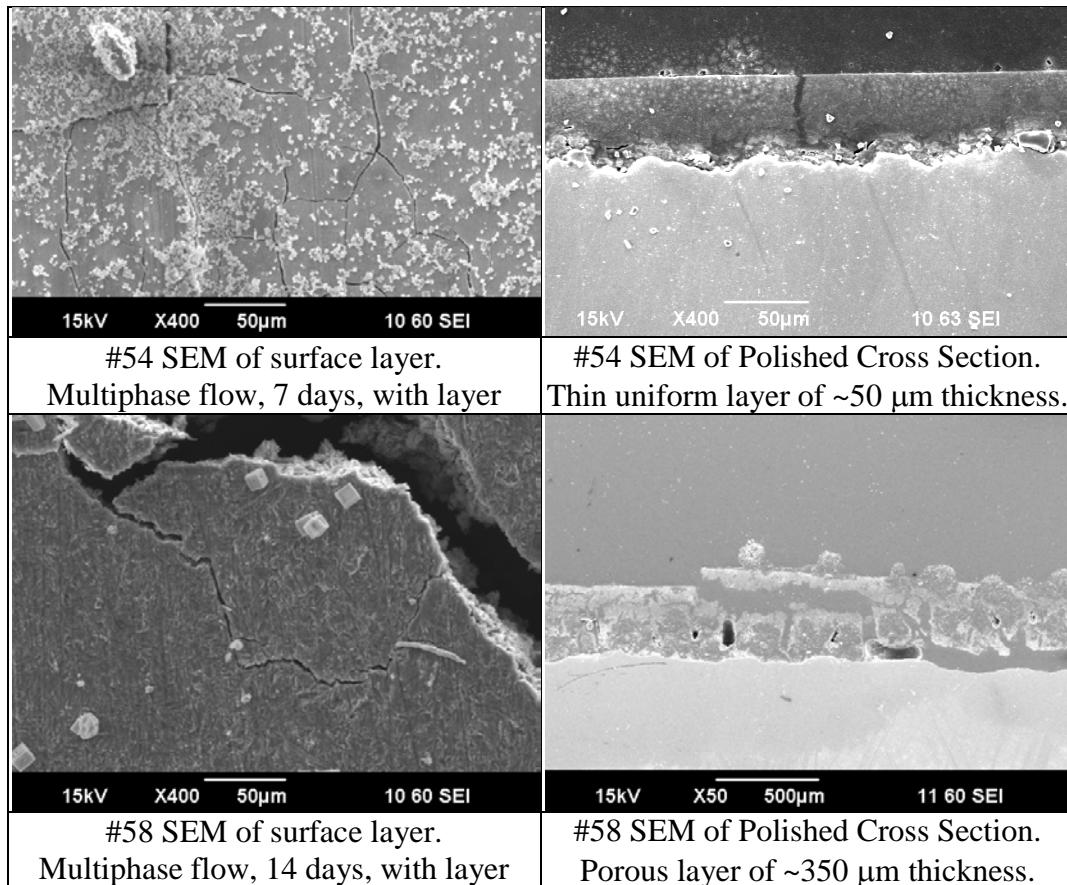
Figure 89. Exp 12. Analysis of corrosion product layer thickness for two WL samples exposed in 60°C, pCO₂ = 7.7 bar, pH₂S = 10 mbar, 10 wt.% NaCl, multiphase phase flow, for 7 and 14 days.

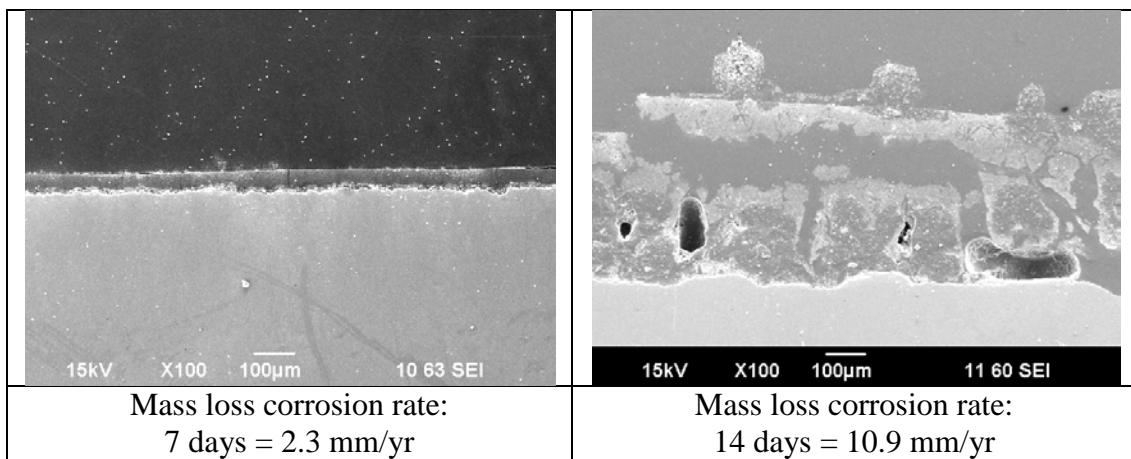
Figure 90. Exp 12. Direct comparison of corrosion product layer thickness for two WL samples exposed in 60°C, pCO₂ = 7.7 bar, pH₂S = 10 mbar, 10 wt.% NaCl, multiphase phase flow, for 7 and 14 days.

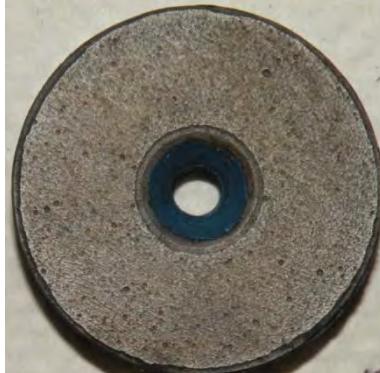
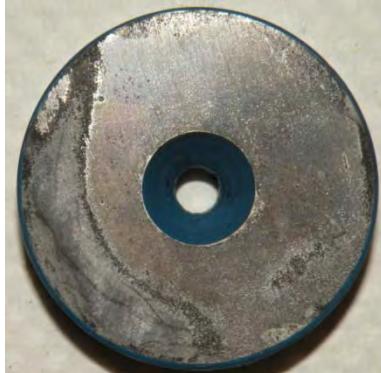
Multiphase, 21 days, without layer	Multiphase, 21 days, without layer

Sample #55 – Multiphase, 21 days	Sample #57 – Multiphase, 21 days
General Corrosion rate = 8.6 mm/yr	General Corrosion rate = 0.16 mm/yr
0.36 g layer weight	0.004 g layer weight
Pit depth = 149 µm	Pit depth = 58 µm
Pit penetration rate = 2.6 mm/yr	Pit penetration rate = 1.0 mm/yr
Ratio = 0.3	Ratio = 6.3

The SEM images at 400x magnification (top of Figure 91) show that the polish marks of the original surface are still visible after 21 days, but the overall view of the samples without the corrosion product layer shows the difference unequivocally. The sample on the left (#55) shows a uniform corrosion that was calculated by weight loss to be 8.6 mm/yr. Pit penetration depths of up to 149 µm were measured by IFM on sample #55 and are equivalent to a 2.6 mm/yr penetration rate. Notice that the 21 day weight loss sample on the right (#57) had an uneven corrosion occurring across the surface. This WL sample also had a negligible general corrosion rate of 0.16 mm/yr with a single pit of 58.5µm depth found for a penetration rate of 1 mm/yr, making sample #57 have the highest pitting ratio with the lowest pit penetration rate found in this series.

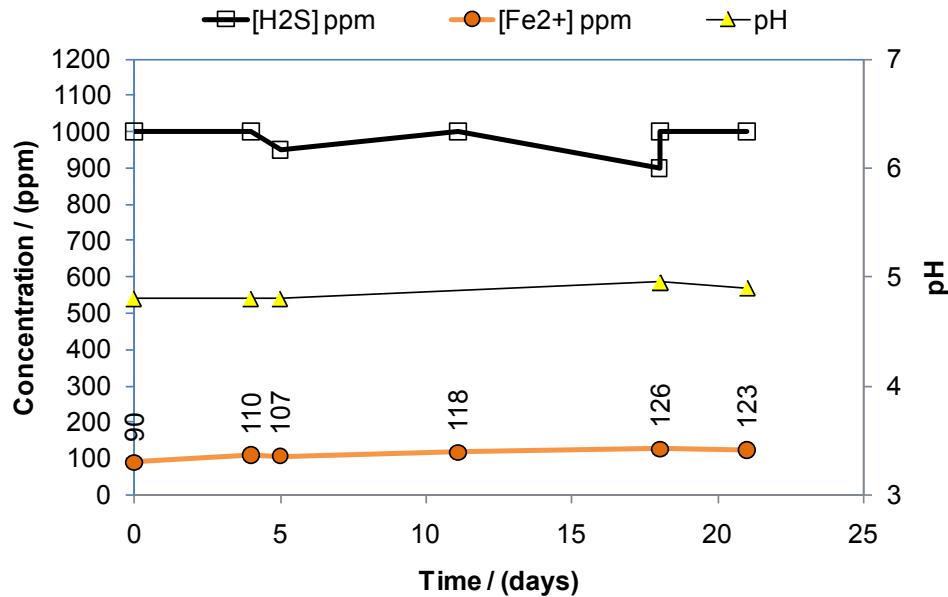
Figure 97. Exp 8: As measured concentrations of hydrogen sulfide and iron ions with pH. Information necessary to calculate saturation values of iron sulfide and iron carbonate. (60°C, 7.7 bar pCO₂, 10 mbar pH₂S, 1wt% NaCl, pH 5)

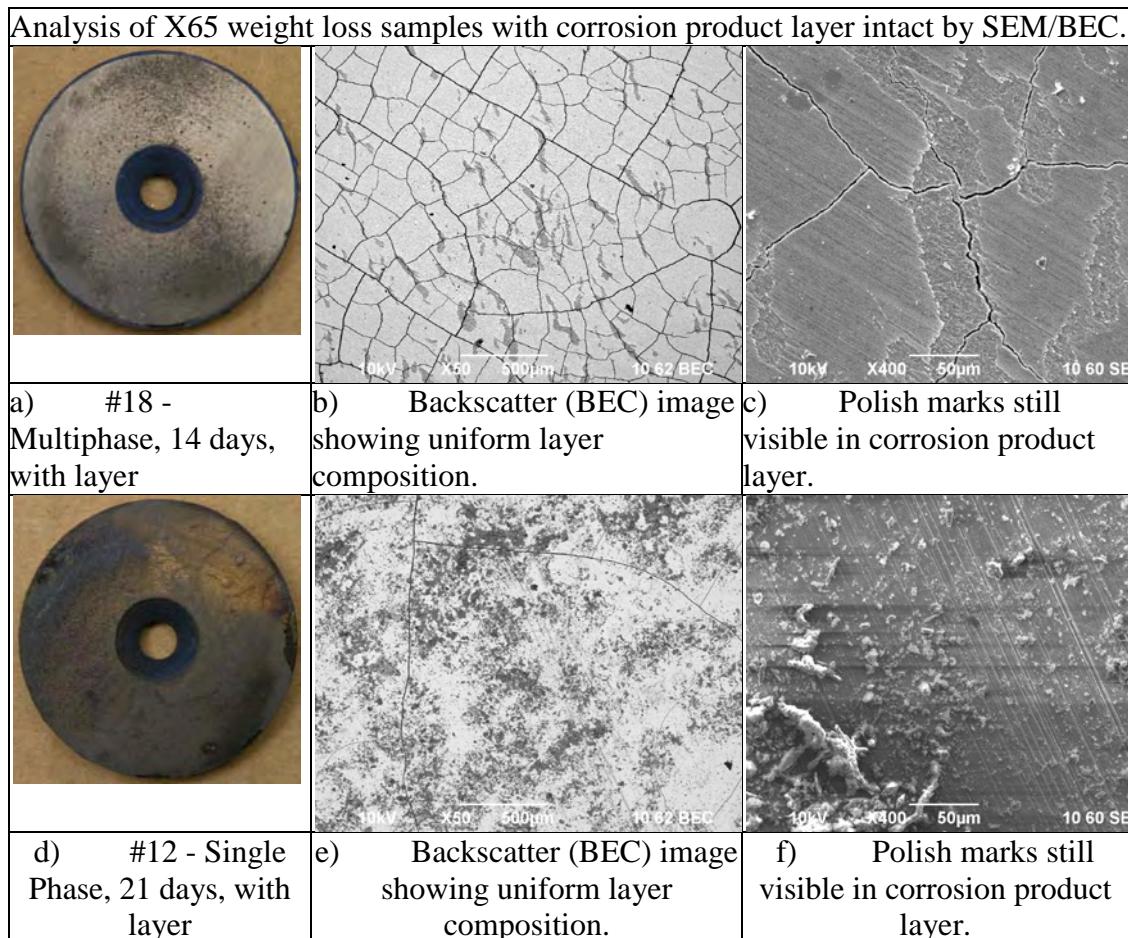
Figure 100. Examples of corrosion product layers formed in multiphase flow after 14 days and in single phase flow after 21 days at 60°C, 7.7 bar pCO₂, 10 mbar pH₂S, 1wt% NaCl, pH 5. (BEC images at 50X magnification and SEM images at 400X magnification.)

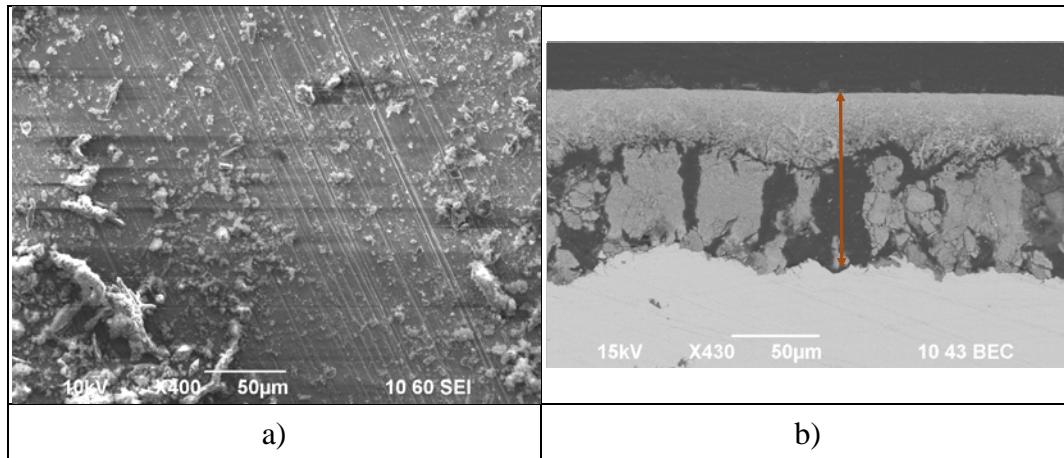
Figure 101. SEM images of surface (a) and cross-section (b) for X65 sample #12 after 21 day exposure to single phase H₂S system conditions of 60°C, 7.7 bar pCO₂, 10 mbar pH₂S, 1 m/s V_{sl}.

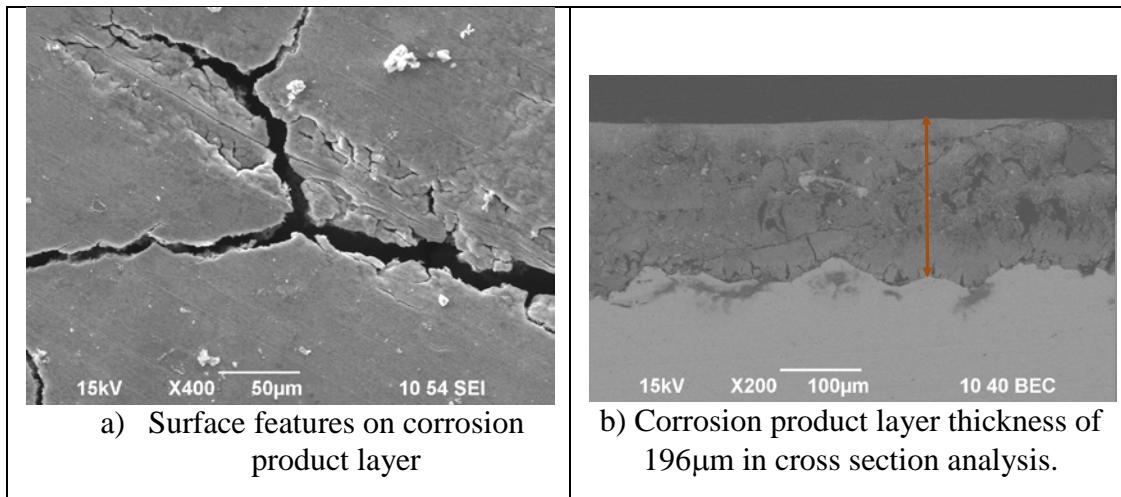
Figure 102. SEM images of surface (a) and cross-section (b) for X65 sample #15 after 21 day exposure to multiphase H₂S system conditions of 60°C, 7.7 bar pCO₂, 10 mbar pH₂S, 1 m/s V_{sl}. (196 μm in 21 days = 3.4 mm/yr)

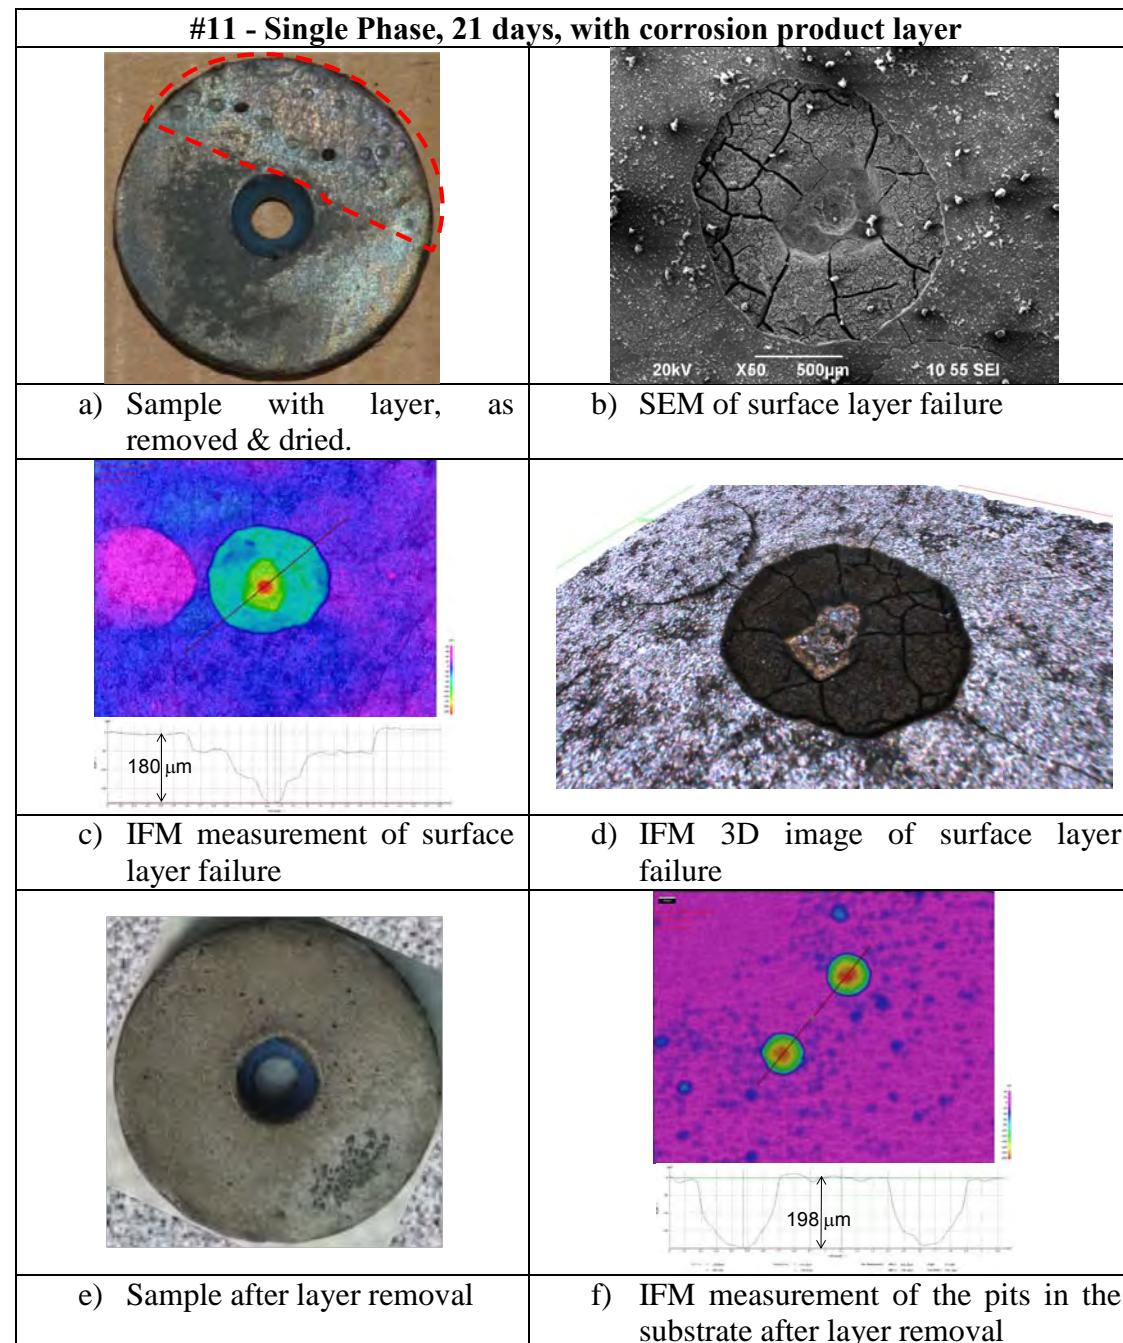
Figure 103. Aspects of analysis for X65 weight loss sample after 21 day exposure in H₂S flow loop. (Single phase, 60°C, 7.7 bar pCO₂, 10 mbar pH₂S, pH 5, 1 m/s V_{sl}).

Figure 104. SEM images at increased magnification of local corrosion product failure from Figure 103b. (Sample 11, 21 days, with corrosion product layer, single phase, 60°C, 7.7 bar pCO₂, 10 mbar pH₂S, pH 5, 1 m/s V_{sl}).

Figure 105. Spot EDS of materials observed in center of local corrosion product failure from Figure 103b. (Sample 11, 21 days, with corrosion product layer, single phase, 60°C, 7.7 bar pCO_2 , 10 mbar pH_2S , pH 5, 1 m/s V_{sl}).

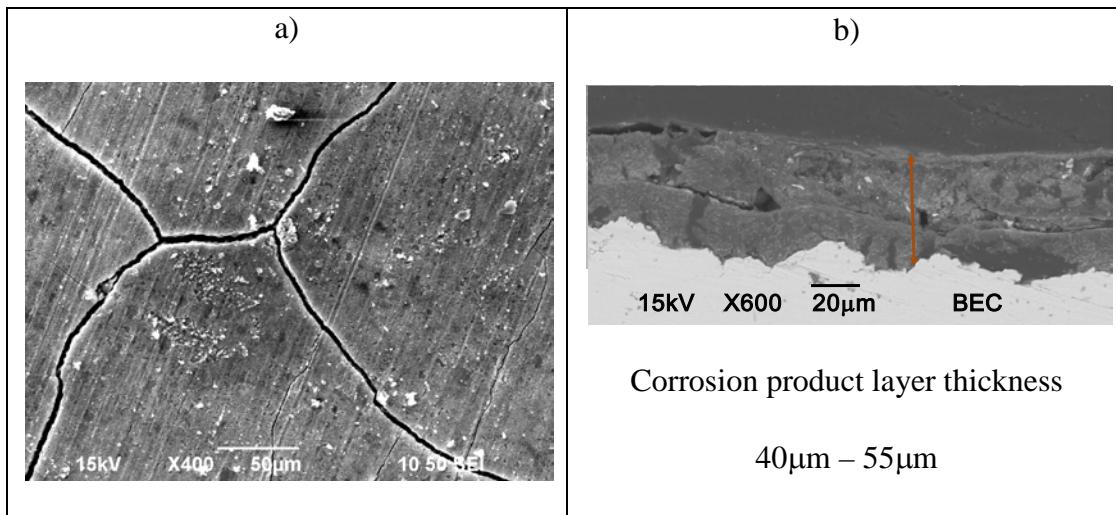
Figure 109. SEM images of surface (a) and cross-section (b) for X65 sample #04 after 21 day exposure to multiphase H₂S system conditions of 60°C, 7.7 bar pCO₂, 0.1 mbar pH₂S, 1 m/s V_{sl}, 3 m/s V_{sg}.

Figure 111. Polish marks visible in SEM image of the corrosion product layer for X65 sample #02 as lines from the upper left to the lower right. A portion of Figure 110(a) is magnified to match the physical measurement shown in Figure 109(a).

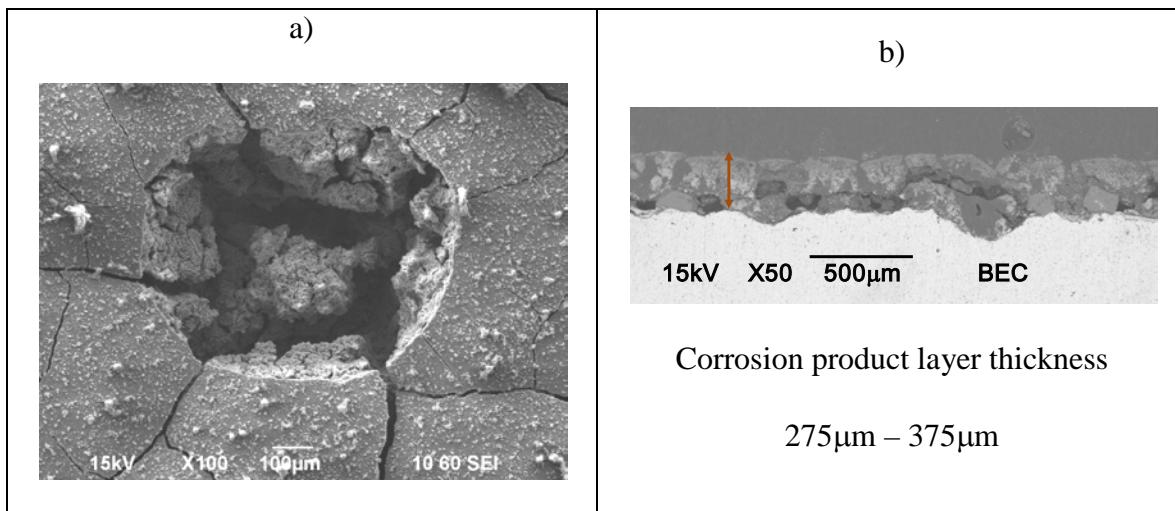
Figure 110. SEM images of surface (a) and cross-section (b) for X65 sample #02 after 21 day exposure to single phase H₂S system conditions of 60°C, 7.7 bar pCO₂, 0.1 mbar pH₂S, 1 m/s V_{sl}.

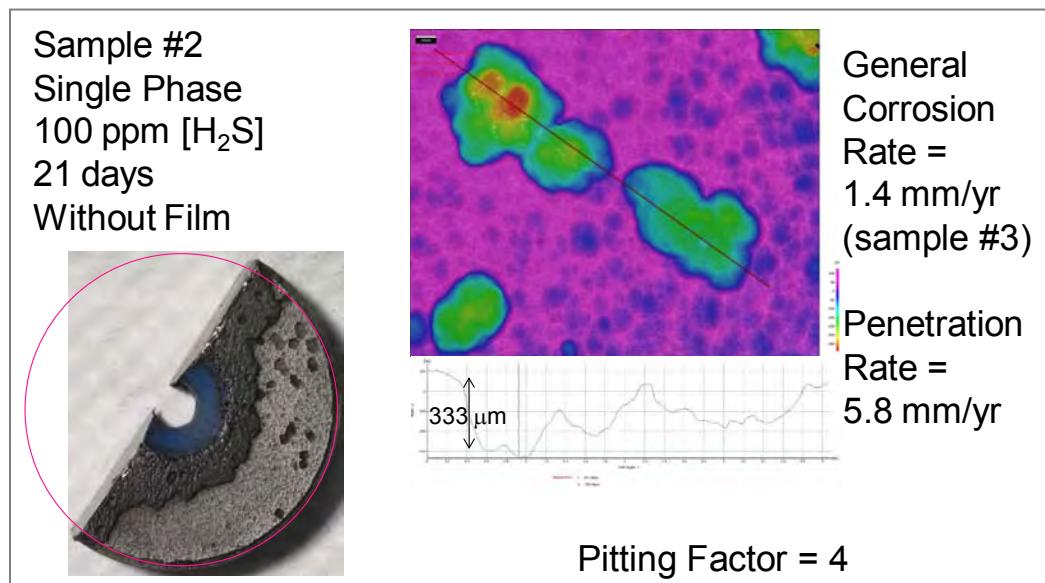
Figure 112. Exp 7: Picture of weight loss sample plus IFM surface imaging of X65 coupon exposed for 21 days in single phase flow for conditions: 60°C, pH 5.0, pCO₂ = 7.7 bar, 1.0 mbar H₂S, 1 wt% NaCl. (General corrosion rate was calculated from Sample #3.)

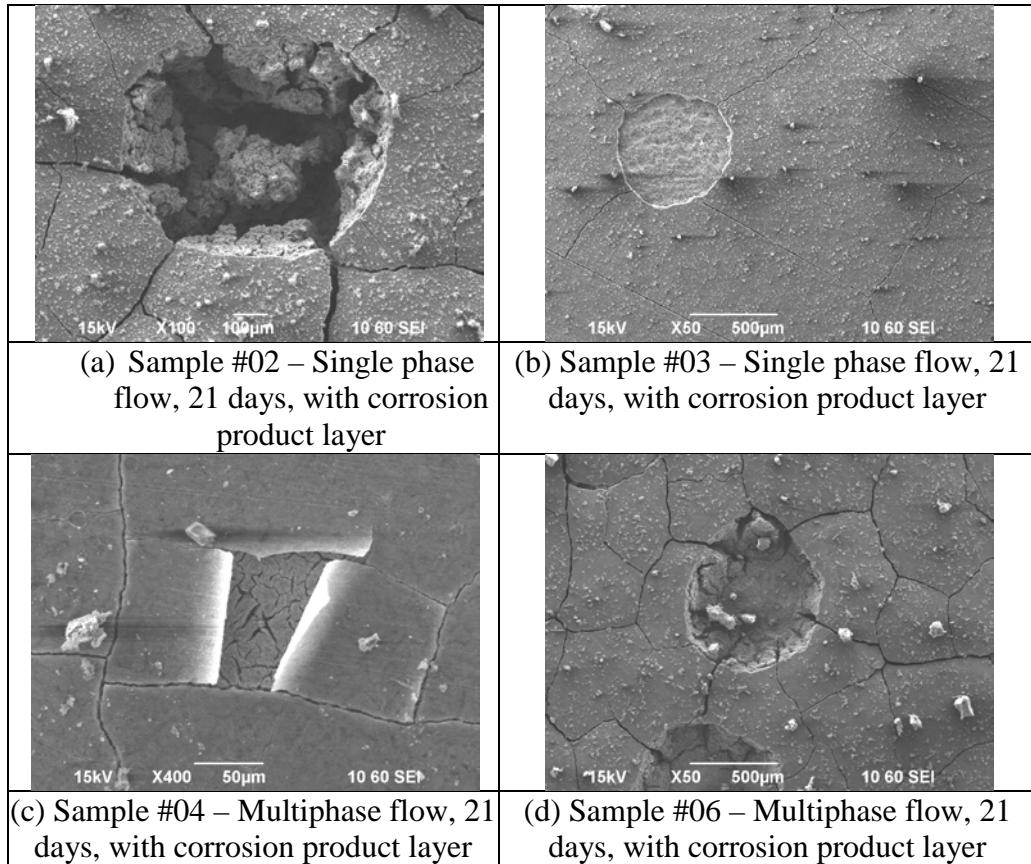
Figure 113. SEM image evidence of an upper corrosion product layer different from the underlying corrosion product layer after 21 days on four samples exposed to H₂S system conditions of 60°C, 7.7 bar pCO₂, 0.1 mbar pH₂S, 1 m/s V_{sl}, 3 m/s V_{sg}.

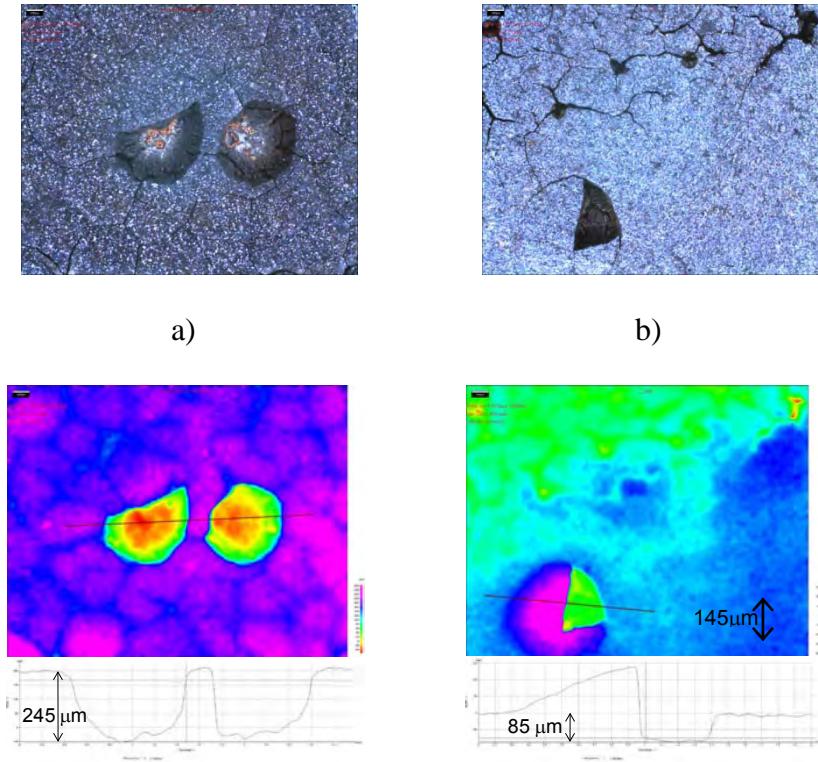
Figure 114. IFM images and analysis of the corrosion product layer on sample #06 showing (a) open pit failures up to 245 μm in depth [1.2 & 1.0 mm diameter, L to R] and (b) a partial layer failure with a raised corrosion product layer [1.3 mm diameter].

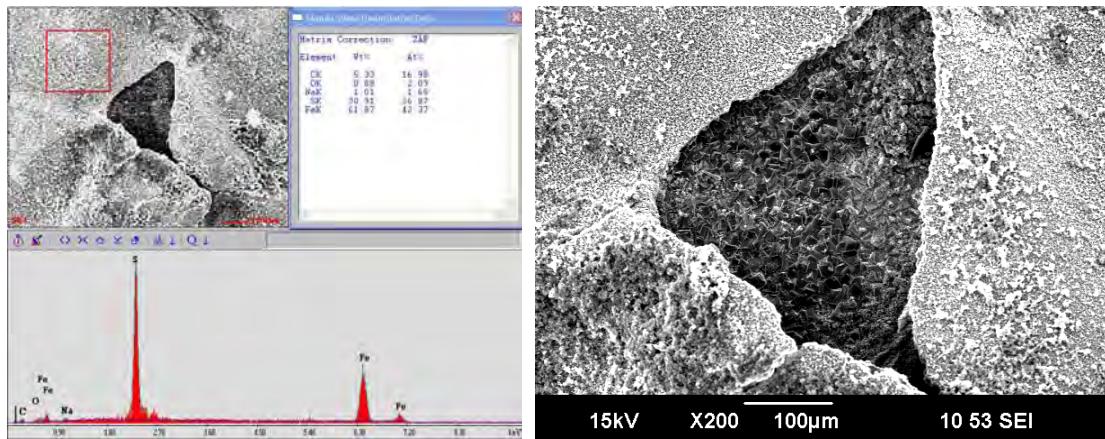
Figure 119. Exp 10. SEM / EDS analysis 14 day WL sample, iron sulfide corrosion product layer cover, 60°C, pH 6, pCO₂ = 2.8 bar, pH₂S = 10 mbar, 1 wt% NaCl

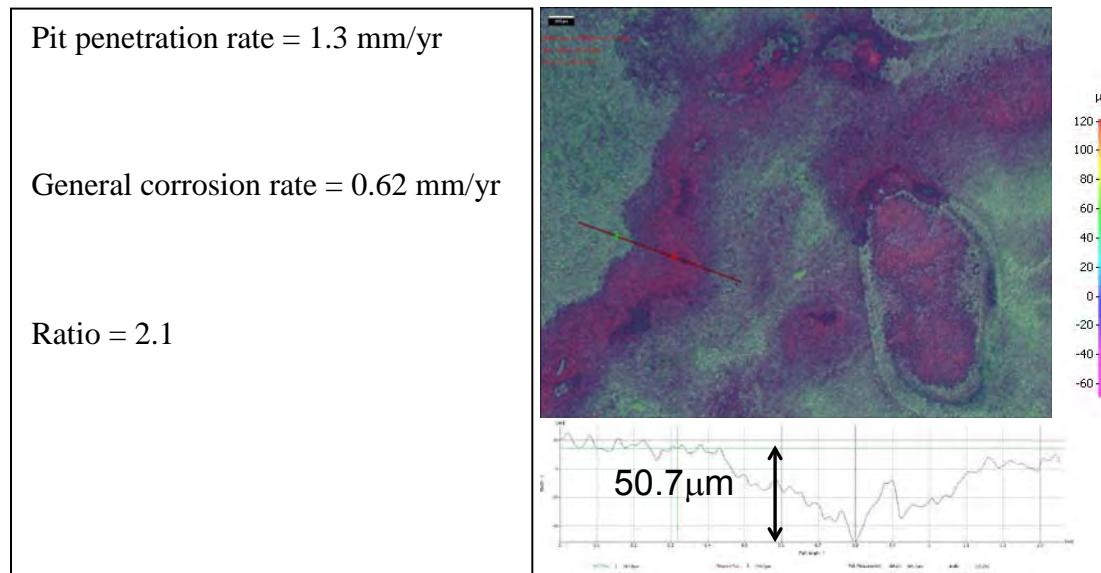
Figure 122. Exp 10. IFM analysis with corrosion product removed, 14 day sample, single phase flow, 60°C, pH 6, pCO₂ = 2.8 bar, pH₂S = 10 mbar, 1 wt% NaCl

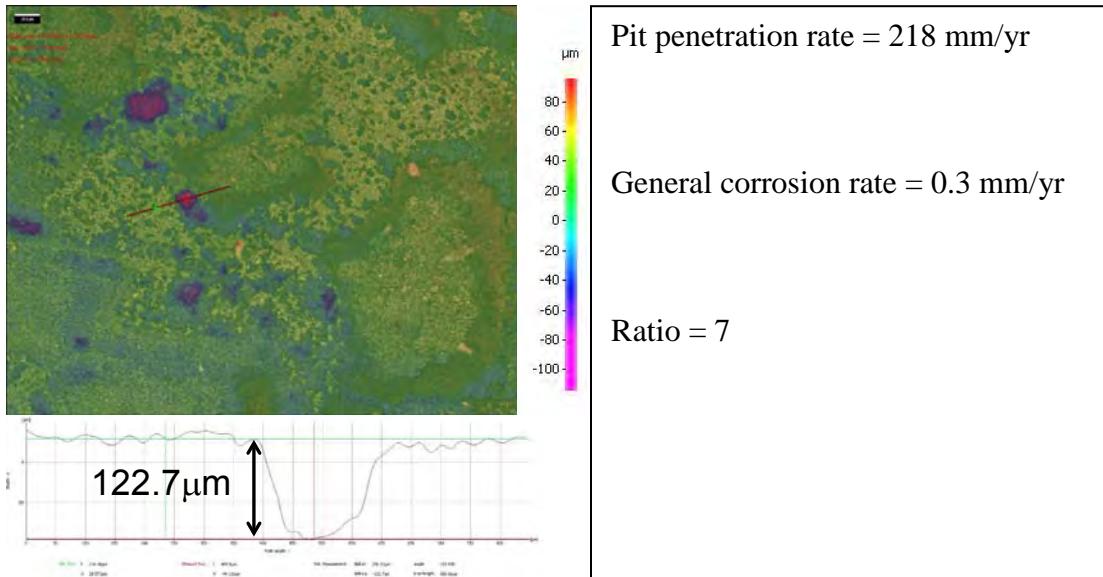
Figure 128. Exp 10. IFM analysis of sample WITHOUT corrosion product layer, Single phase flow, 21 days, 60°C, pH 6, pCO₂ = 2.8 bar, pH₂S = 10 mbar, 1 wt% NaCl

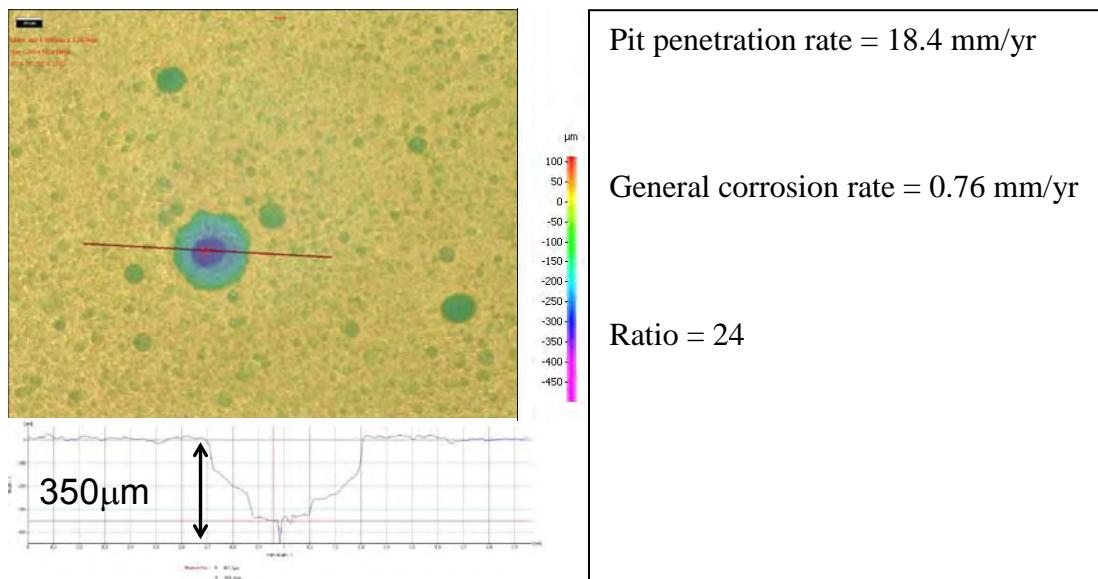
Figure 138. Exp 11. IFM of WL sample WITHOUT corrosion product layer. stratified flow, 40°C, pH 5, pCO₂ = 2.8 bar, pH₂S = 4 mbar, 1 wt% NaCl, 7 days.

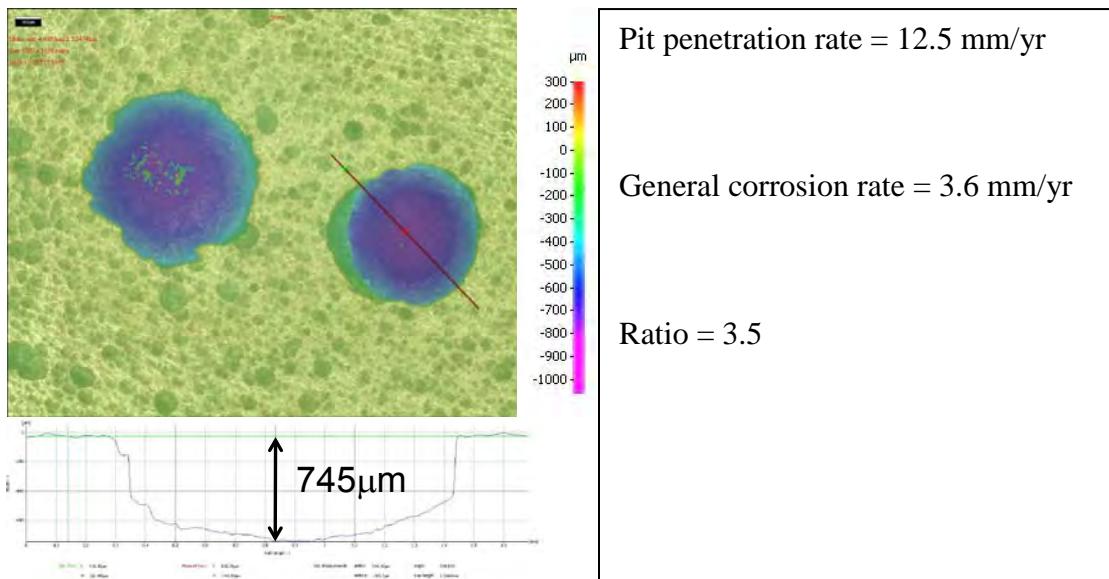
Figure 140. Exp 11. IFM of WL sample WITHOUT corrosion product layer, 21 days, stratified flow, 40°C, pH 5, $p\text{CO}_2 = 2.8$ bar, $p\text{H}_2\text{S} = 4$ mbar, 1 wt% NaCl

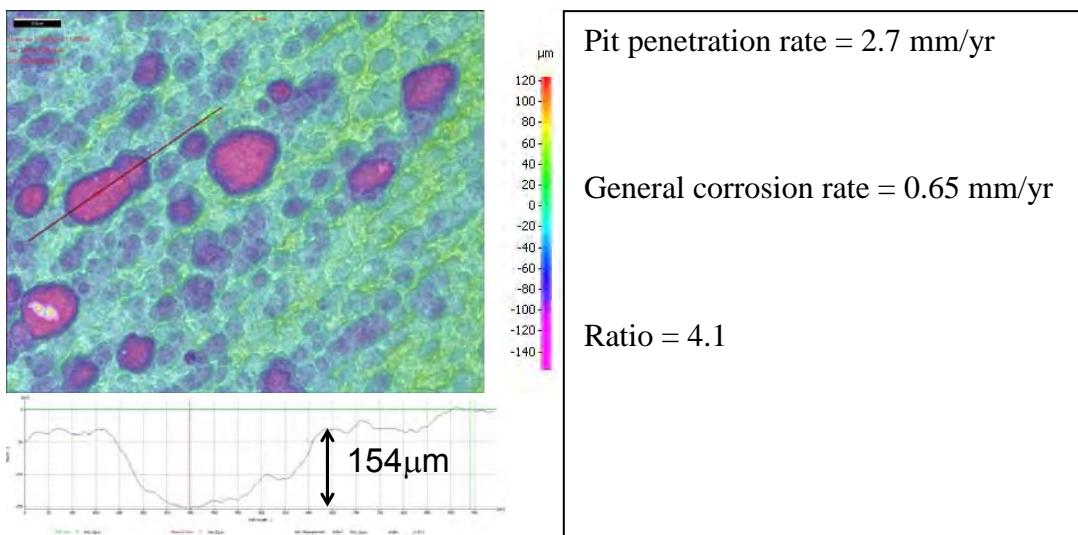
Figure 145. Exp 11. IFM analysis without corrosion product layer, 21 days, single phase flow, 40°C, pH 5, $p\text{CO}_2 = 2.8$ bar, $p\text{H}_2\text{S} = 4$ mbar, 1 wt% NaCl

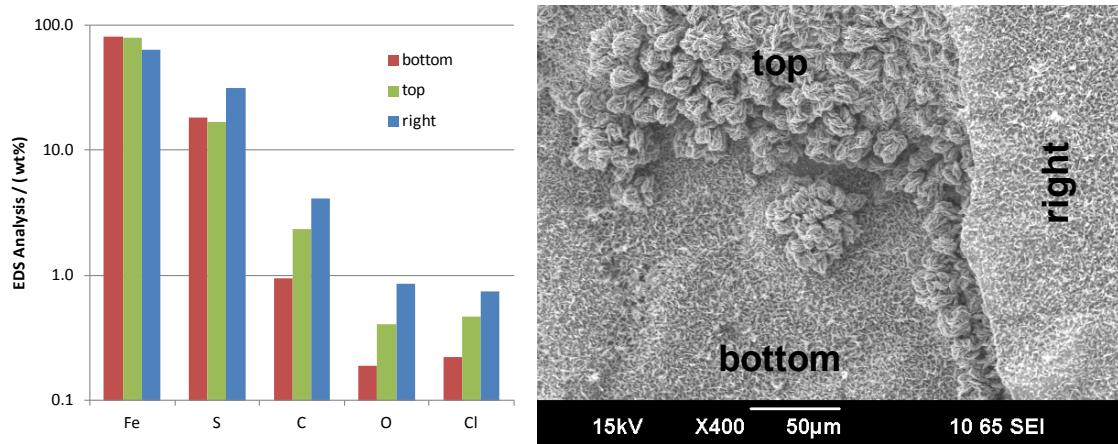
Figure 153. EDS analysis of corrosion product layer surface features. 25°C, pH 5.0, pCO₂ = 2.8 bar, pH₂S = 100 mbar, 1 wt.% NaCl, 7 days.

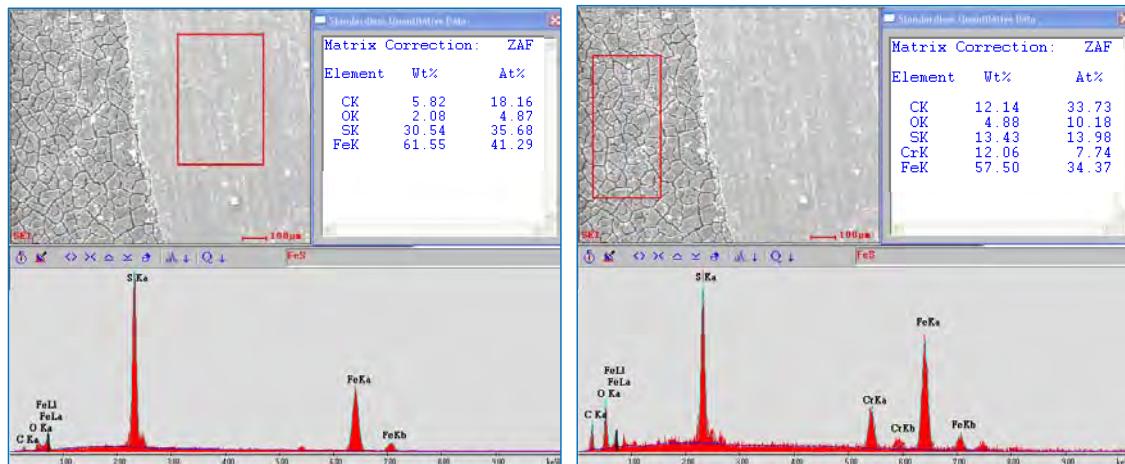
Figure 160. Corrosion product layer has two components. The top layer shows the polish marks (left side image), while the bottom layer could be described as the remaining carbide layer or an iron depleted substrate. Multiphase flow, 7 days' exposure to conditions, 25°C, pH 5, pCO₂ = 2 bar, pH₂S = 100 mbar, 1 wt% NaCl solution.

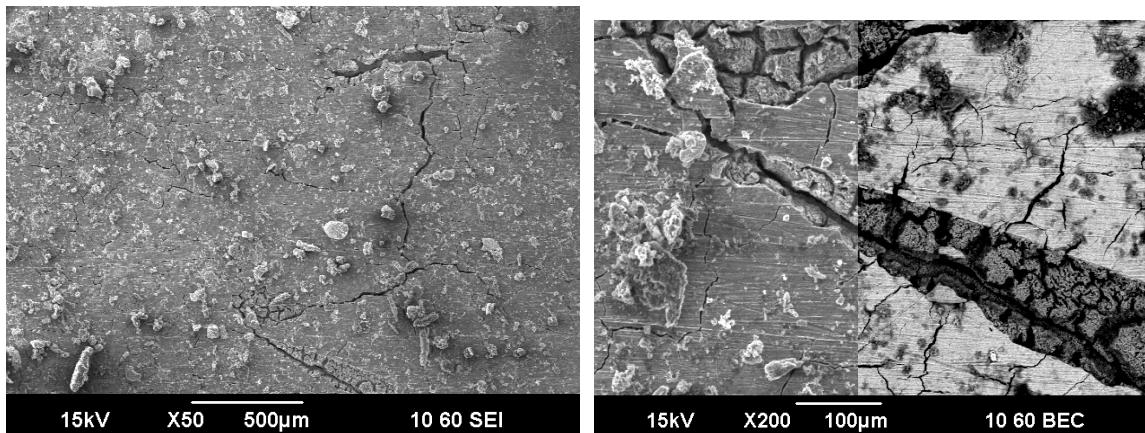
Figure 162. Thin layer, top layer failure. Multiphase 21 days, thin layer, top layer failure. Polish marks are still visible. Multiphase flow after 21 days exposure to conditions, 25°C, pH 5, pCO₂ = 2 bar, pH₂S = 100 mbar, 1 wt% NaCl solution.

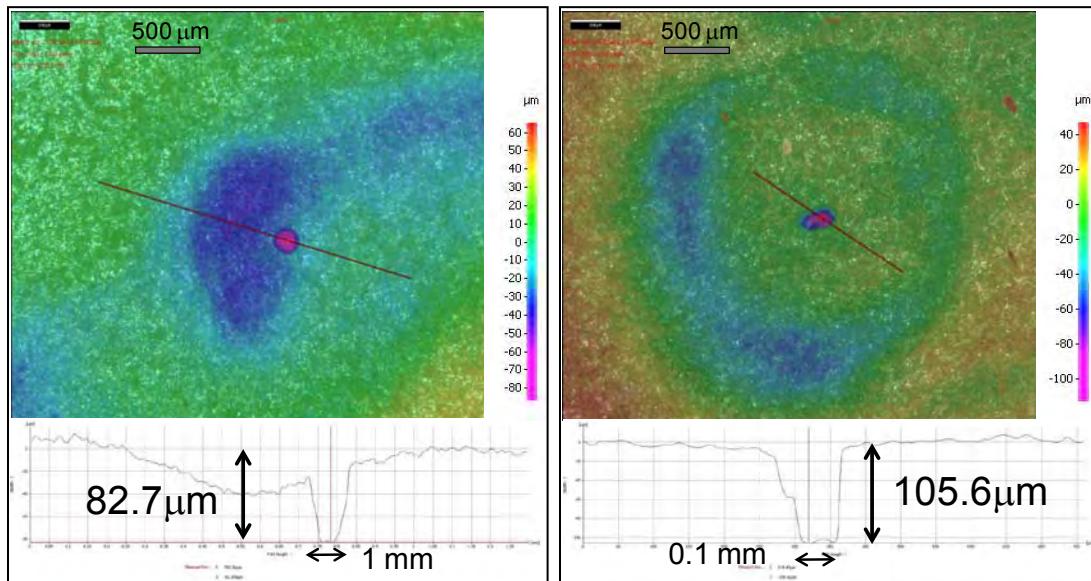
Figure 178. Similar areas of corrosion initiation at 7 days (left) and at 14 days (right) exposure to conditions 40°C , pH 5, $\text{pCO}_2 = 2.8$ bar, $\text{pH}_2\text{S} = 100$ mbar, 1 wt% NaCl solution.

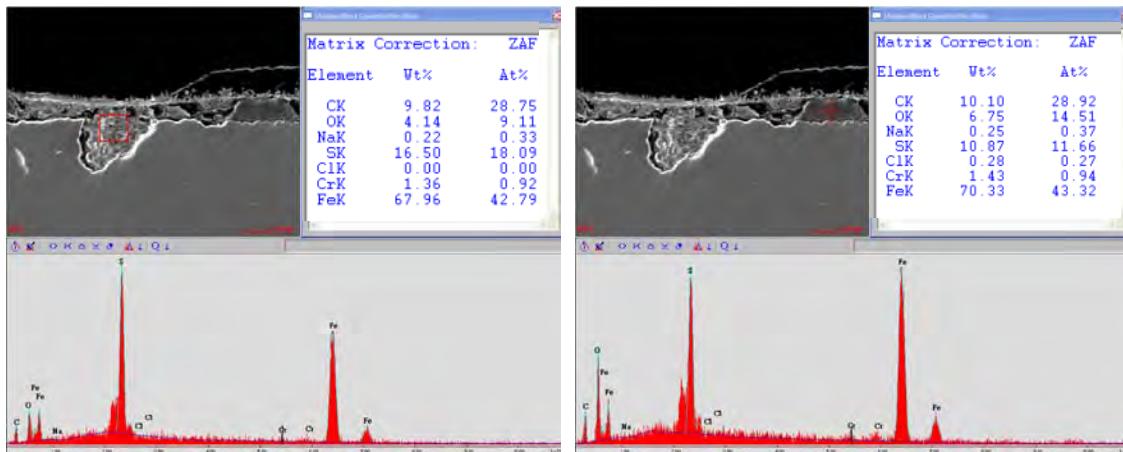
Figure 184. EDS analysis shows lower sulfur content underneath the “lifted” thin layer. Multiphase flow, 21 days, 40°C, pH 5, $p\text{CO}_2 = 2.8$ bar, $\text{pH}_2\text{S} = 100$ mbar, 1 wt% NaCl solution.

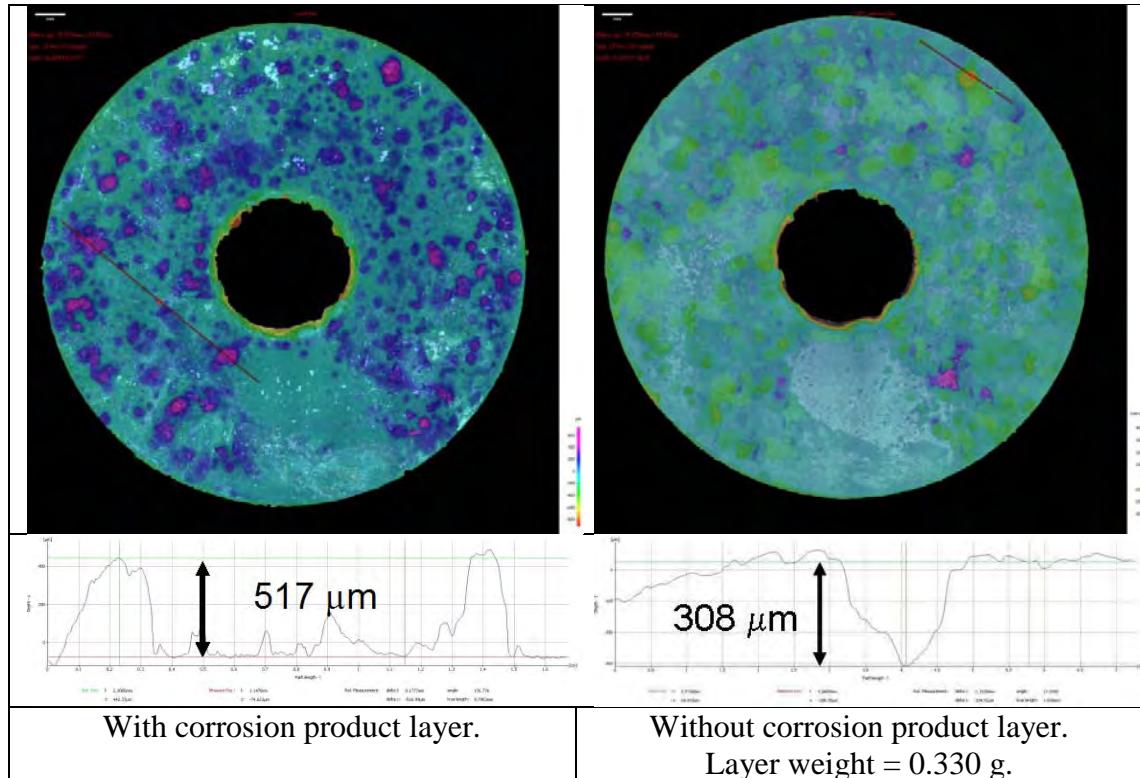
Figure 187. WL coupon after 10 days exposure to conditions in single phase flow.

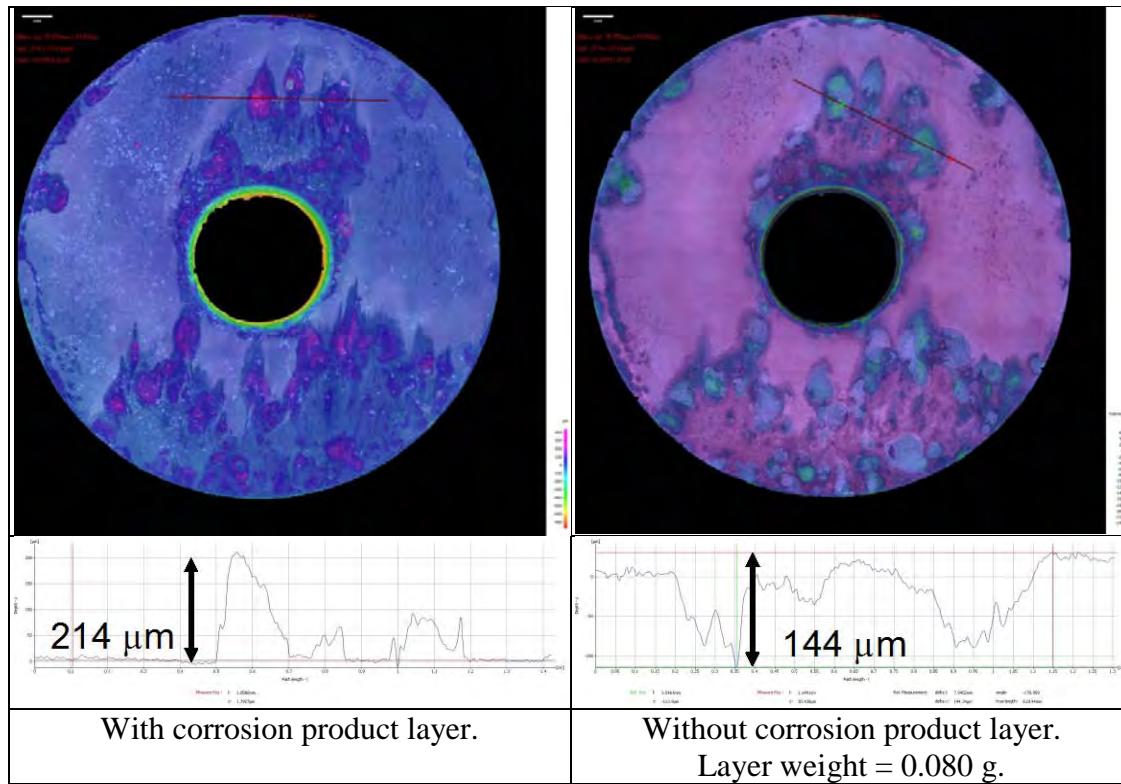
Figure 188. WL samples after 10 days exposure to initial conditions in multiphase flow.
